Suggested citation: Gómez-Fragoso, Julieta, and Torres-Sierra, Heriberto, 2016, Dam failure analysis for the Lago El Guineo Dam, Orocoivi, Puerto Rico: U.S. Geological Survey Scientific Investigations Report 2016-5070, 49 p., <http://dx.doi.org/10.3133/sir20165070>.

## Flood-Inundation Map During Sunny Day Conditions, Northern Part of Rio Grande de Manati Basin

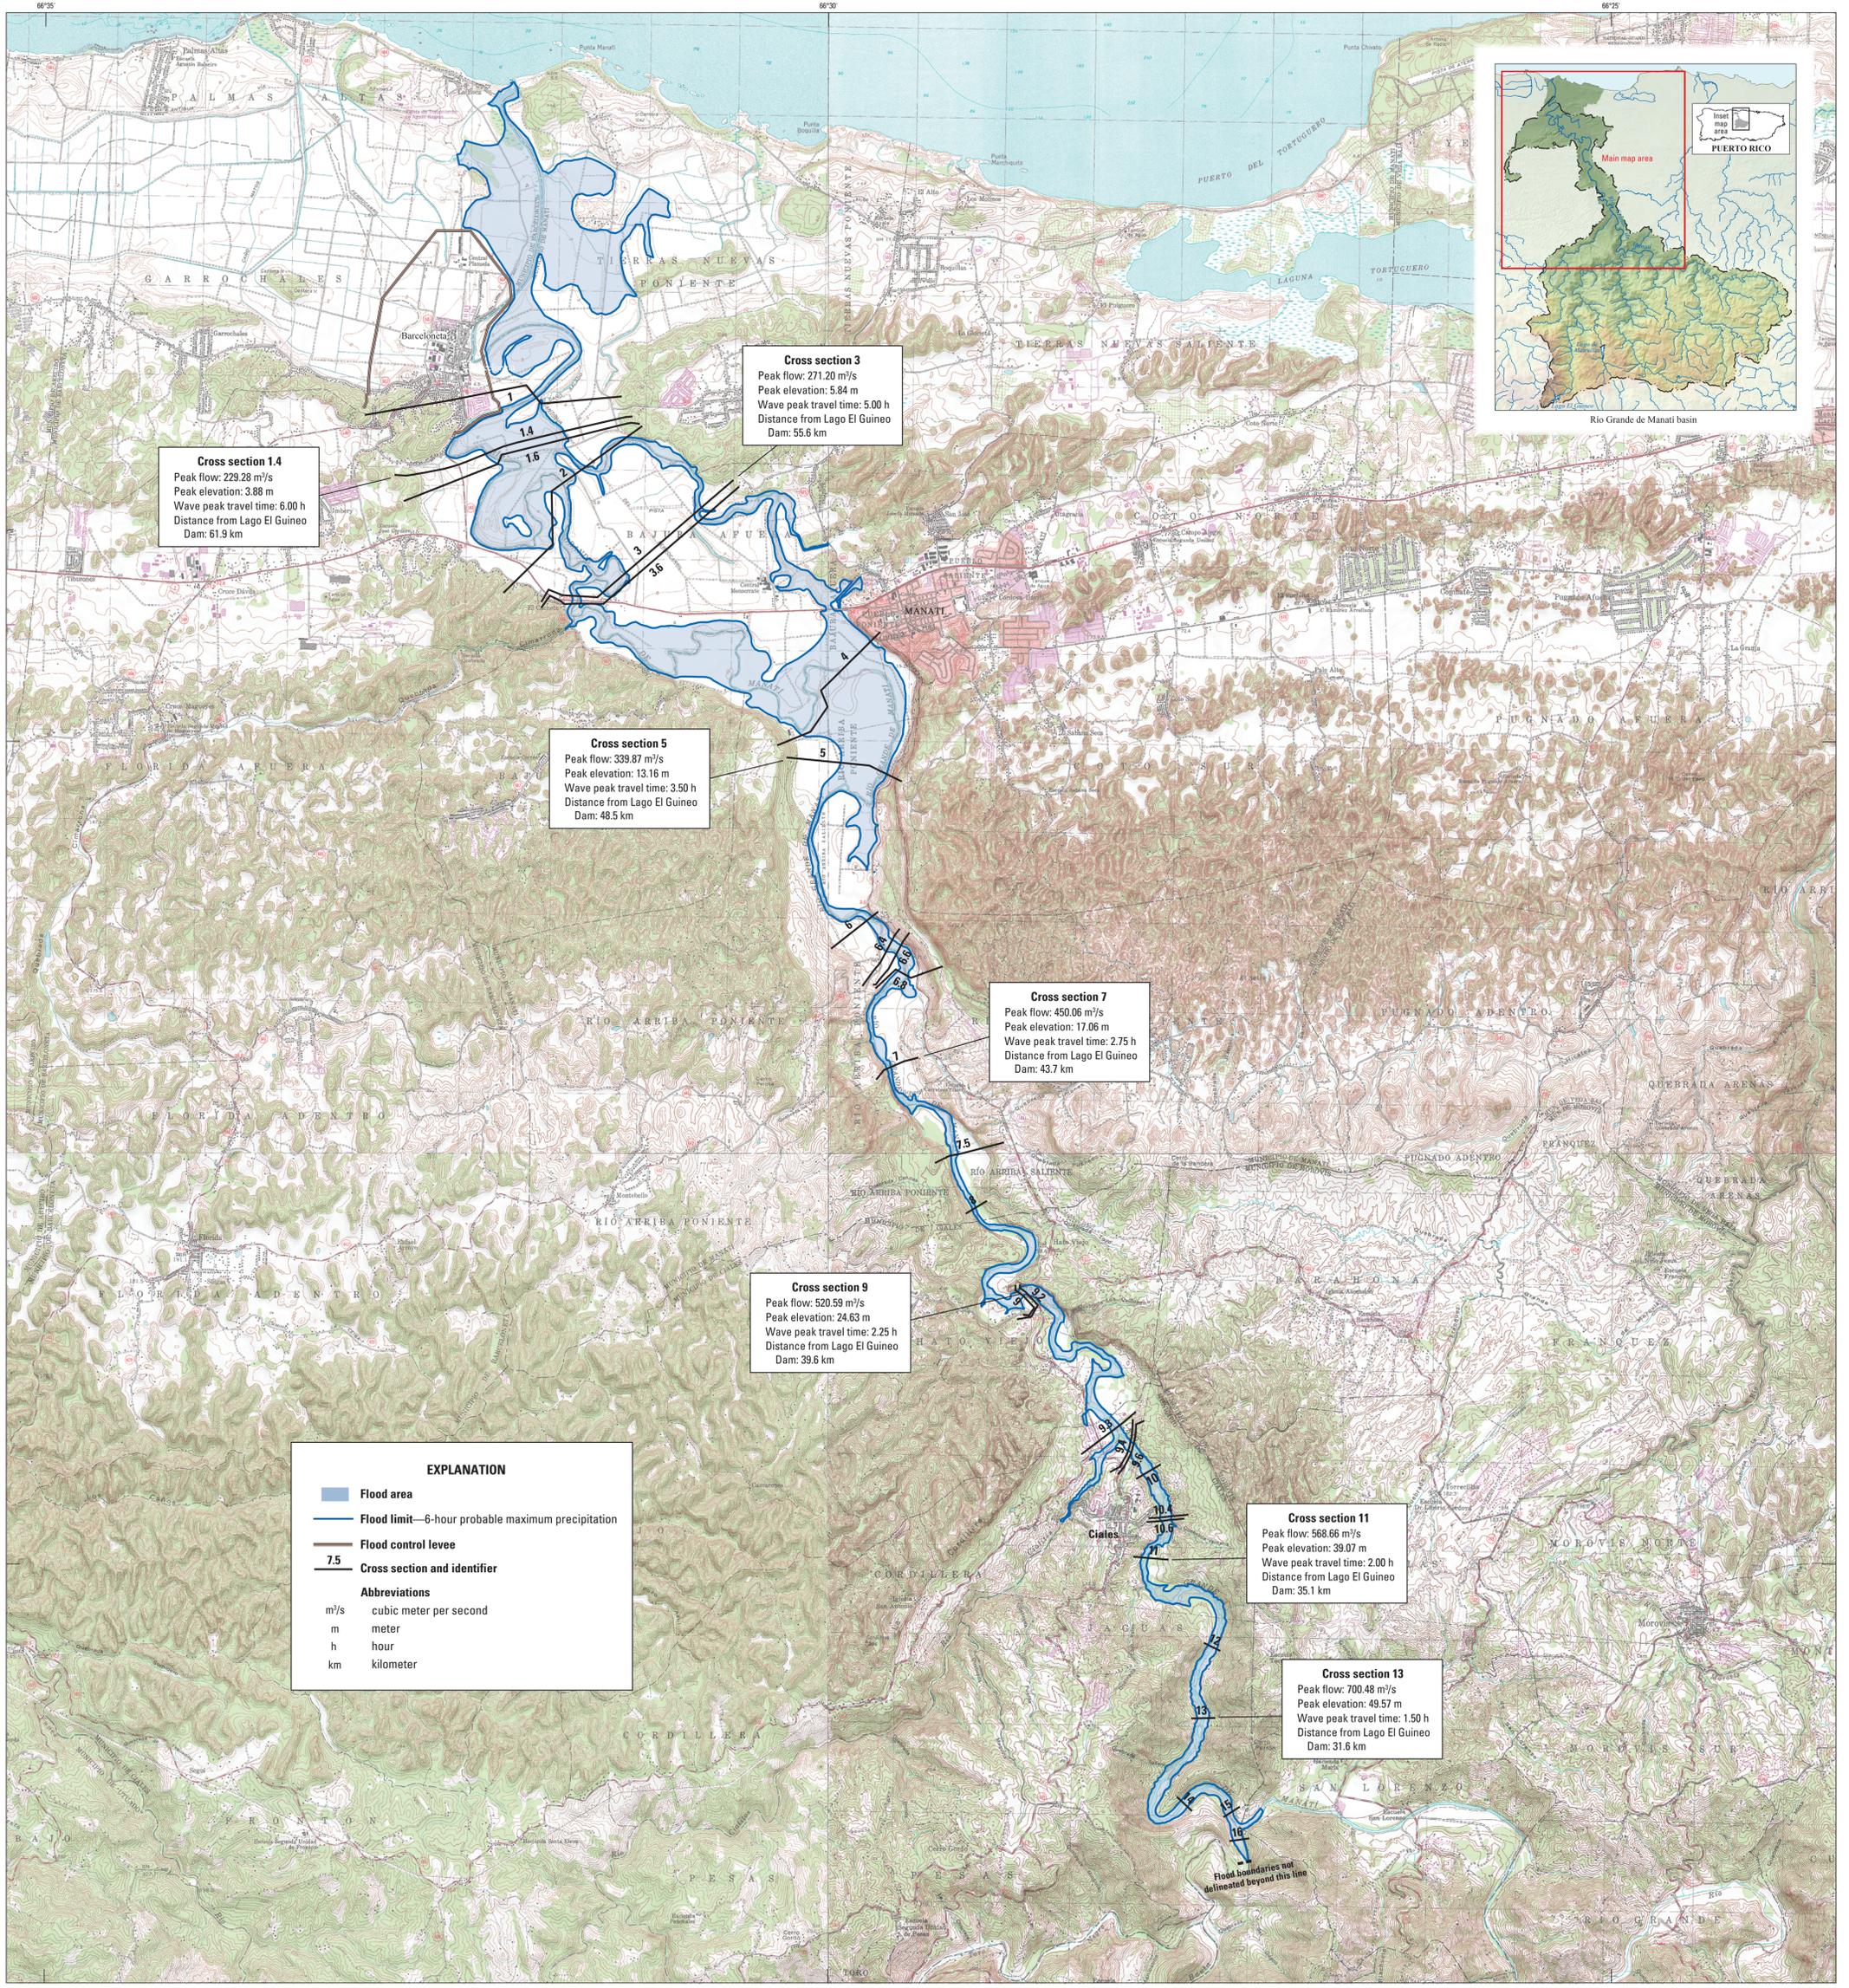
Base modified from U.S. Geological Survey Digital Raster Graphics for Barceloneta, Manati, Florida, and Ciales, 1:25,000. Elevation from U.S. Geological Survey National Elevation Dataset (NED). Lambert conformal conic projection, Puerto Rico Datum, 1940 Adjustment. Flood area delineated from hydraulic model results using the U.S. Army Corps of Engineers, Hydrologic Engineer Center's River Analysis System (HEC-RAS).
