Bathymetric Contour Map and Surface Area and Capacity Table for Number 41 Lake (Milan Golf Course Lake; lake 18) near Milan, Missouri, 2020

By
Richard J. Huizinga, Benjamin C. Rivers, Joseph M. Richards, and Garrett J. Waite
2023

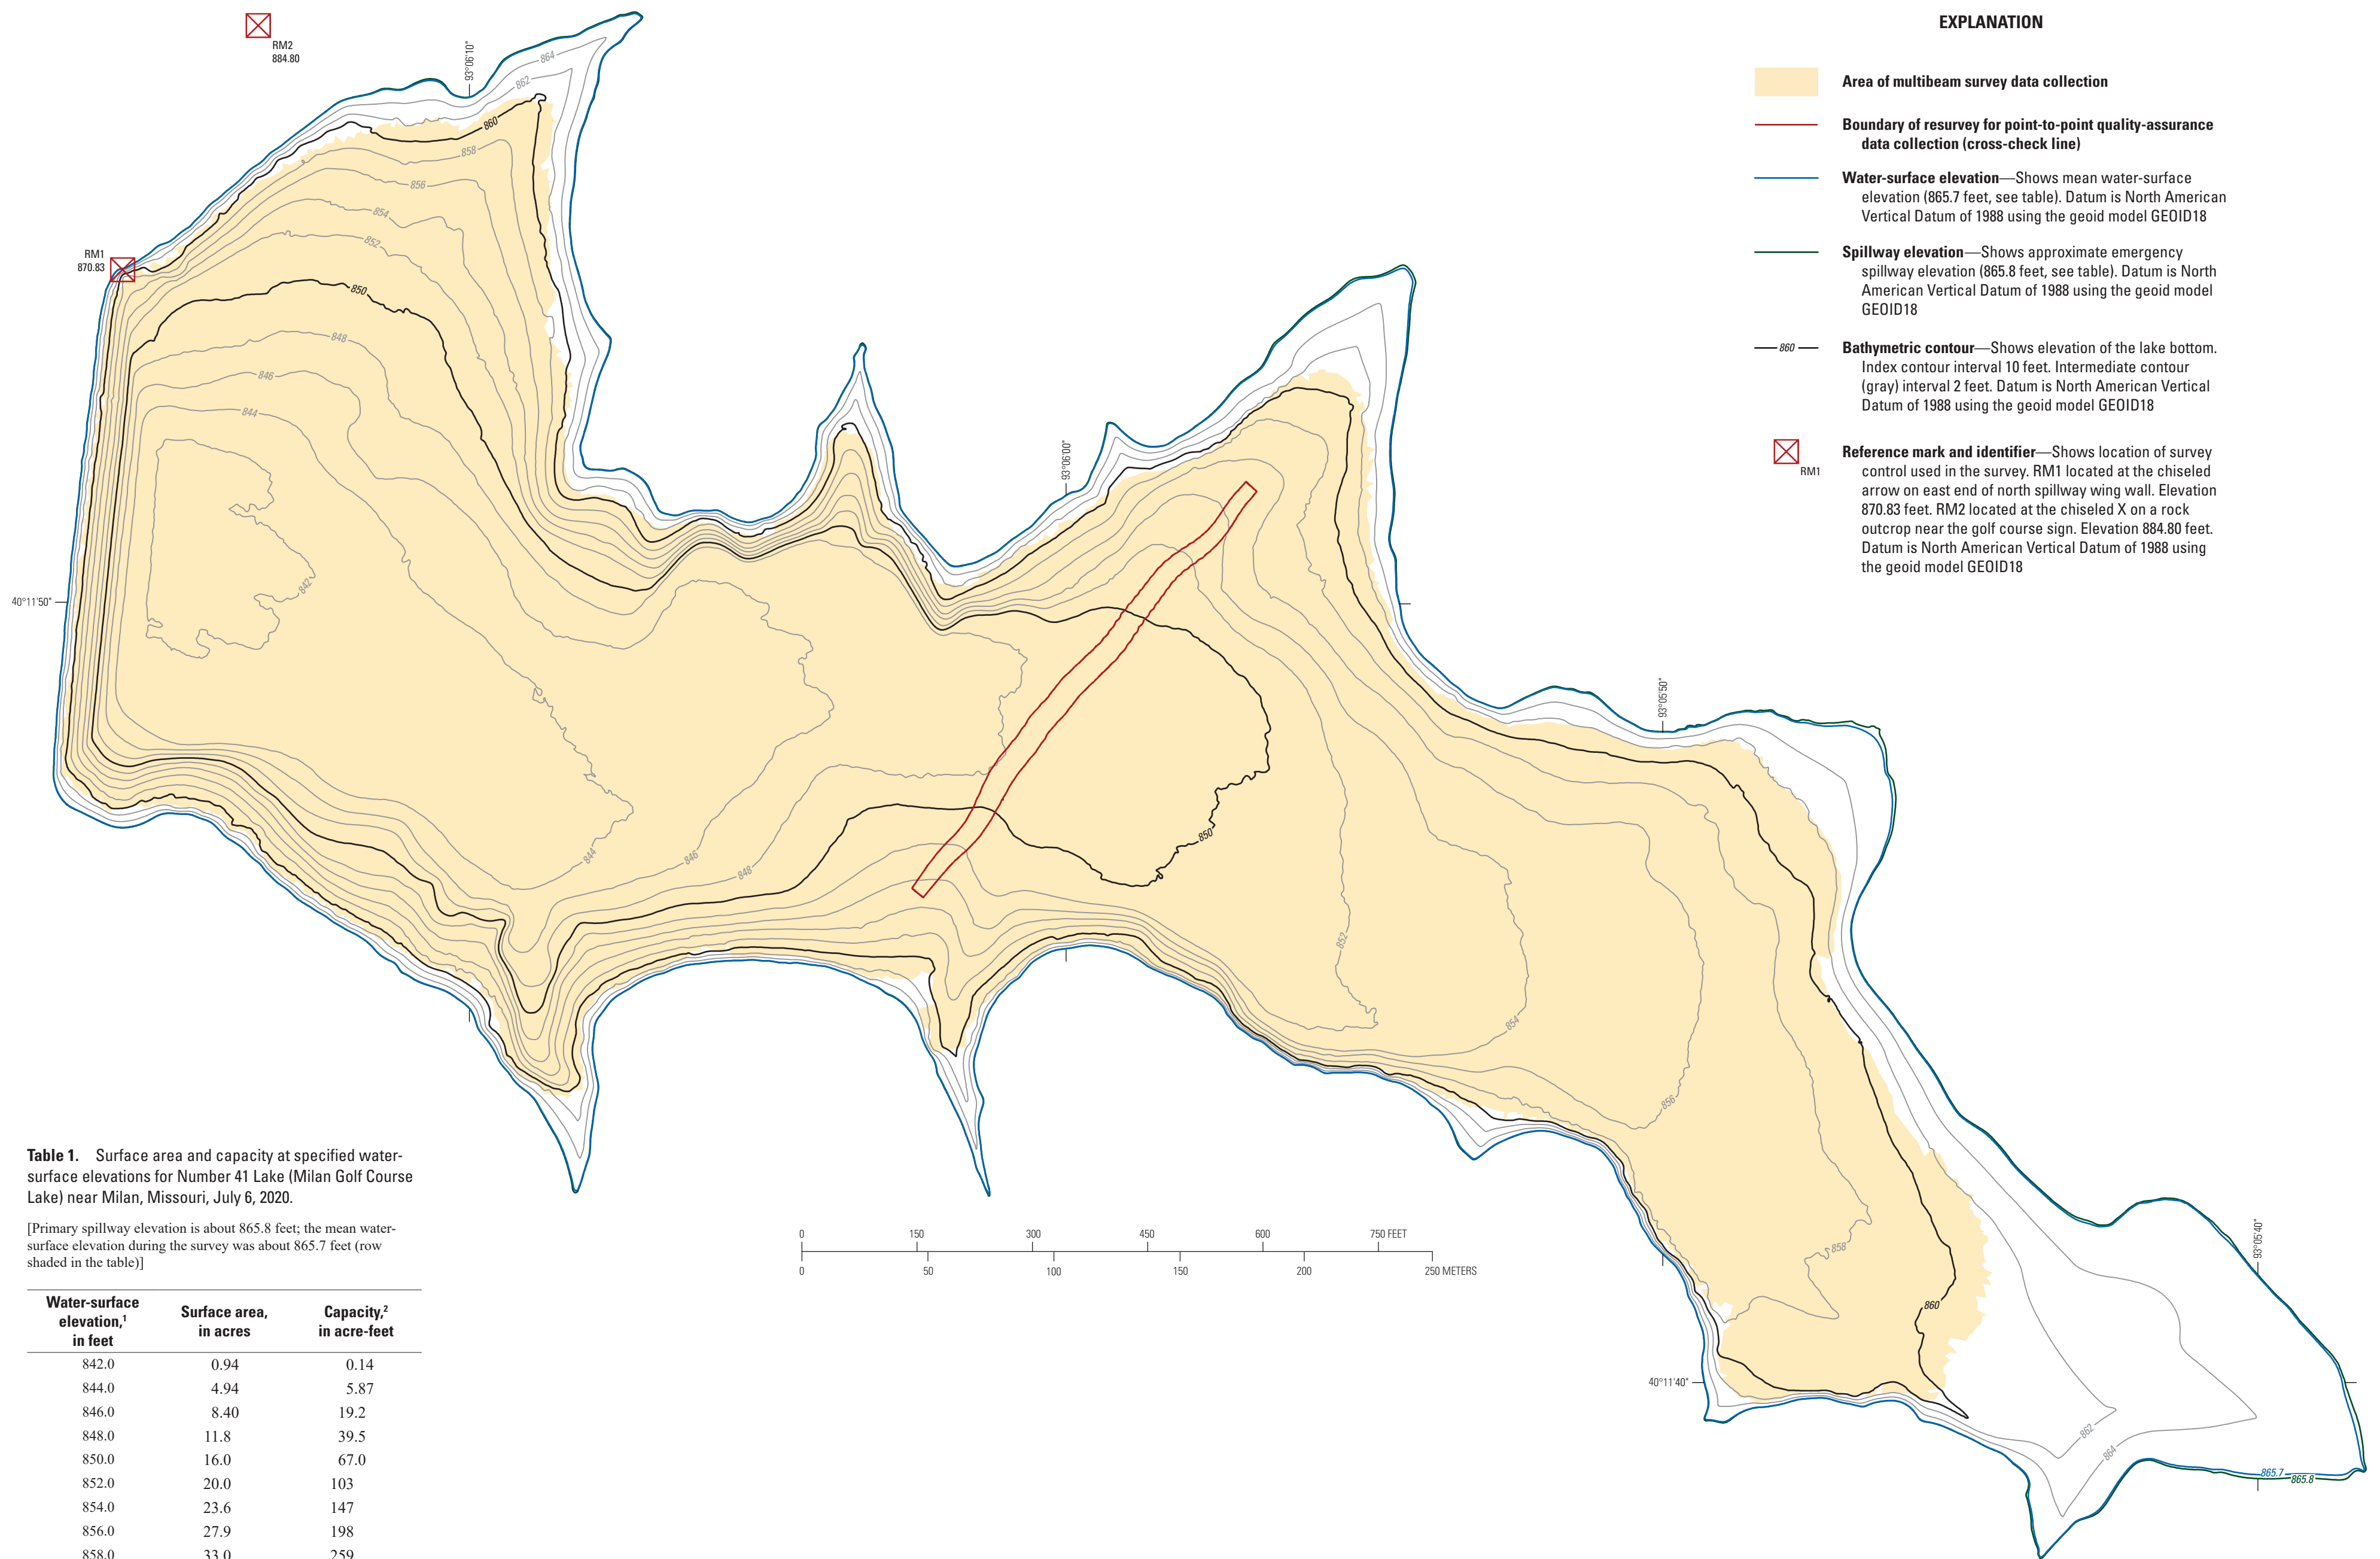
- Area of multibeam survey data collection**
- Boundary of resurvey for point-to-point quality-assurance data collection (cross-check line)**
- Water-surface elevation**—Shows mean water-surface elevation (865.7 feet, see table). Datum is North American Vertical Datum of 1988 using the geoid model GEOID18

- Spillway elevation**—Shows approximate emergency spillway elevation (865.8 feet, see table). Datum is North American Vertical Datum of 1988 using the geoid model GEOID18

- Bathymetric contour**—Shows elevation of the lake bottom. Index contour interval 10 feet. Intermediate contour (gray) interval 2 feet. Datum is North American Vertical Datum of 1988 using the geoid model GEOID18

- Reference mark and identifier**—Shows location of survey control used in the survey. RM1 located at the chiseled arrow on east end of north spillway wing wall. Elevation 870.83 feet. RM2 located at the chiseled X on a rock outcrop near the golf course sign. Elevation 884.80 feet. Datum is North American Vertical Datum of 1988 using the geoid model GEOID18
