Hydrology by G. C. Lines, 1975

FIGURE 6.—SATURATED THICKNESS OF THE ARIKAREE AQUIFER IN THE DWYER AREA, SOUTHEASTERN WYOMING, SEPTEMBER 1973

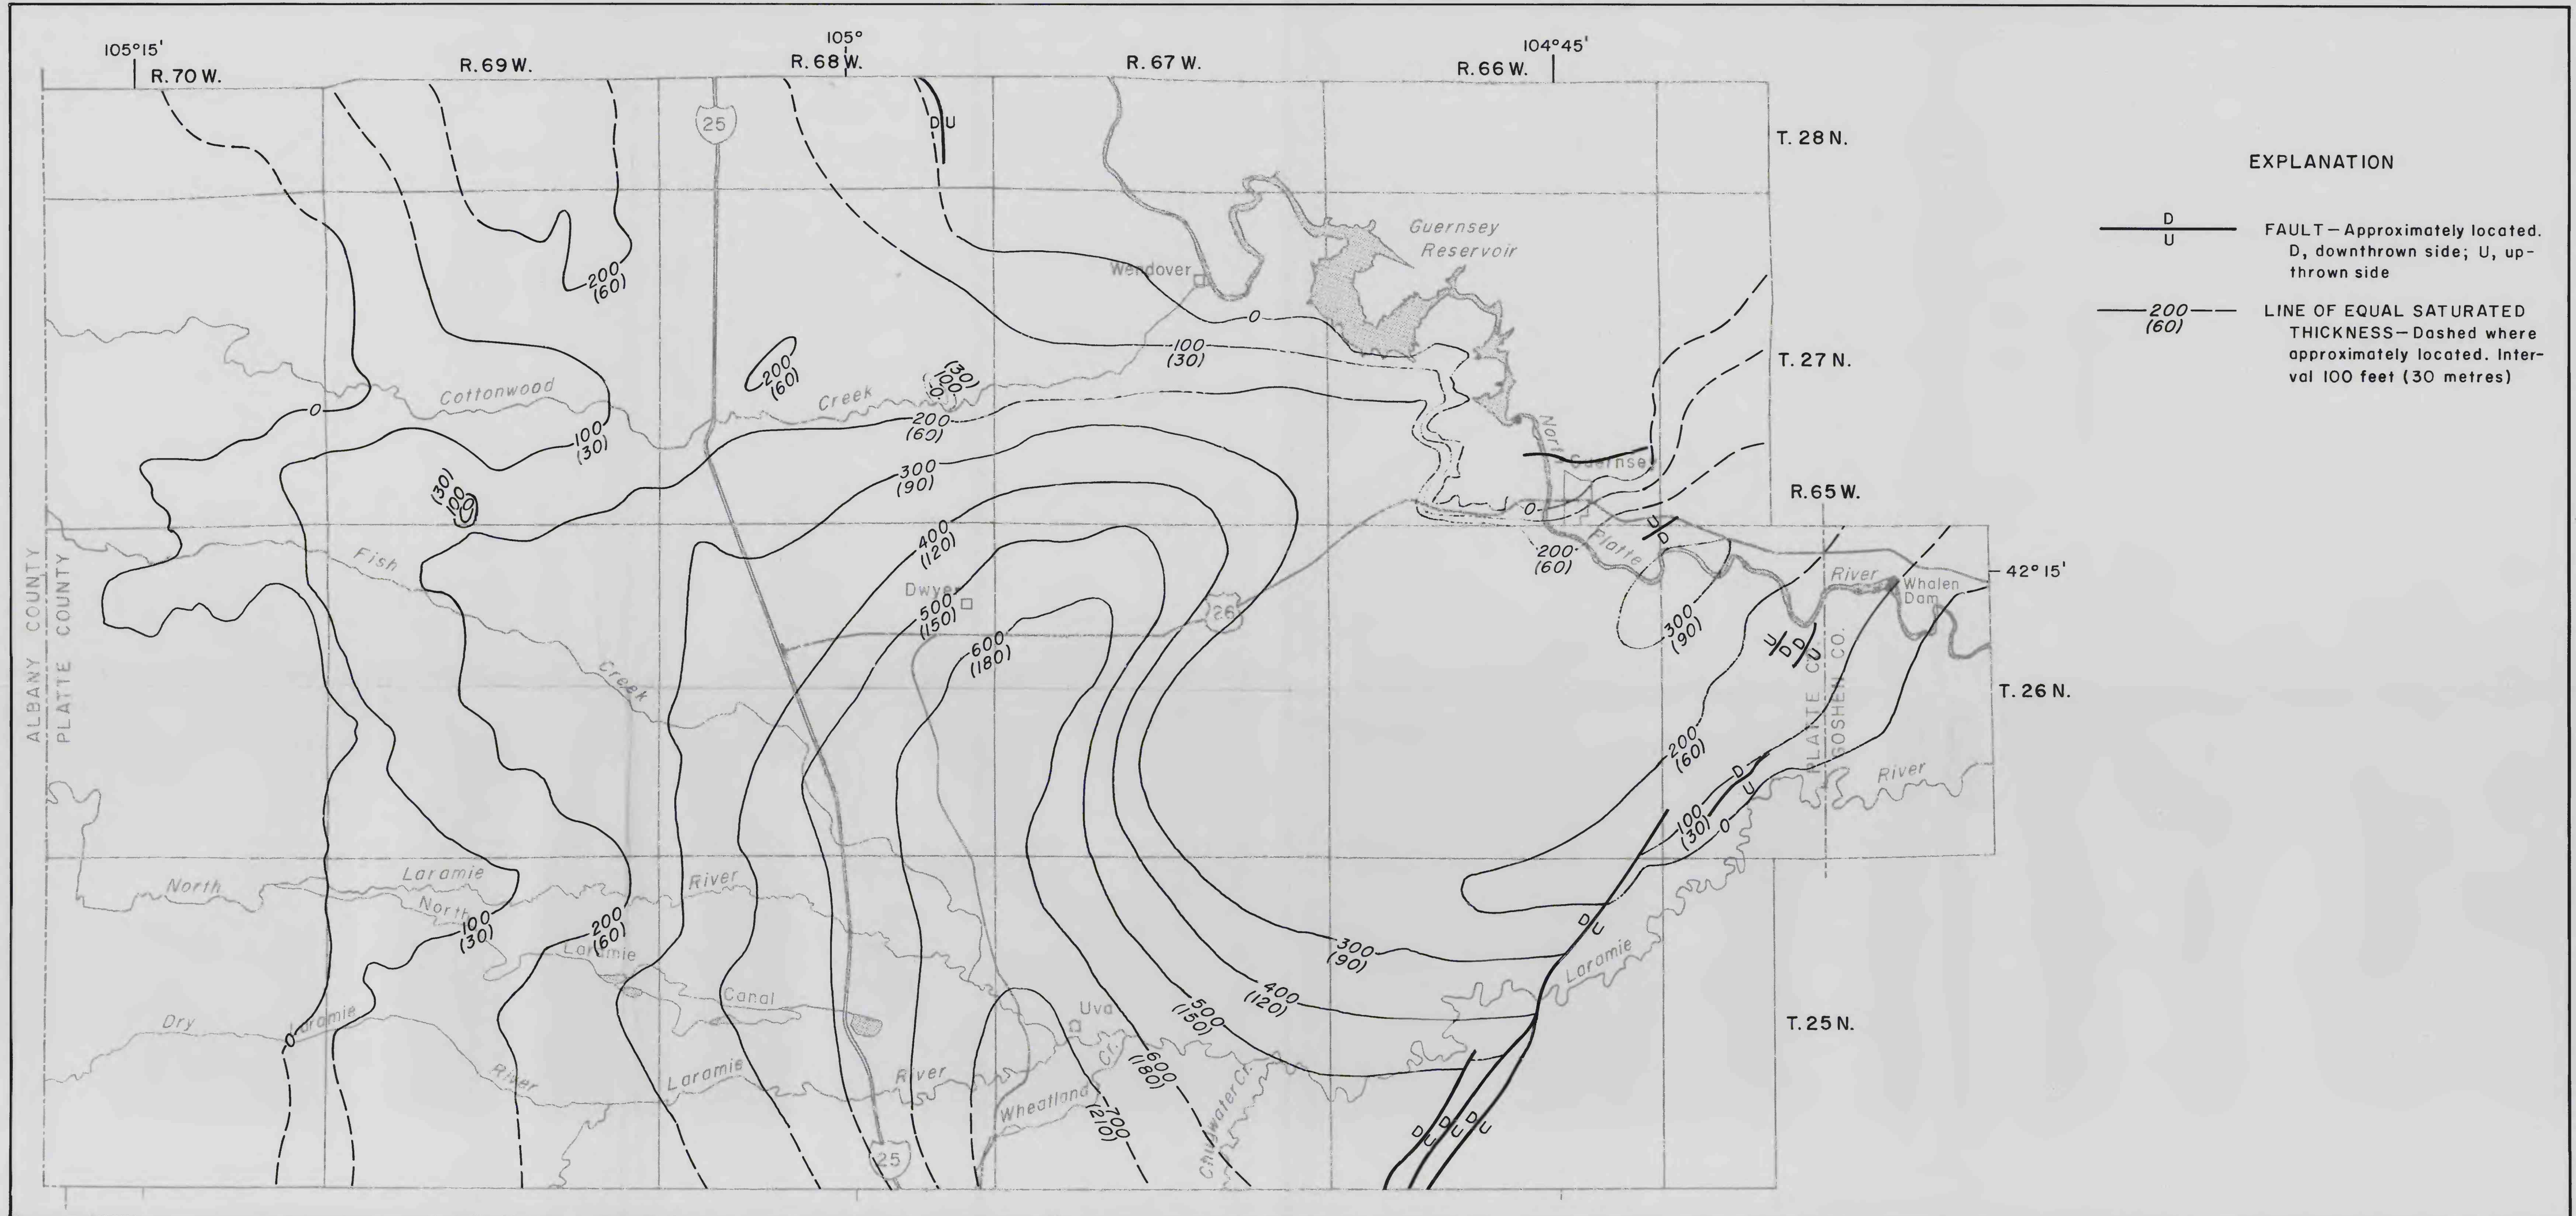
$\frac{D}{U}$ FAULT—Approximately located.
D, downthrown side; U, up-
thrown side

$\frac{200}{(60)}$ LINE OF EQUAL SATURATED
THICKNESS—Dashed where
approximately located. Interval
100 feet (30 metres)
