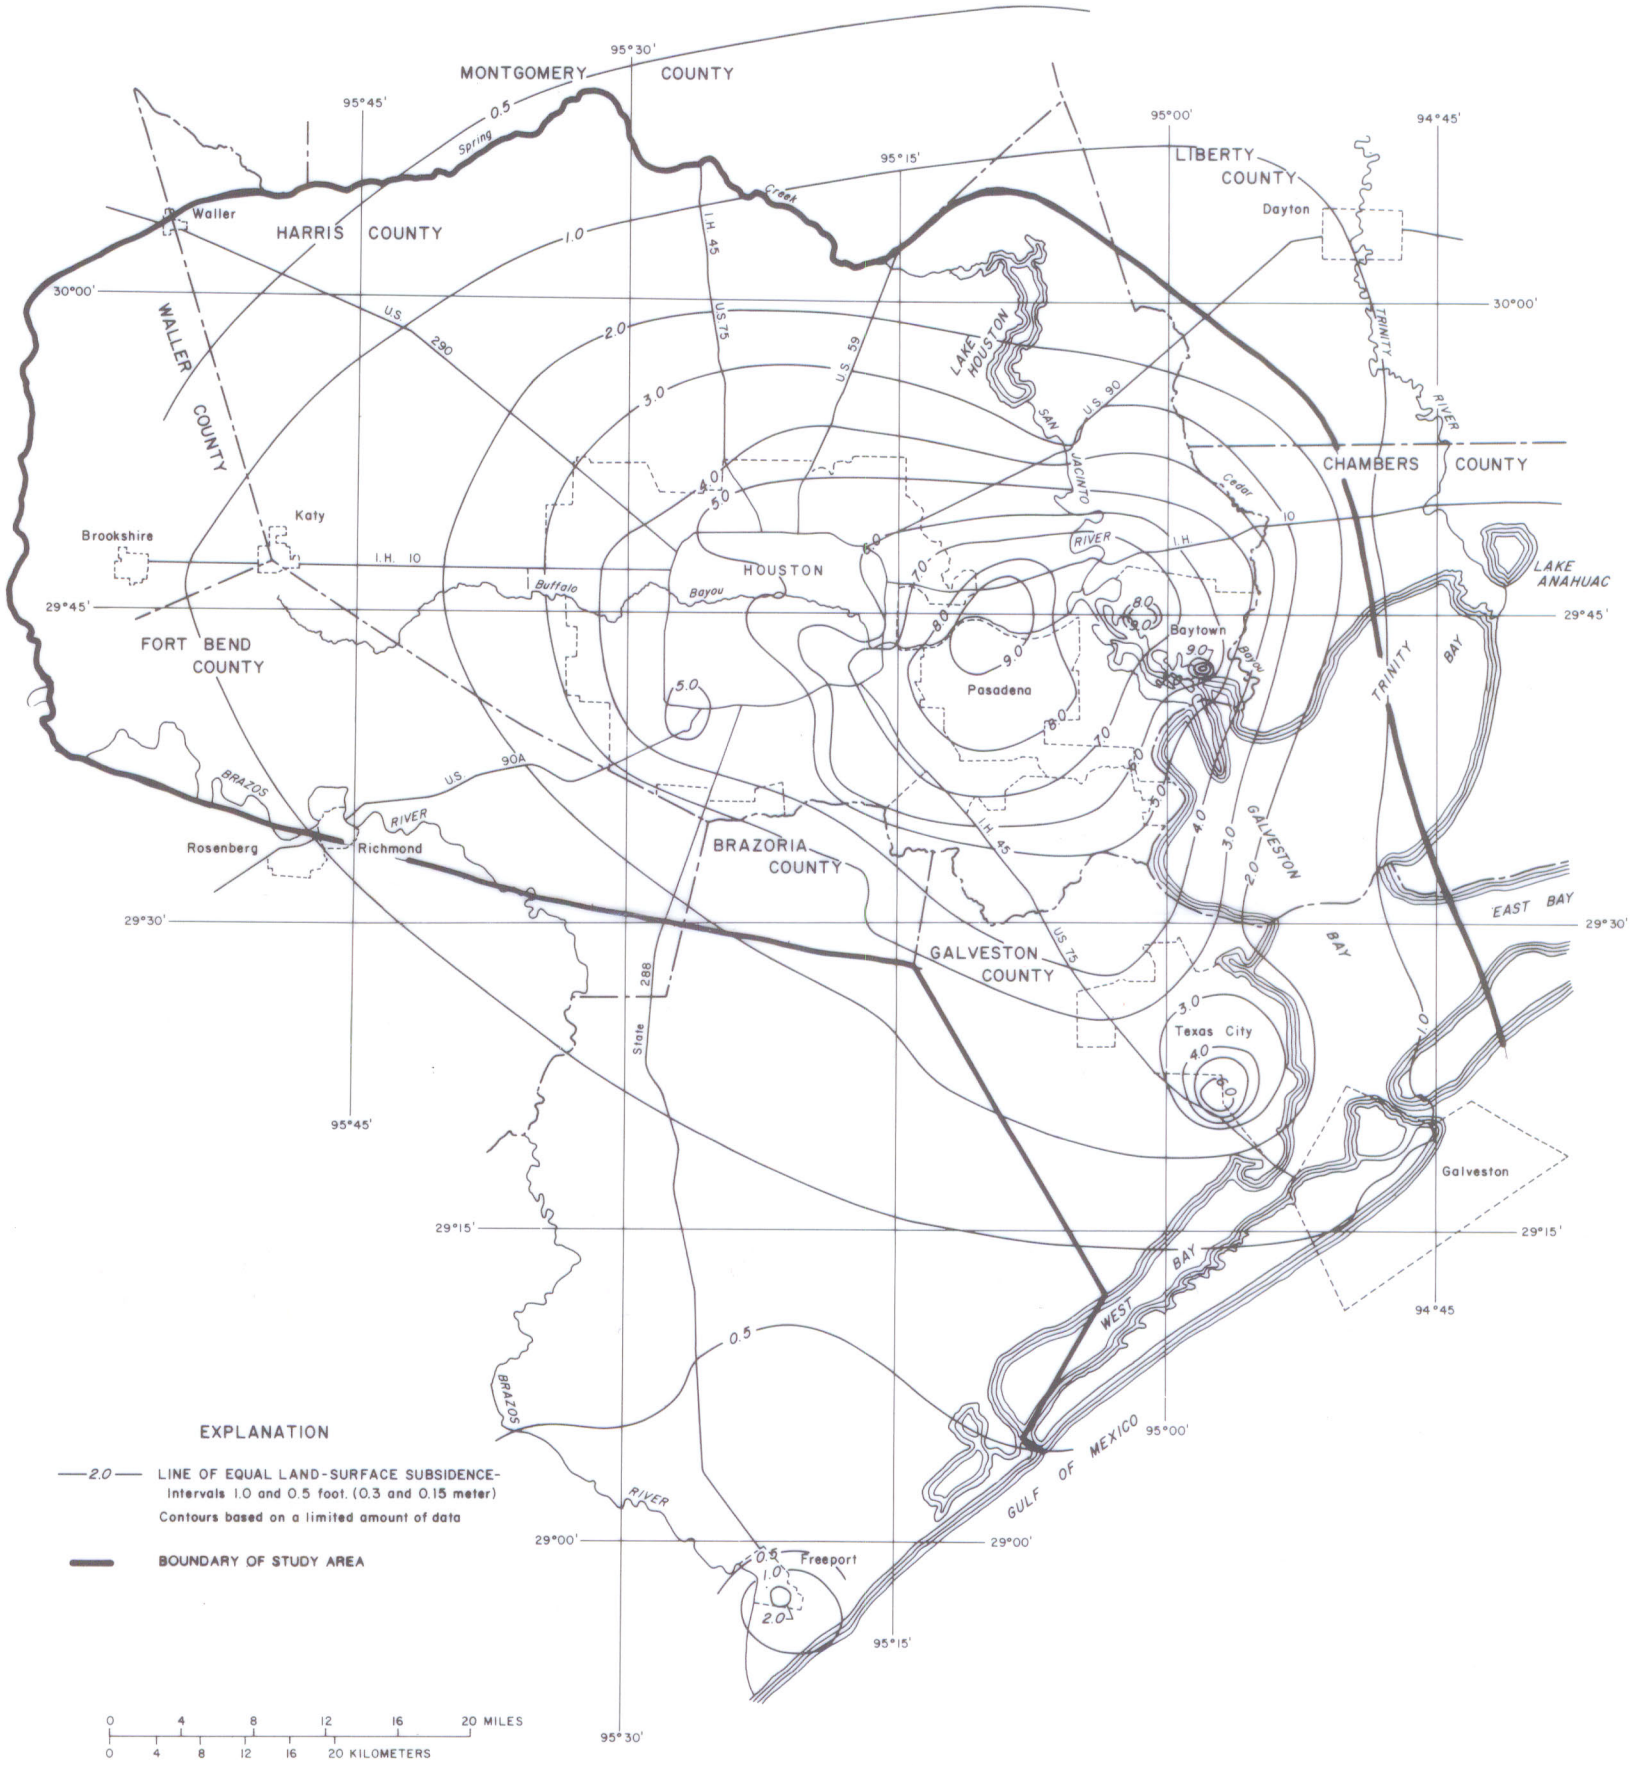
Figure 26.--Approximate land-surface subsidence, 1906-78, Houston district and vicinity.
