MAP SHOWING HYDROGEOLOGIC AREAS IN THE COASTAL PLAIN OF VIRGINIA

Richardson, D.L., 1994, Ground-water discharge  
from the Coastal Plain of Virginia:  
U.S. Geological Survey Water-Resources Investigations Report 93-4191

By  
Donna L. Richardson

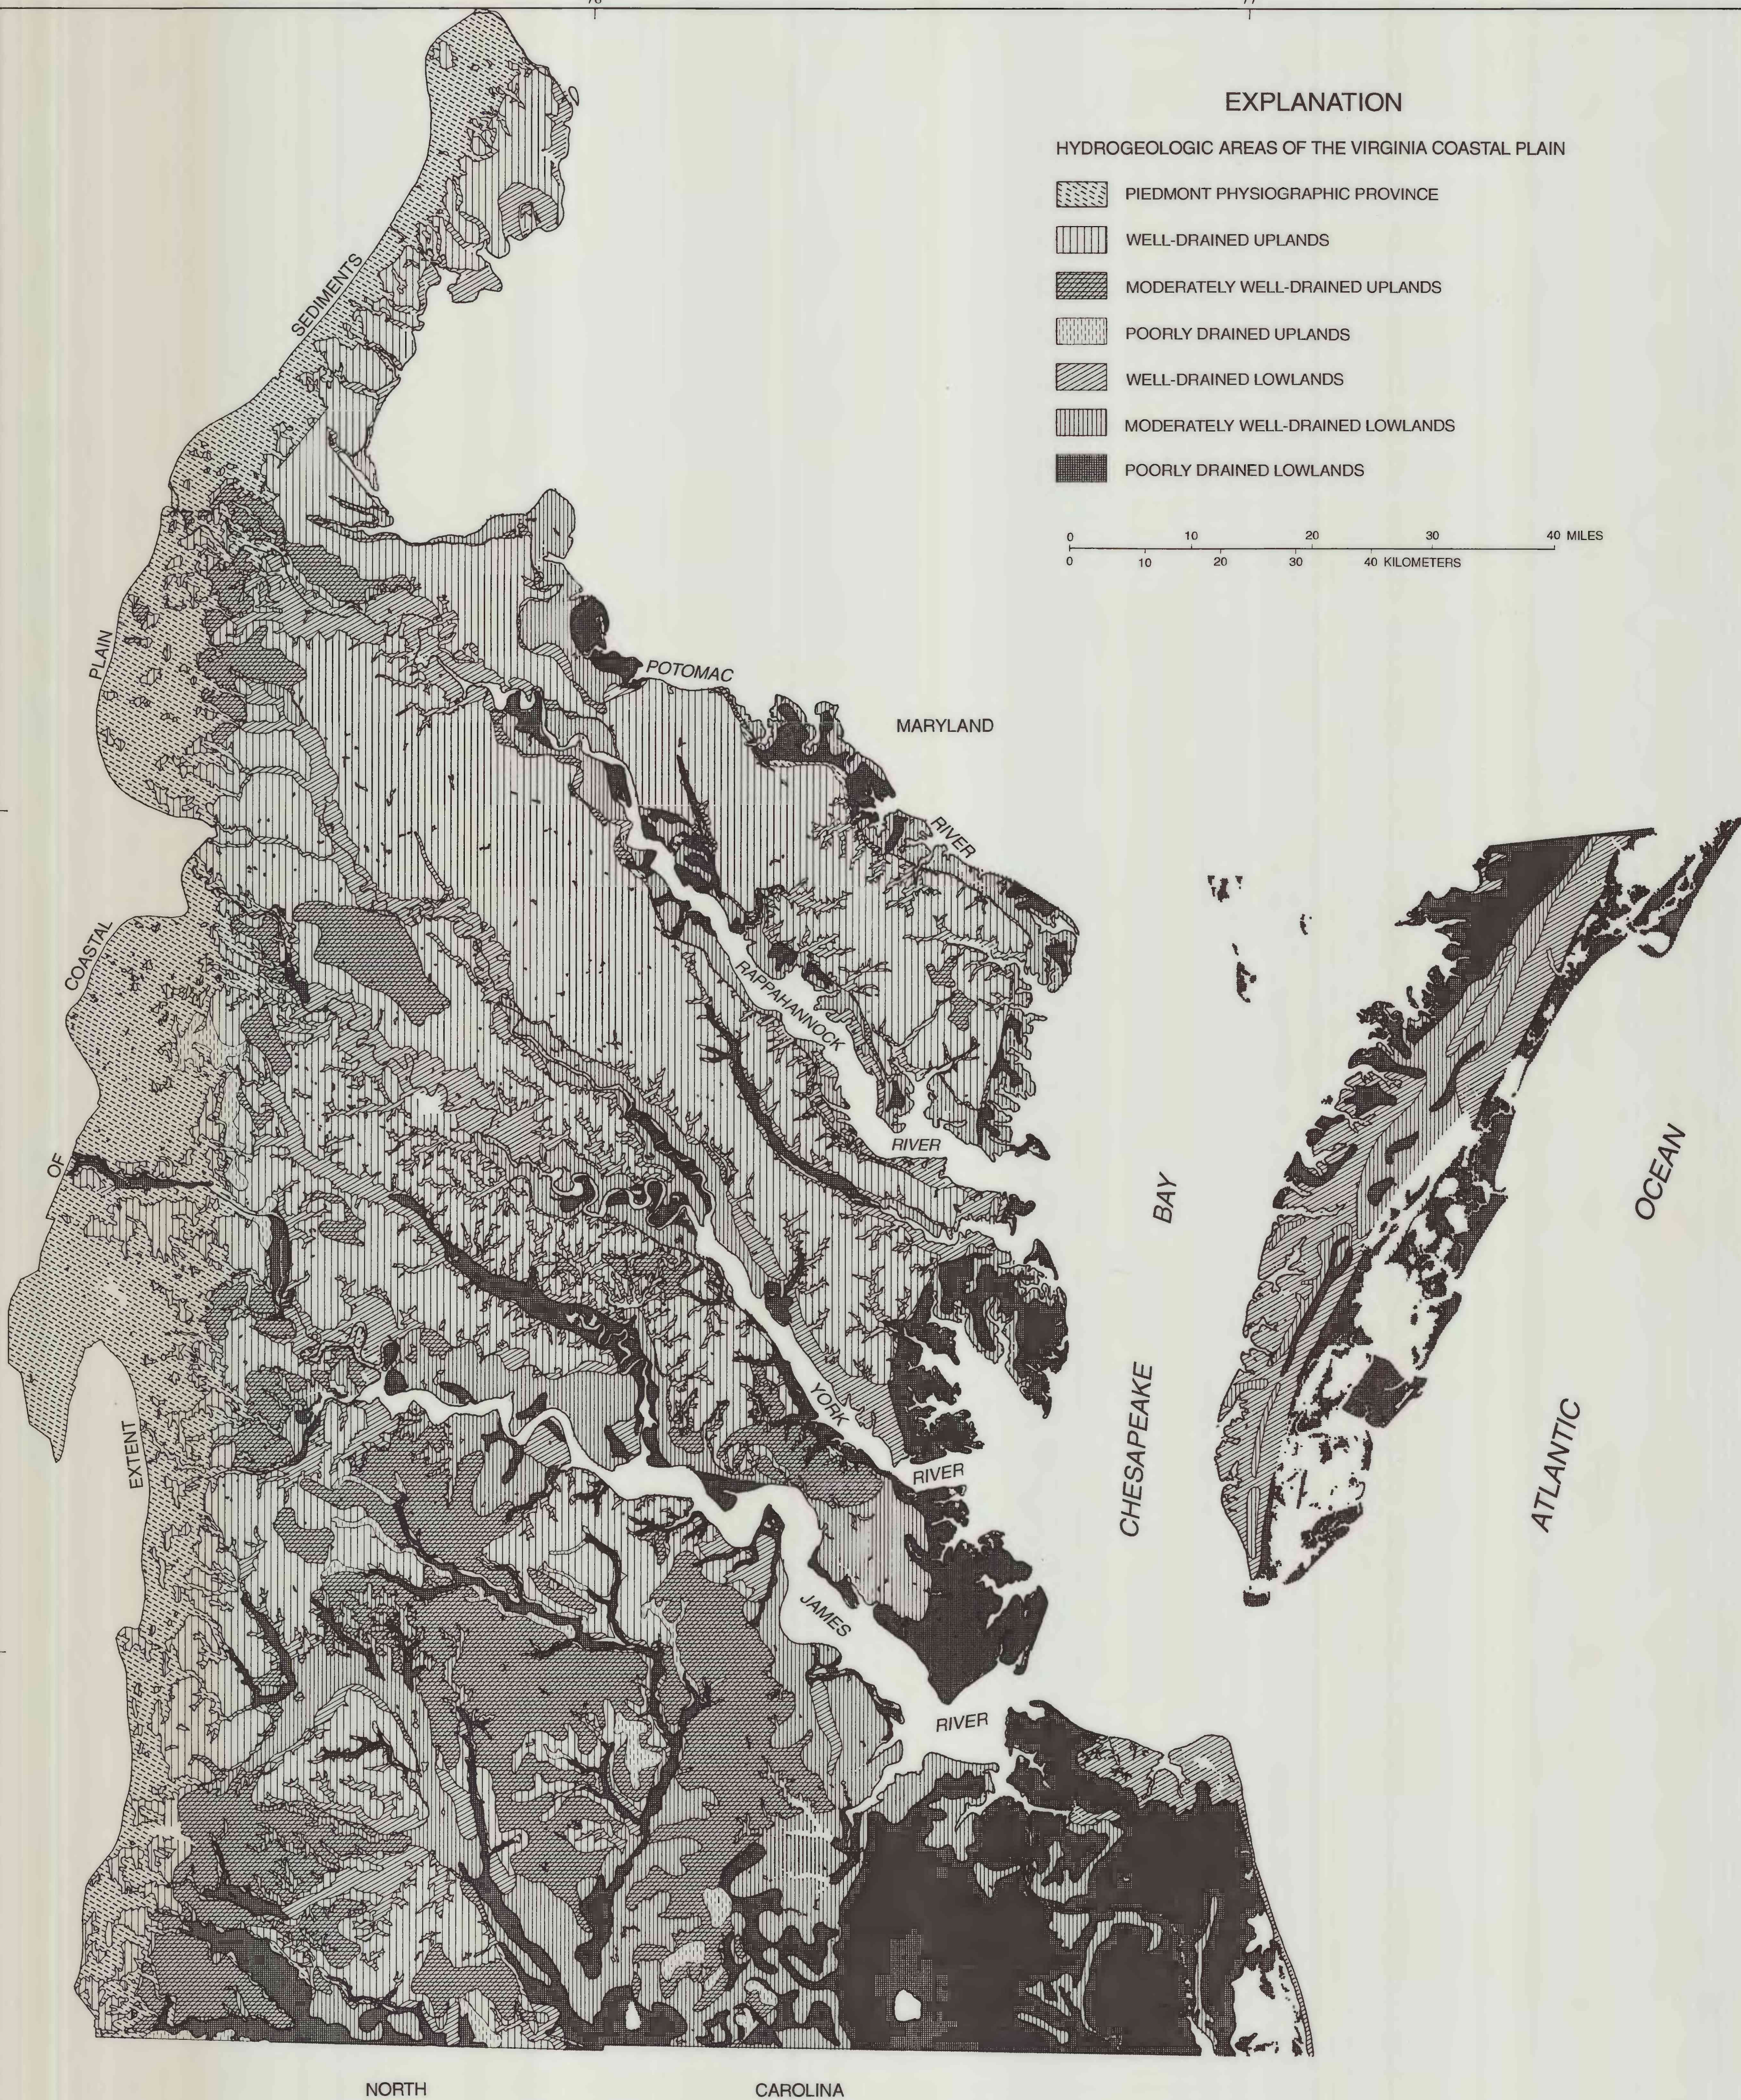
#### HYDROGEOLOGIC AREAS OF THE VIRGINIA COASTAL PLAIN
