# Hydrologic Data Collected During the 1994 Lake Mills Drawdown Experiment, Elwha River, Washington

**U.S. GEOLOGICAL SURVEY**  
**Water-Resources Investigations Report 99-4215**

Prepared in cooperation with  
BUREAU OF RECLAMATION,  
NATIONAL PARK SERVICE,  
and LOWER ELWHA  
KLALLAM TRIBE

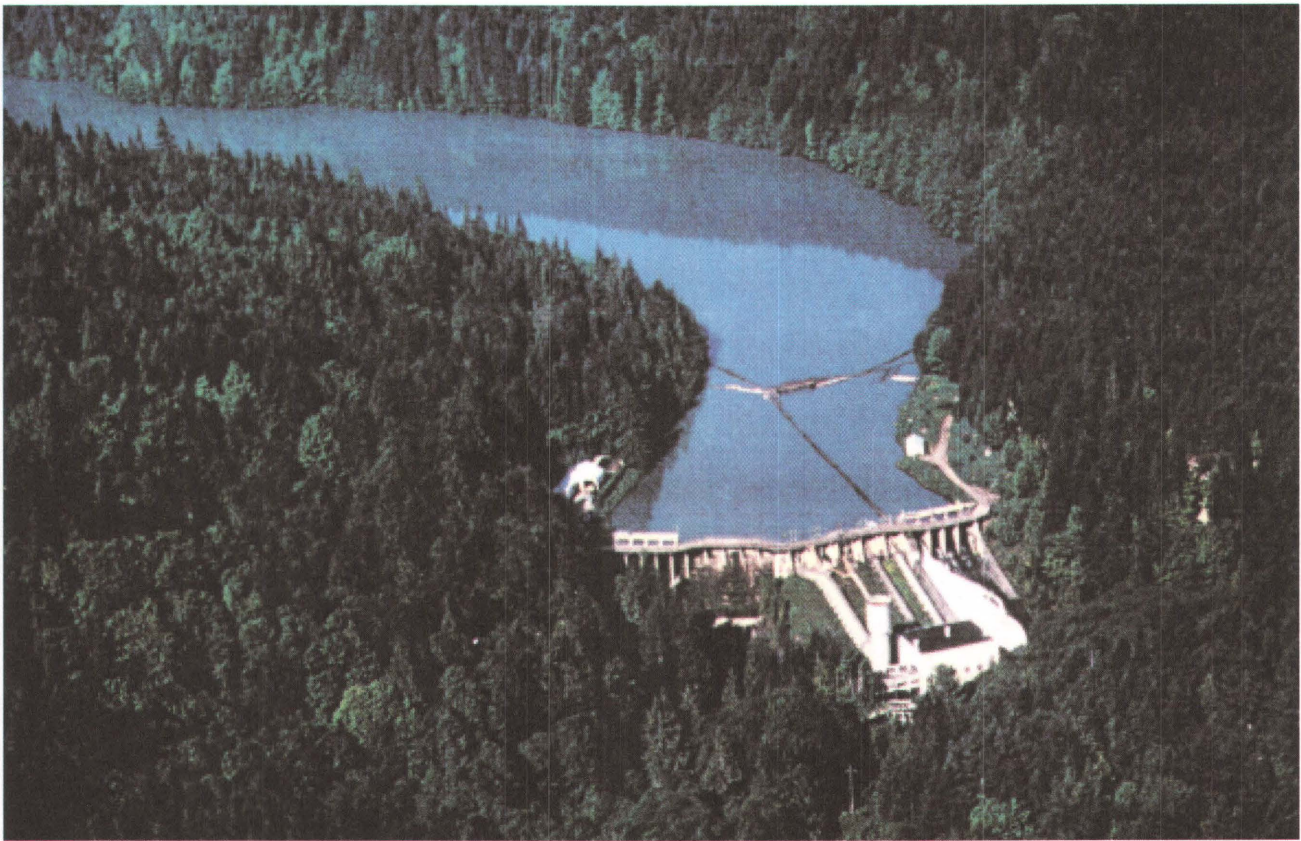
**Figure 1.** Elwha Dam (left), powerhouse (center), spillway channel (right), and Lake Aldwell (background). Photograph provided by the Bureau of Reclamation.

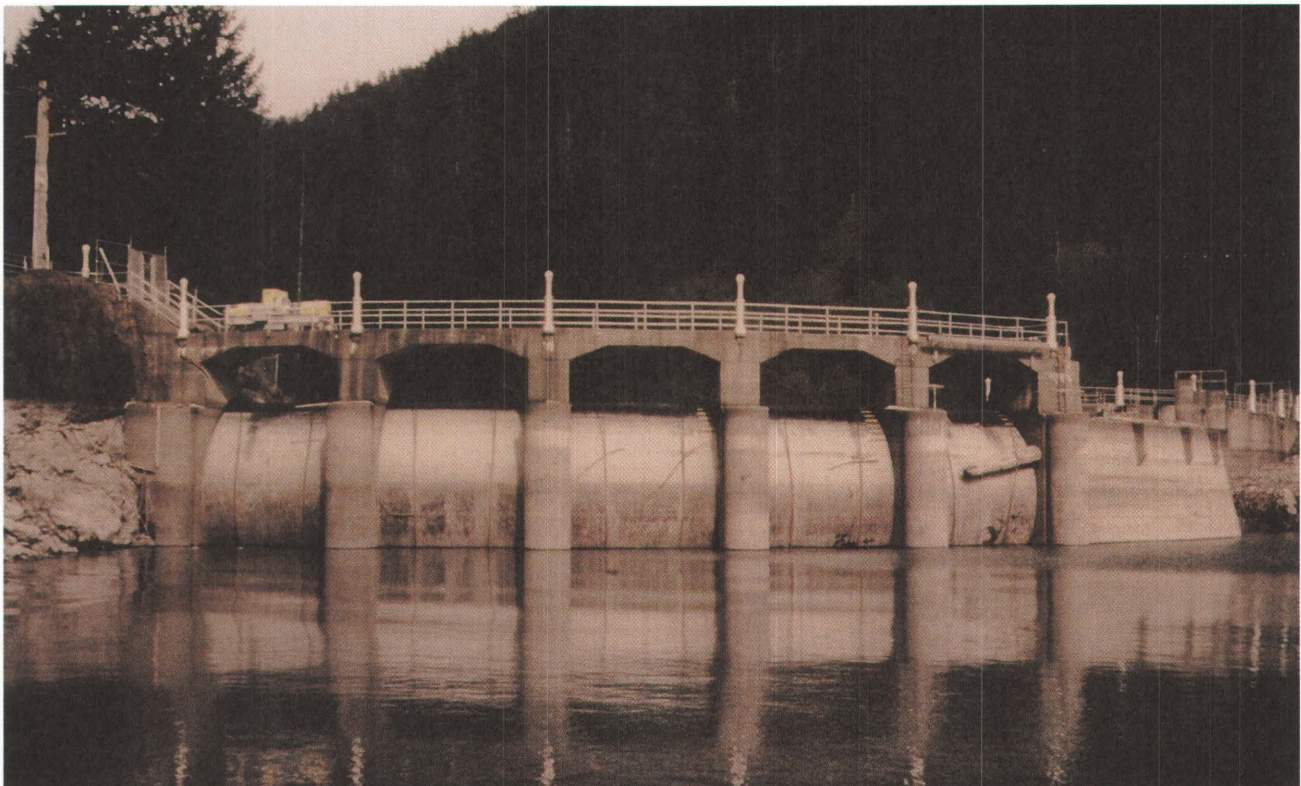
**Figure 2.** Glines Canyon Dam.

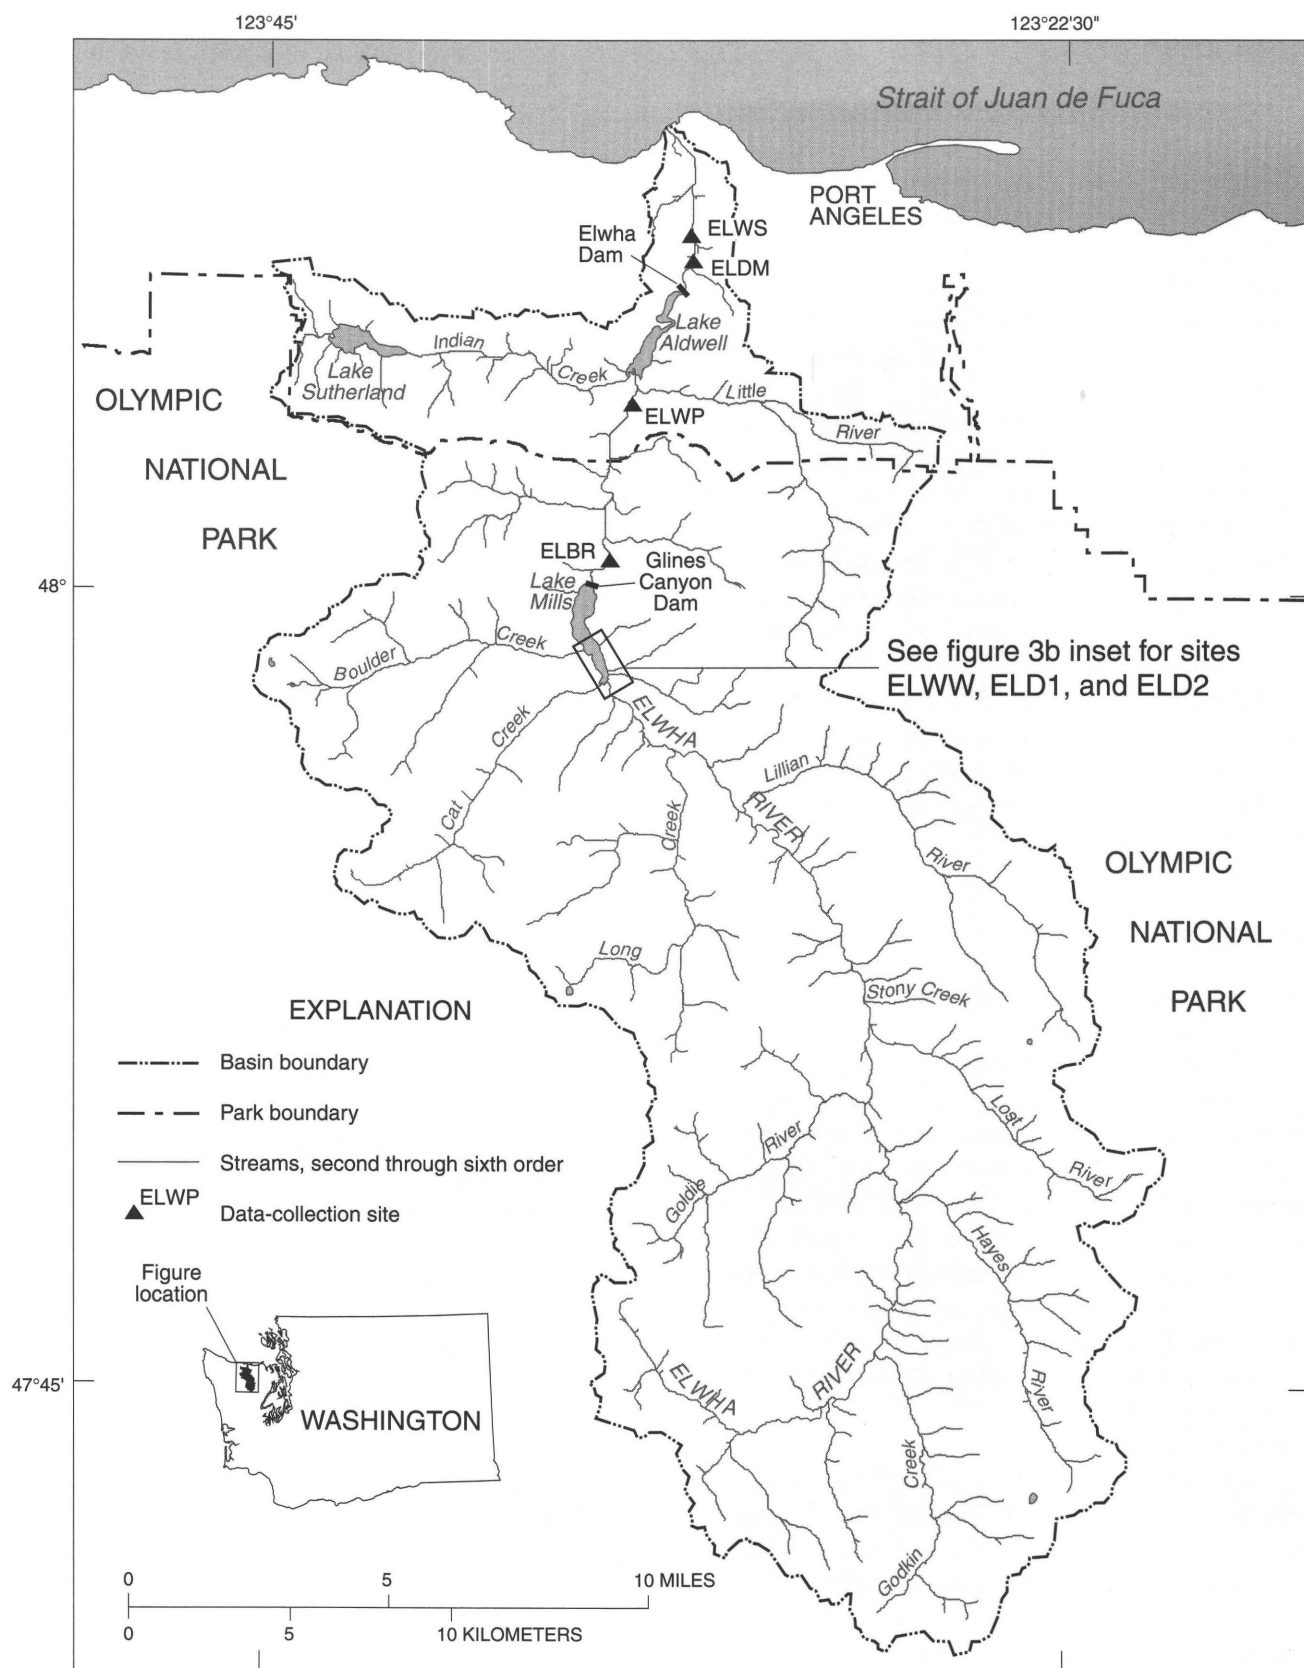
**Figure 3a.** Study area in the lower Elwha River Valley and locations of streamflow and sediment data-collection sites ELBR, ELWP, ELDM, and ELWS. The USGS station number and name for each site are given in table 1a. The types of data collected at each site are given in table 1b.

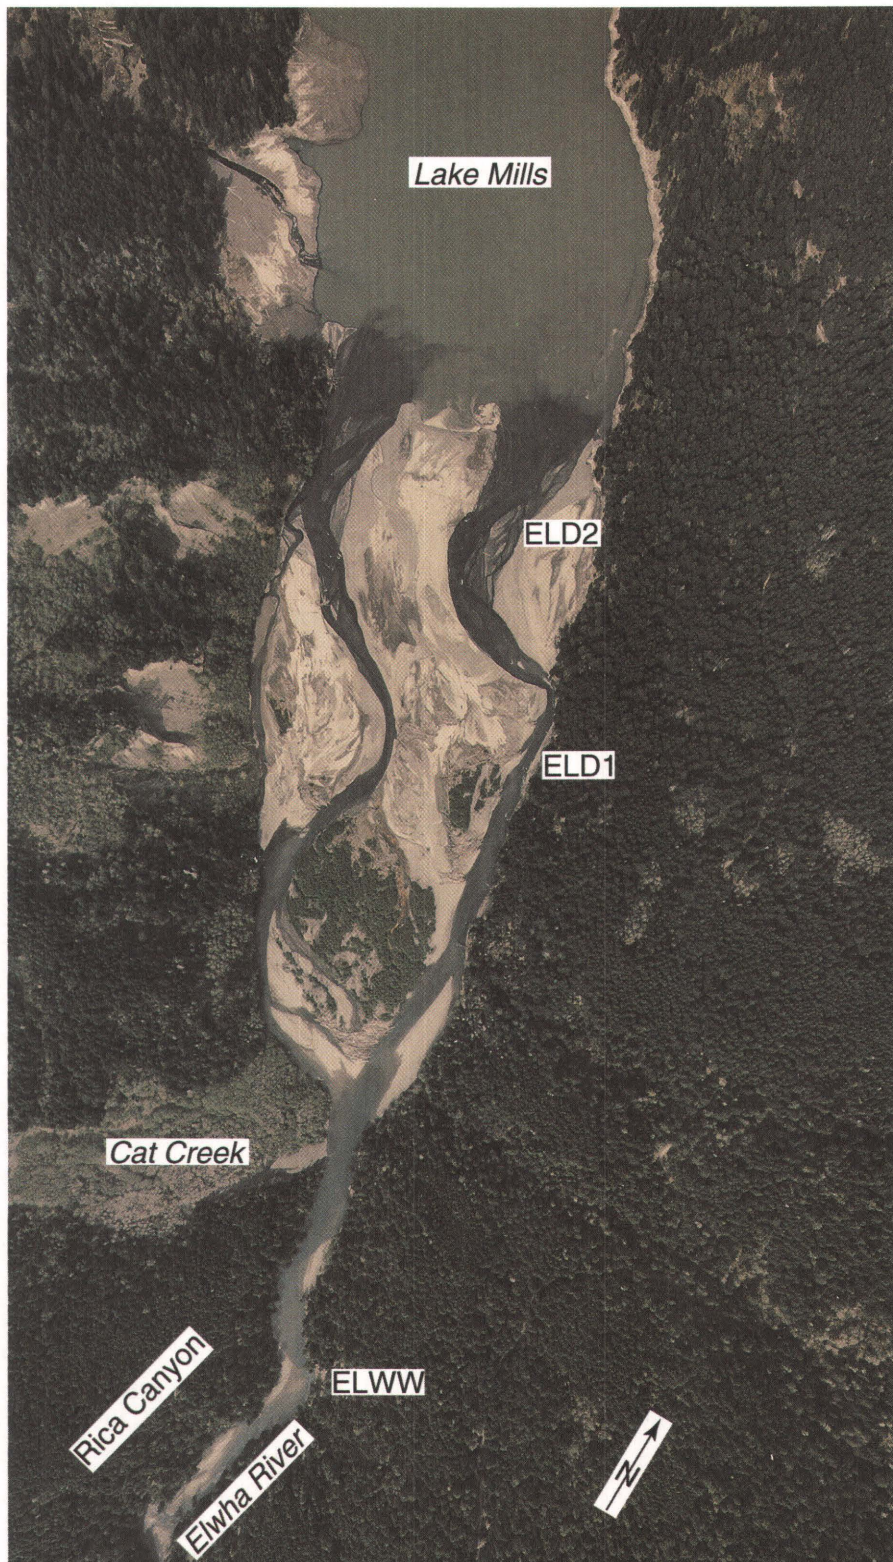
**Figure 3b.** Locations of streamflow and sediment data-collection sites ELWW, ELD1, and ELD2. Aerial photograph was taken on April 16, 1994, at time of full 18-foot drawdown of Lake Mills. Elwha River is flowing from south to north and has divided into a right (east) channel and a left (west) channel in the delta area. Photograph provided by the Bureau of Reclamation.

The largest rocks were concentrated in the upper part of the delta, in the Cat Creek fan, and in Rica Canyon (photo, fig. 3b, and map, fig. 14). The largest rocks were found in surface particle counts, which showed the maximum intermediate diameters of individual rocks to be less than 362 millimeters, with 99 percent being less than 256 millimeters. Pit samples showed similar results, with all rocks being less than 300 millimeters in size.

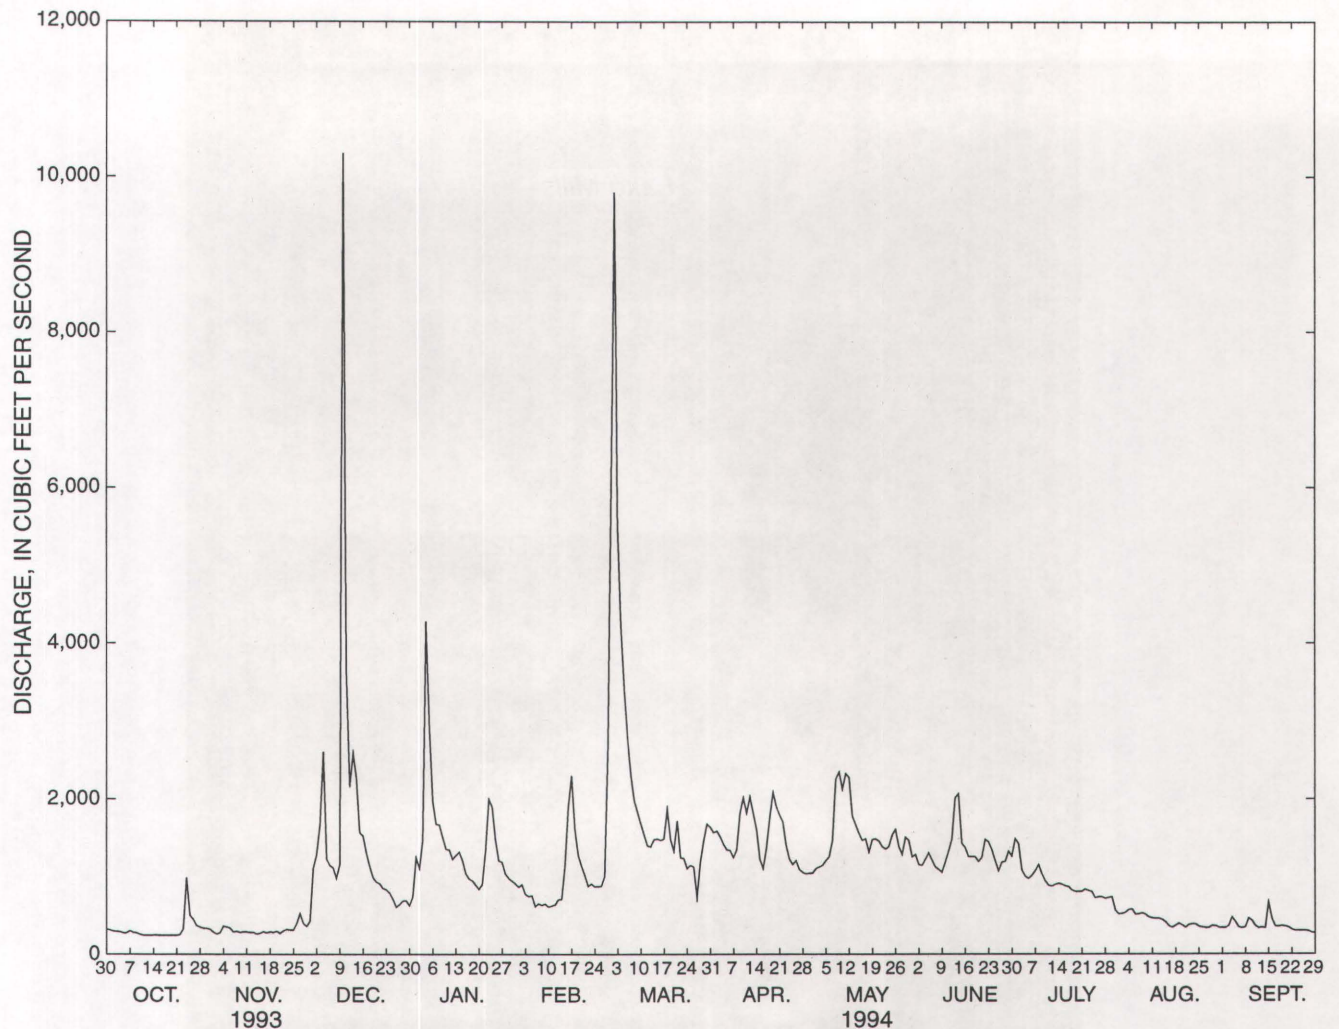
**Figure 4.** Daily streamflow record at site 12045500, Elwha River at McDonald Bridge (ELWP), for the 1994 water year.

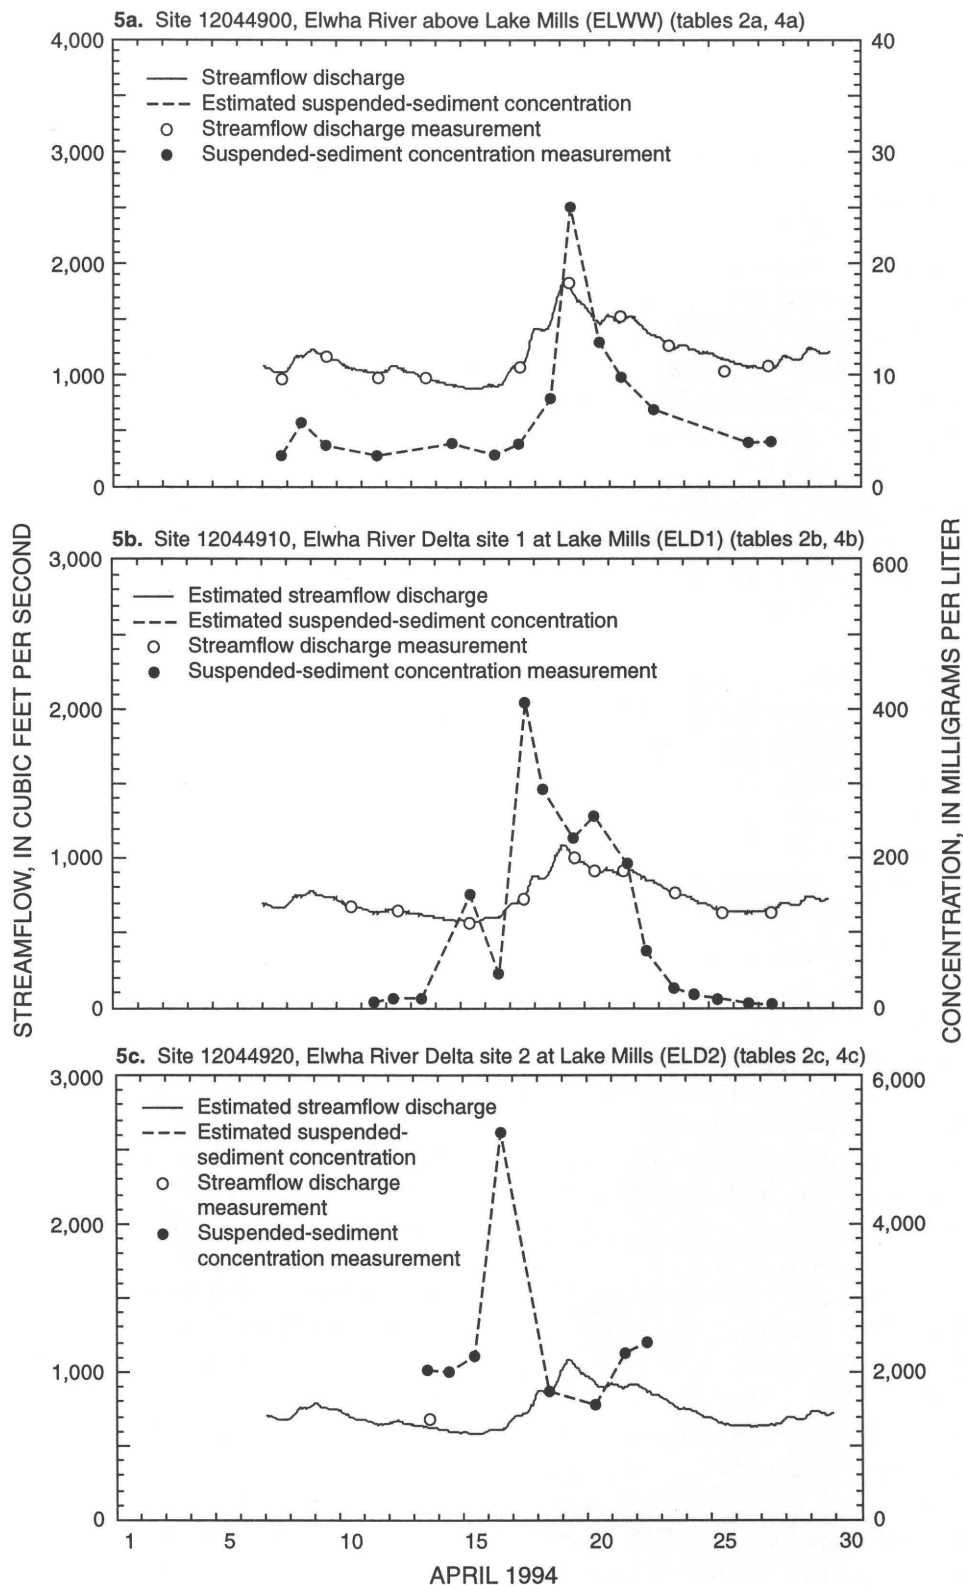
**Figure 5a-c.** Continuous record of streamflow and suspended-sediment concentration, instantaneous measurements of streamflow, and suspended-sediment samples at sites on the Elwha River, Washington. Whenever two consecutive samples were collected on the same day at a site, the average suspended-sediment concentration of the two samples is plotted.

The maximum concentrations of suspended sediment measured at delta sites ELD1 and ELD2, where erosion of the delta was adding large quantities of sediment to the river, were 443 and 6,110 mg/L, respectively. However, most of the suspended sediment measured at the delta sites must have been trapped in Lake Mills because only small increases in suspended-sediment concentrations were found downstream from Glines Canyon and Elwha Dams. Concentrations below Glines Canyon Dam increased from a background level of about 5 mg/L to a maximum of 20 mg/L, while concentrations below Elwha Dam increased from a background level of about 3 mg/L to a maximum of 12 mg/L. The leading edge of the suspended-sediment plume was detected downstream from Glines Canyon Dam about 2 days after erosion of the Lake Mills Delta deposits began and downstream from Elwha Dam about an additional 3 days later.

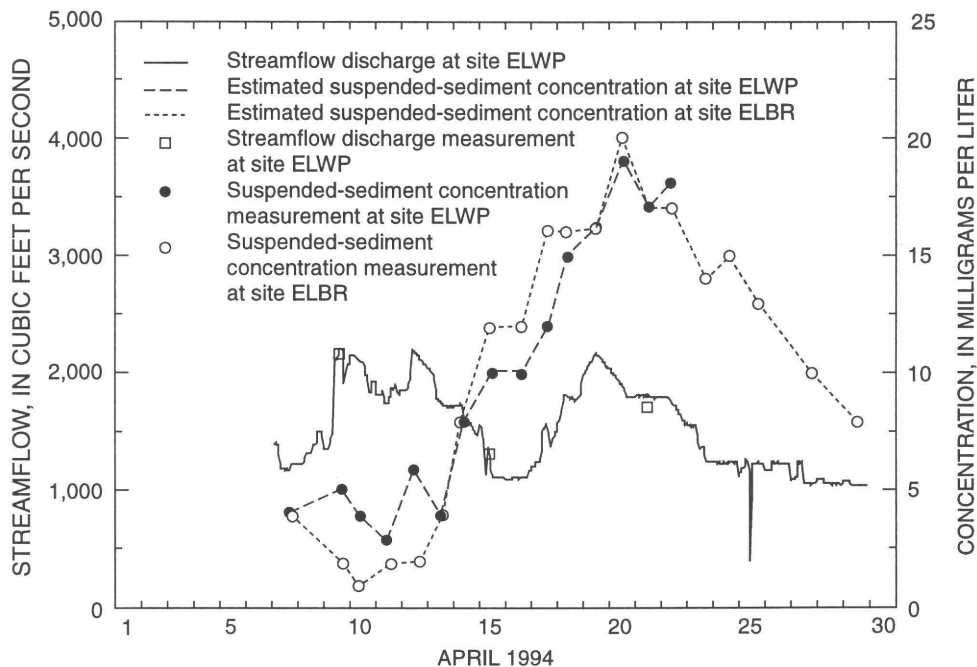
**Figure 5d.** Continuous record of streamflow and suspended-sediment concentration, instantaneous measurements of streamflow, and suspended-sediment samples at site 12045500, Elwha River at McDonald Bridge (ELWP); and continuous record of suspended-sediment concentration and suspended-sediment samples at site 12045200, Elwha River at Altaire Bridge (ELBR) (tables 2d, 4d, 4e). Whenever two consecutive samples were collected on the same day at a site, the average suspended-sediment concentration of the two samples is plotted.

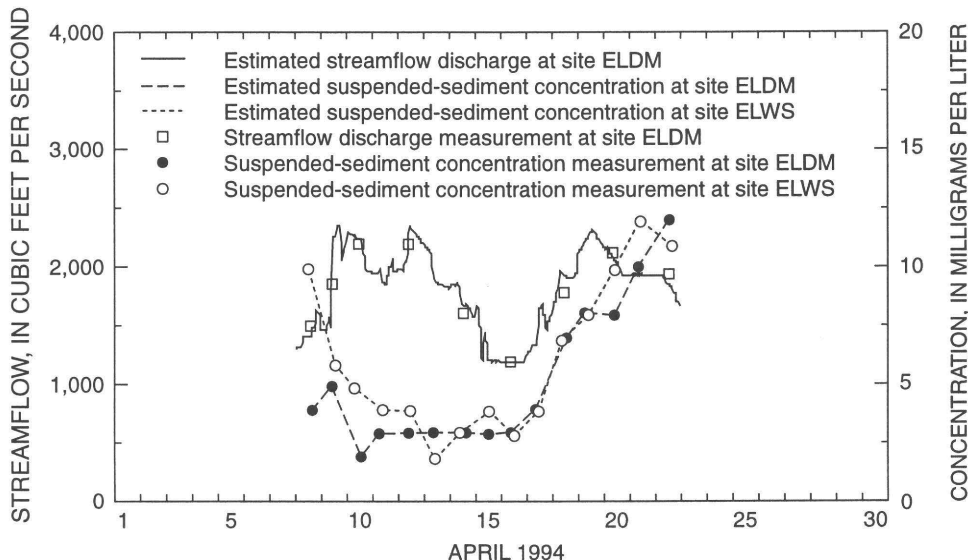
**Figure 5e.** Continuous record of streamflow and suspended-sediment concentration, instantaneous measurements of streamflow, and suspended-sediment samples at site 12046100, Elwha River below Elwha Dam (ELDM); and continuous record of suspended-sediment concentration and suspended-sediment samples at site 12046300, Elwha River diversion below Elwha Dam (ELWS) (tables 2e, 4f, 4g). Whenever two consecutive samples were collected on the same day at a site, the average suspended-sediment concentration of the two samples is plotted.

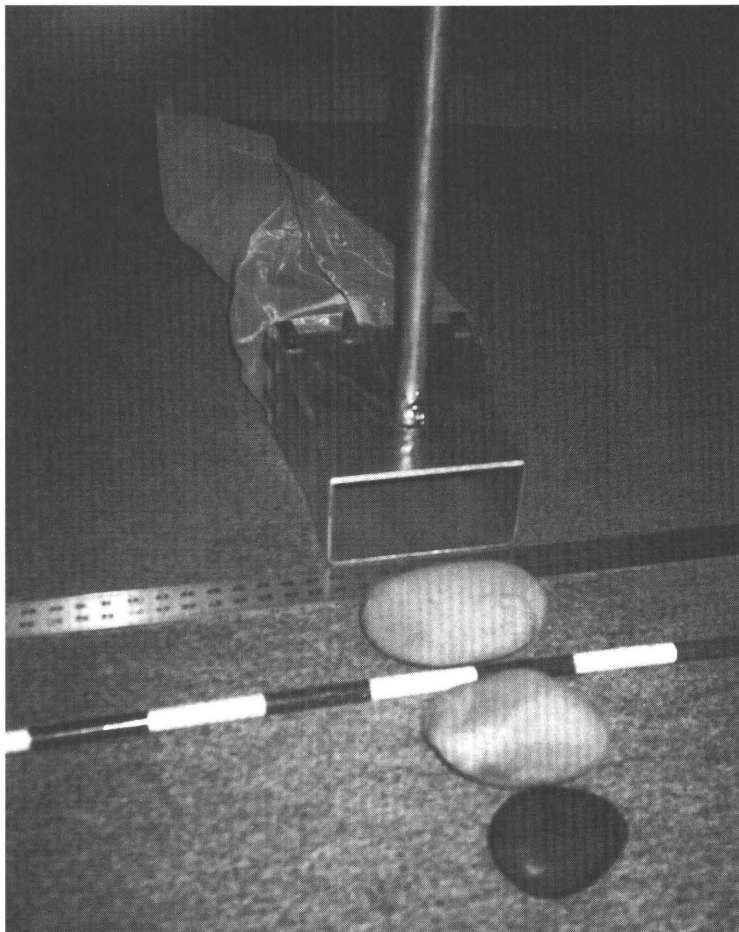
**Figure 6.** Sampler used to collect Elwha River bedload samples. Rod in middle foreground is marked in 10-centimeter increments.

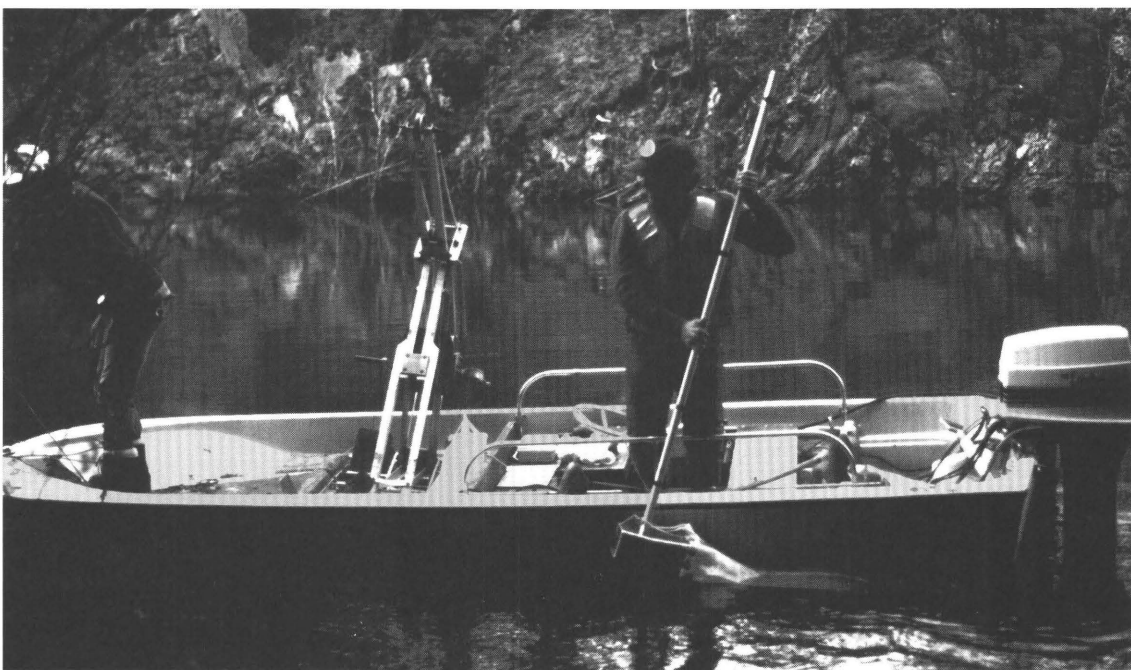
**Figure 7.** Sampling bedload at site 12044900, Elwha River above Lake Mills (ELWW), from a boat using a tether line attached to the boat gannet.

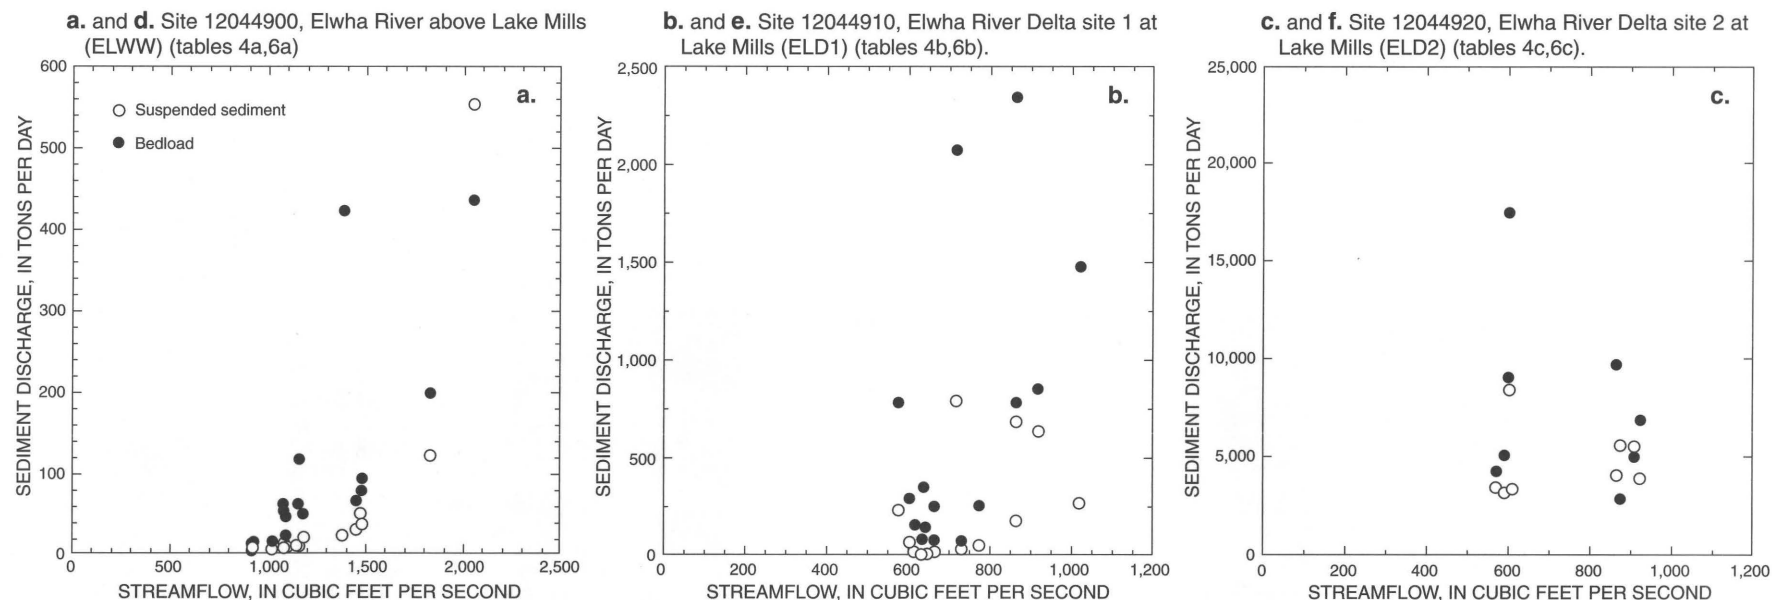
**Figure 8a-c.** Suspended-sediment and bedload discharges for samples collected at selected sites. Whenever two or more consecutive samples were collected on the same day, the average sediment discharges of the samples collected were used to calculate the values shown on the graph.

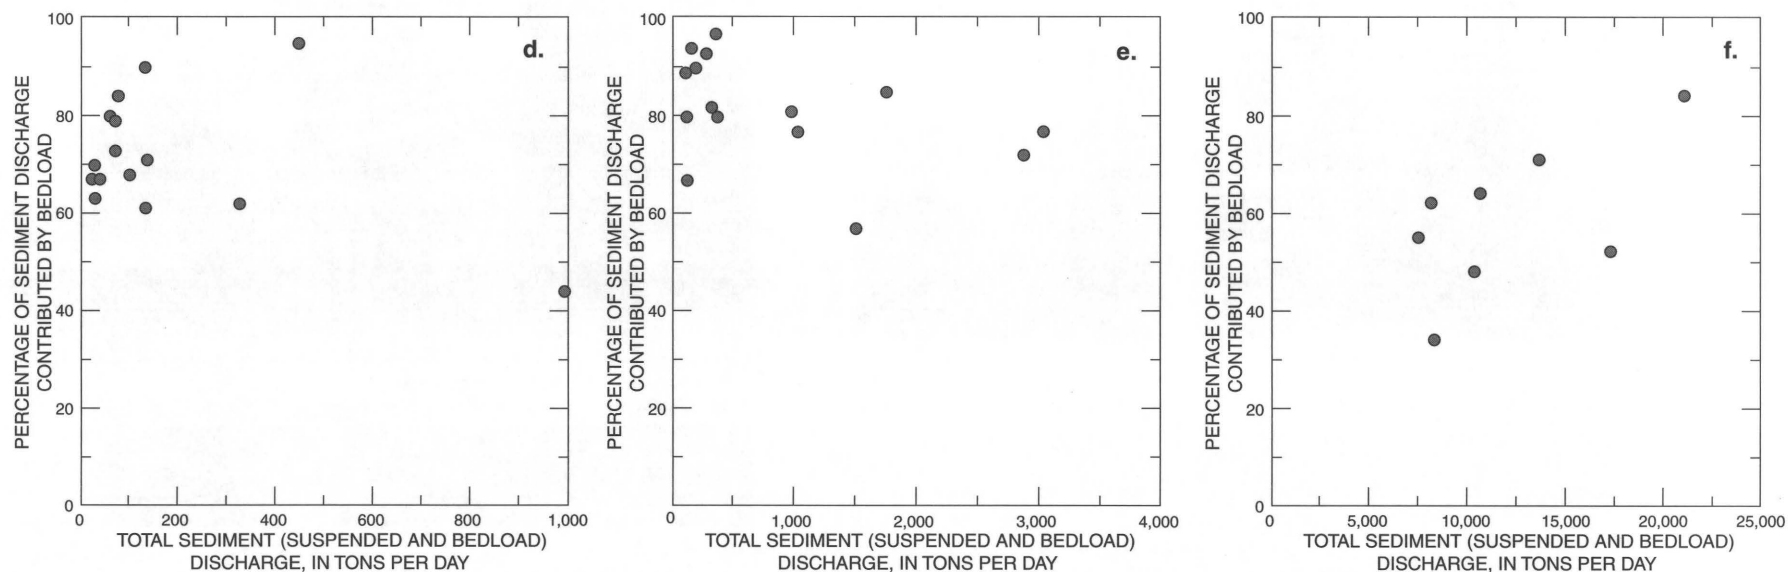
**Figure 8d-f.** Percentage of total sediment discharge that is contributed by bedload for samples collected at selected sites. Whenever two or more consecutive samples were collected on the same day, the average sediment discharges of the samples collected were used to calculate the values shown on the graph.

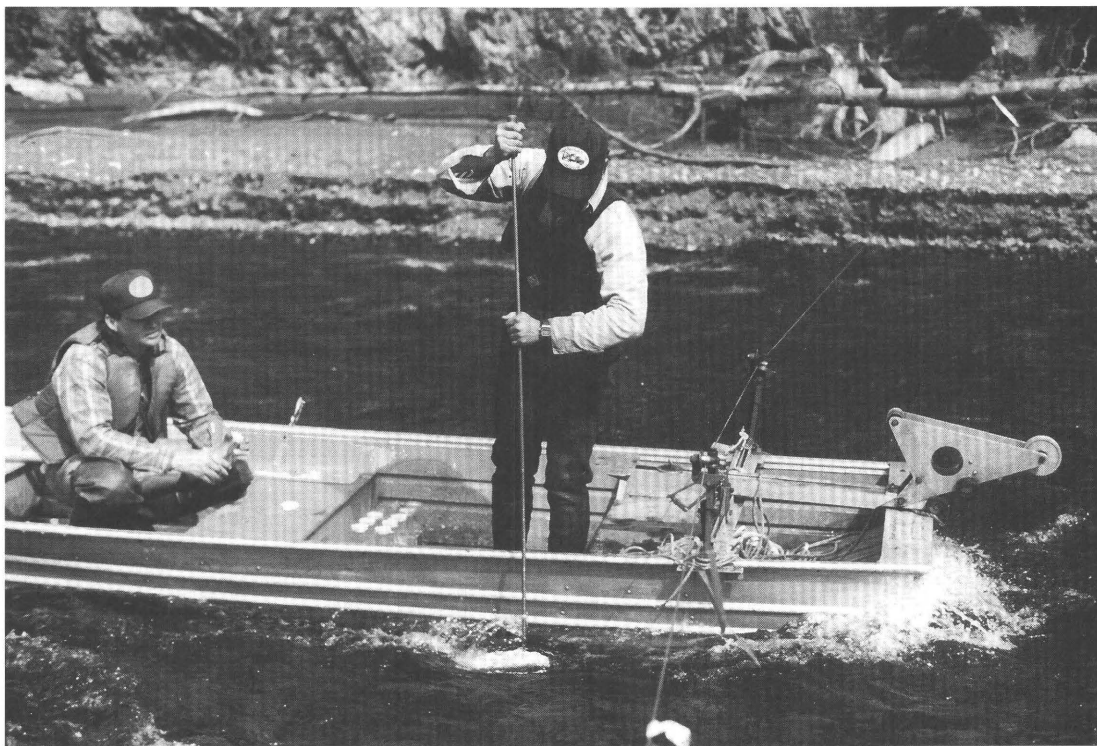
**Figure 9.** Suspended-sediment sampling using a long wading rod and a DH-48 suspended-sediment sampler from a boat at site 12044910, Elwha River Delta site 1 at Lake Mills (ELD1).

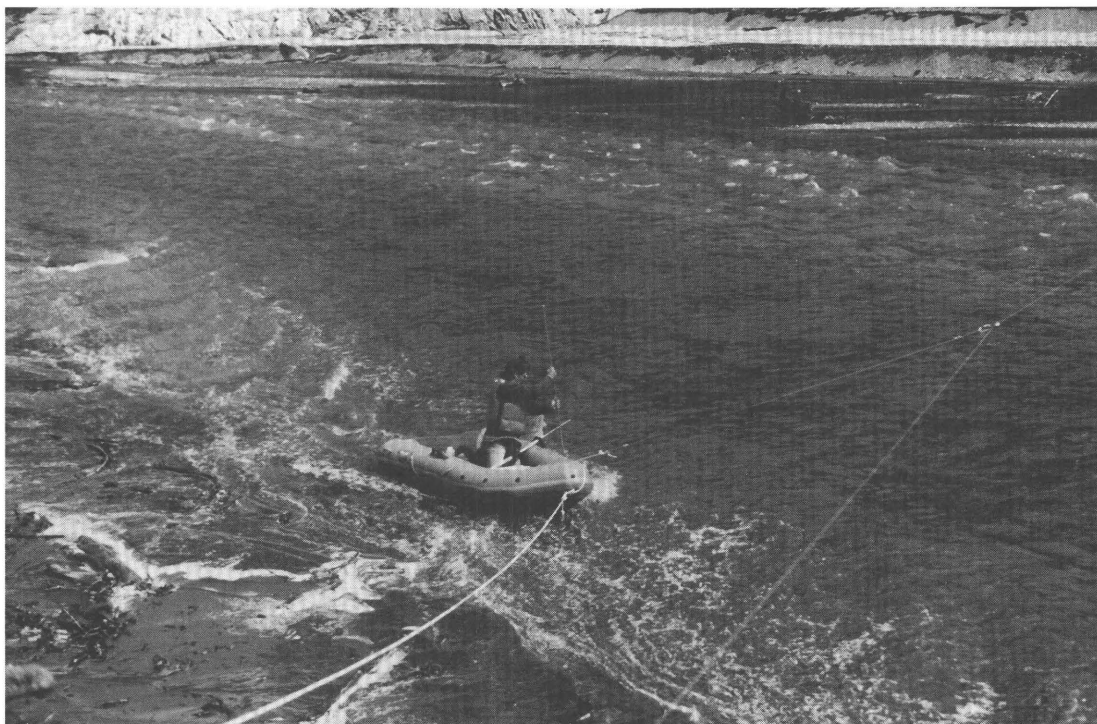
**Figure 10.** Suspended-sediment sampling using a standard wading rod and a DH-48 suspended-sediment sampler from a boat at site 12044920, Elwha River Delta site 2 at Lake Mills (ELD2).

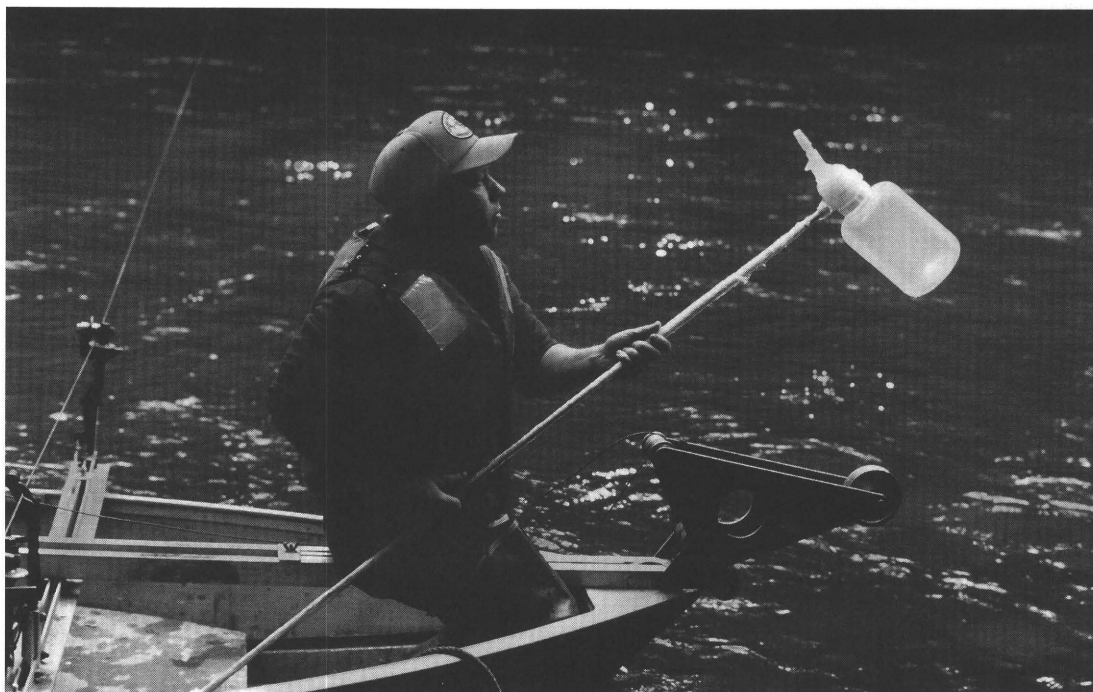
**Figure 11.** Wading-rod-mounted DH-81 water-quality and suspended-sediment sampler.

Protocols for sampling low-level dissolved constituents (Horowitz and others, 1994) were followed during sampling. At ELWW, ELD2, and ELDM, a wading-rod-mounted DH-81 water-quality sampler, with teflon cap, nozzle, and sample bottle, was used from the front of a boat, which was anchored to a boat tagline (photo, fig. 11). At ELWP, a D-77 sampler, with teflon cap, nozzle, and sample bottle, was suspended from a reel in a cable car.

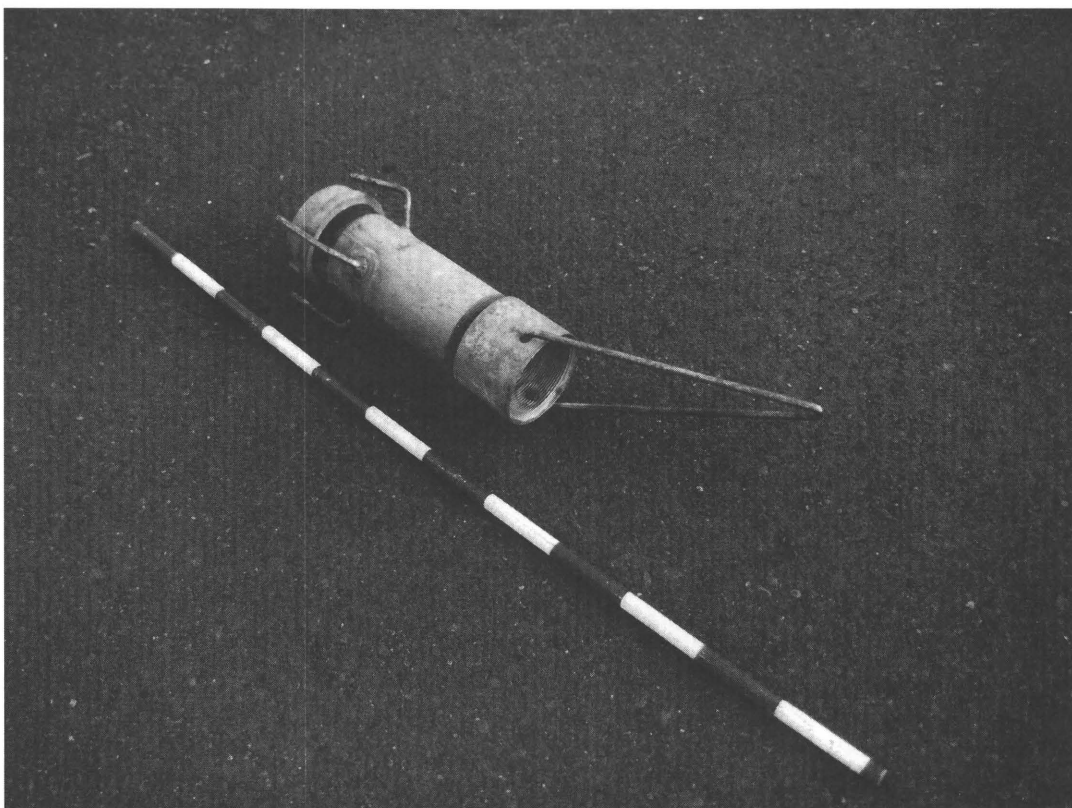
**Figure 12.** Three-inch (76 millimeters) pipe dredge used to collect bed-material samples. All bed material collected was finer than 45 millimeters. Rod is marked in 10-centimeter increments.

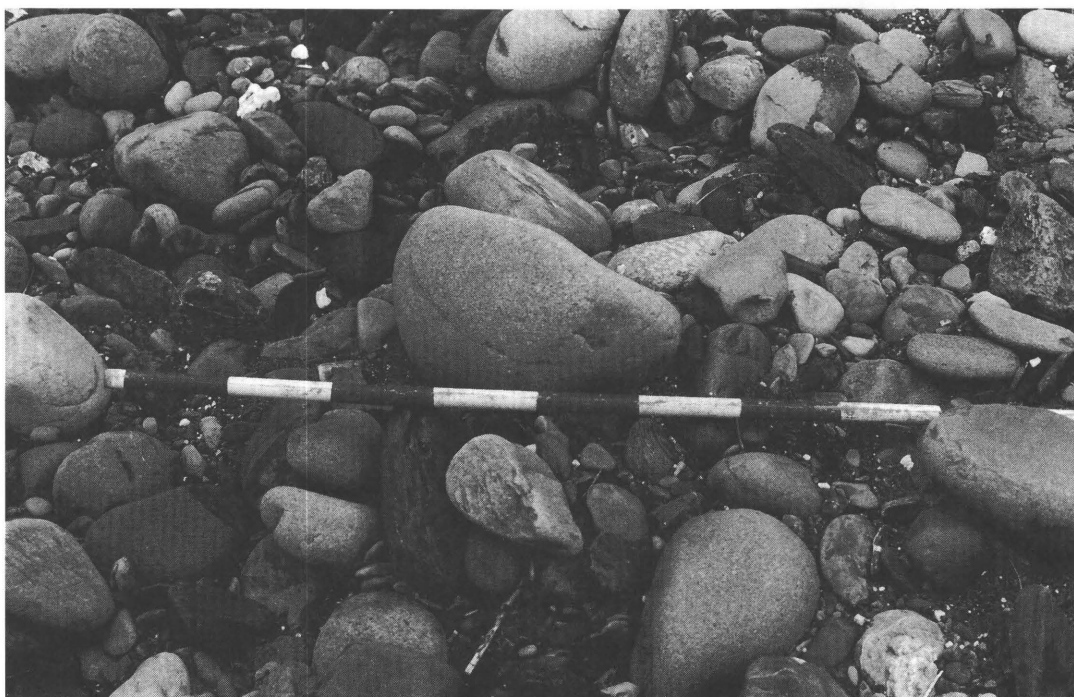
**Figure 13a.** Gravel bar surface near site 12044910, Elwha River Delta site 1 at Lake Mills (ELD1). Rod is marked in 10-centimeter increments.

Particle counts, each consisting of 200 sampling points, were collected from the surface of the upstream and downstream ends of the left bank gravel bar near ELWW. About 300 sampling points were included in particle-count measurements at the upstream end and midpoint of the left bank gravel bar near ELD1. Bulk samples of subsurface sediment were collected with each particle count. The particle-size distributions of the sediments in the surface and subsurface samples are given in tables 9a and 9b. The photographs in figures 13a and 13b show the surface armoring of the

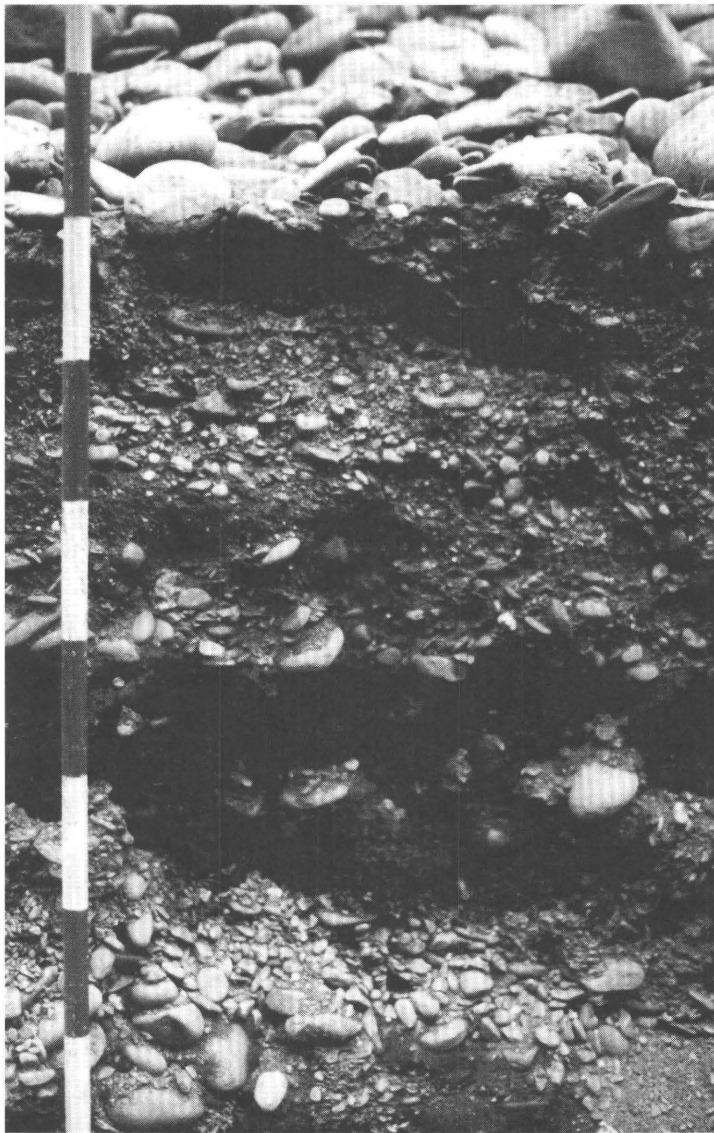
**Figure 13b.** Cut bank showing surface armoring and finer-grained subsurface sediment near site 12044910, Elwha River Delta site1 at Lake Mills (ELD1). Rod is marked in 10-centimeter increments.

streambed by fine to coarse gravel and the finer sediment found below the surface of the left bank gravel bar near ELD1.

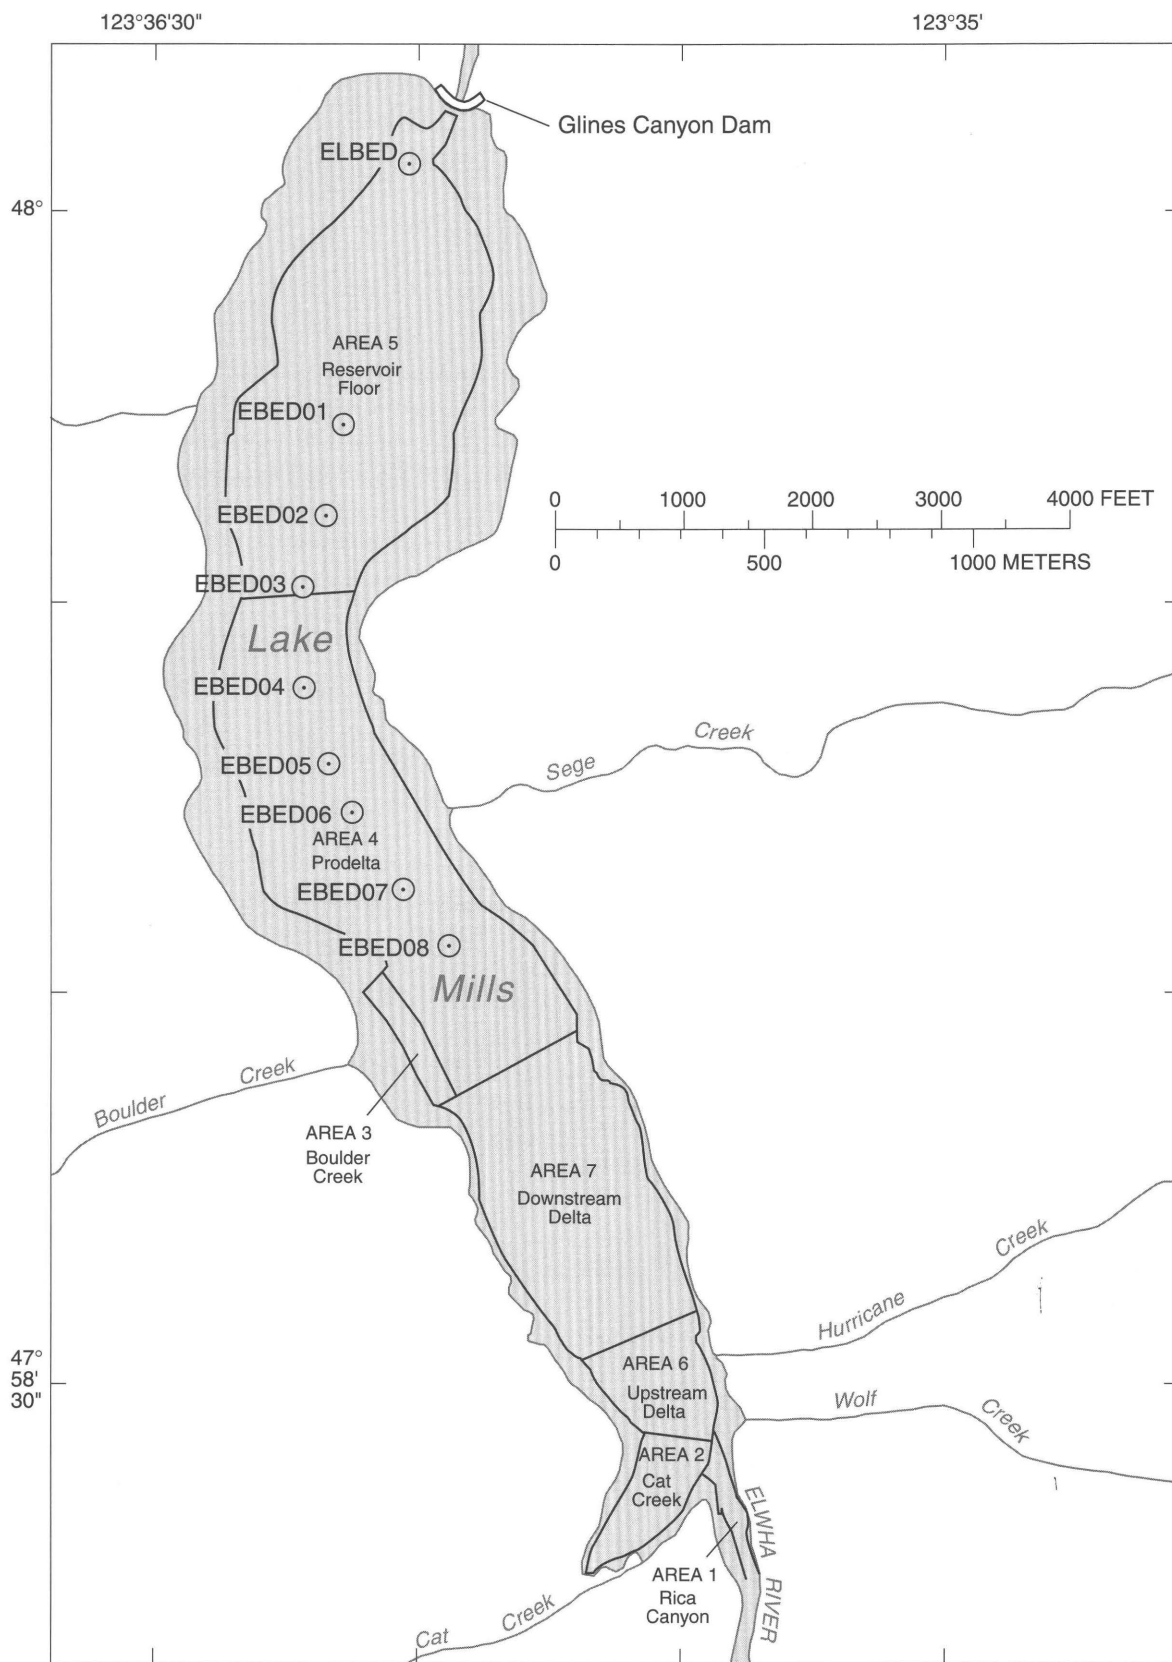
**Figure 14.** Lake Mills sedimentation areas (modified from Gilbert and Link, 1995, figure 6), and locations of lakebed samples ELBED (table 7e) and EBED01-EBED08 (table 12).

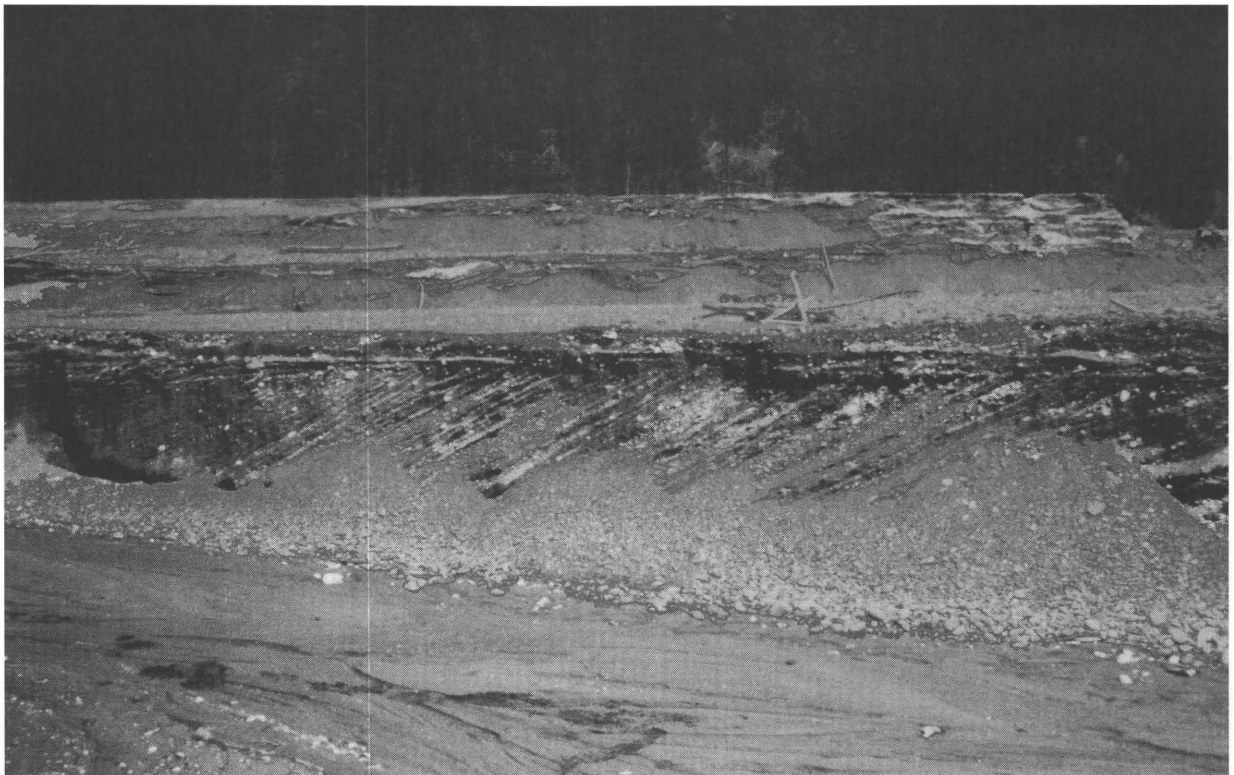
**Figure 15.** Topset beds overlying foreset beds near site 12044920, Elwha River Delta site 2 at Lake Mills (ELD2).
