# Hydrologic Data Collected During the 1994 Lake Mills Drawdown Experiment, Elwha River, Washington

**U.S. GEOLOGICAL SURVEY**  
**Water-Resources Investigations Report 99-4215**

Prepared in cooperation with  
BUREAU OF RECLAMATION,  
NATIONAL PARK SERVICE,  
and LOWER ELWHA  
KLALLAM TRIBE

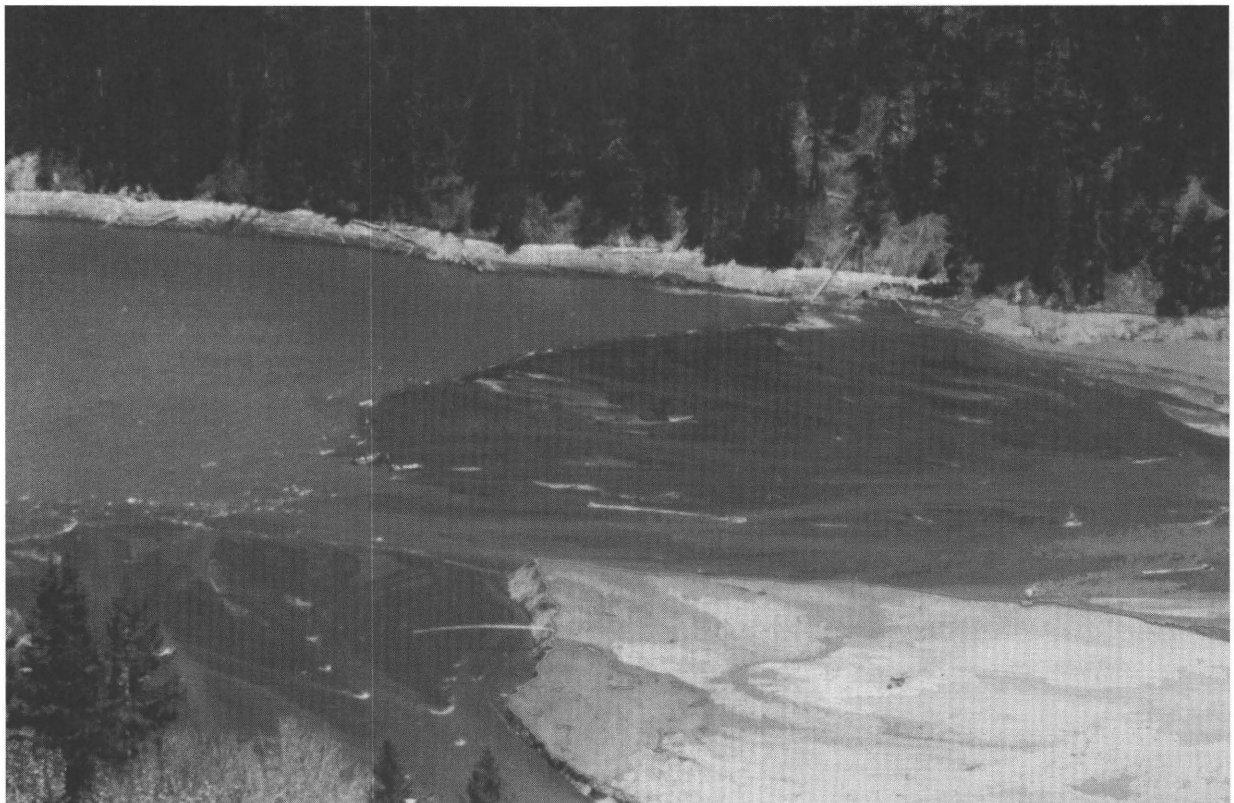
**Figure 16.** New delta forming immediately downstream of toe of the exposed older delta.

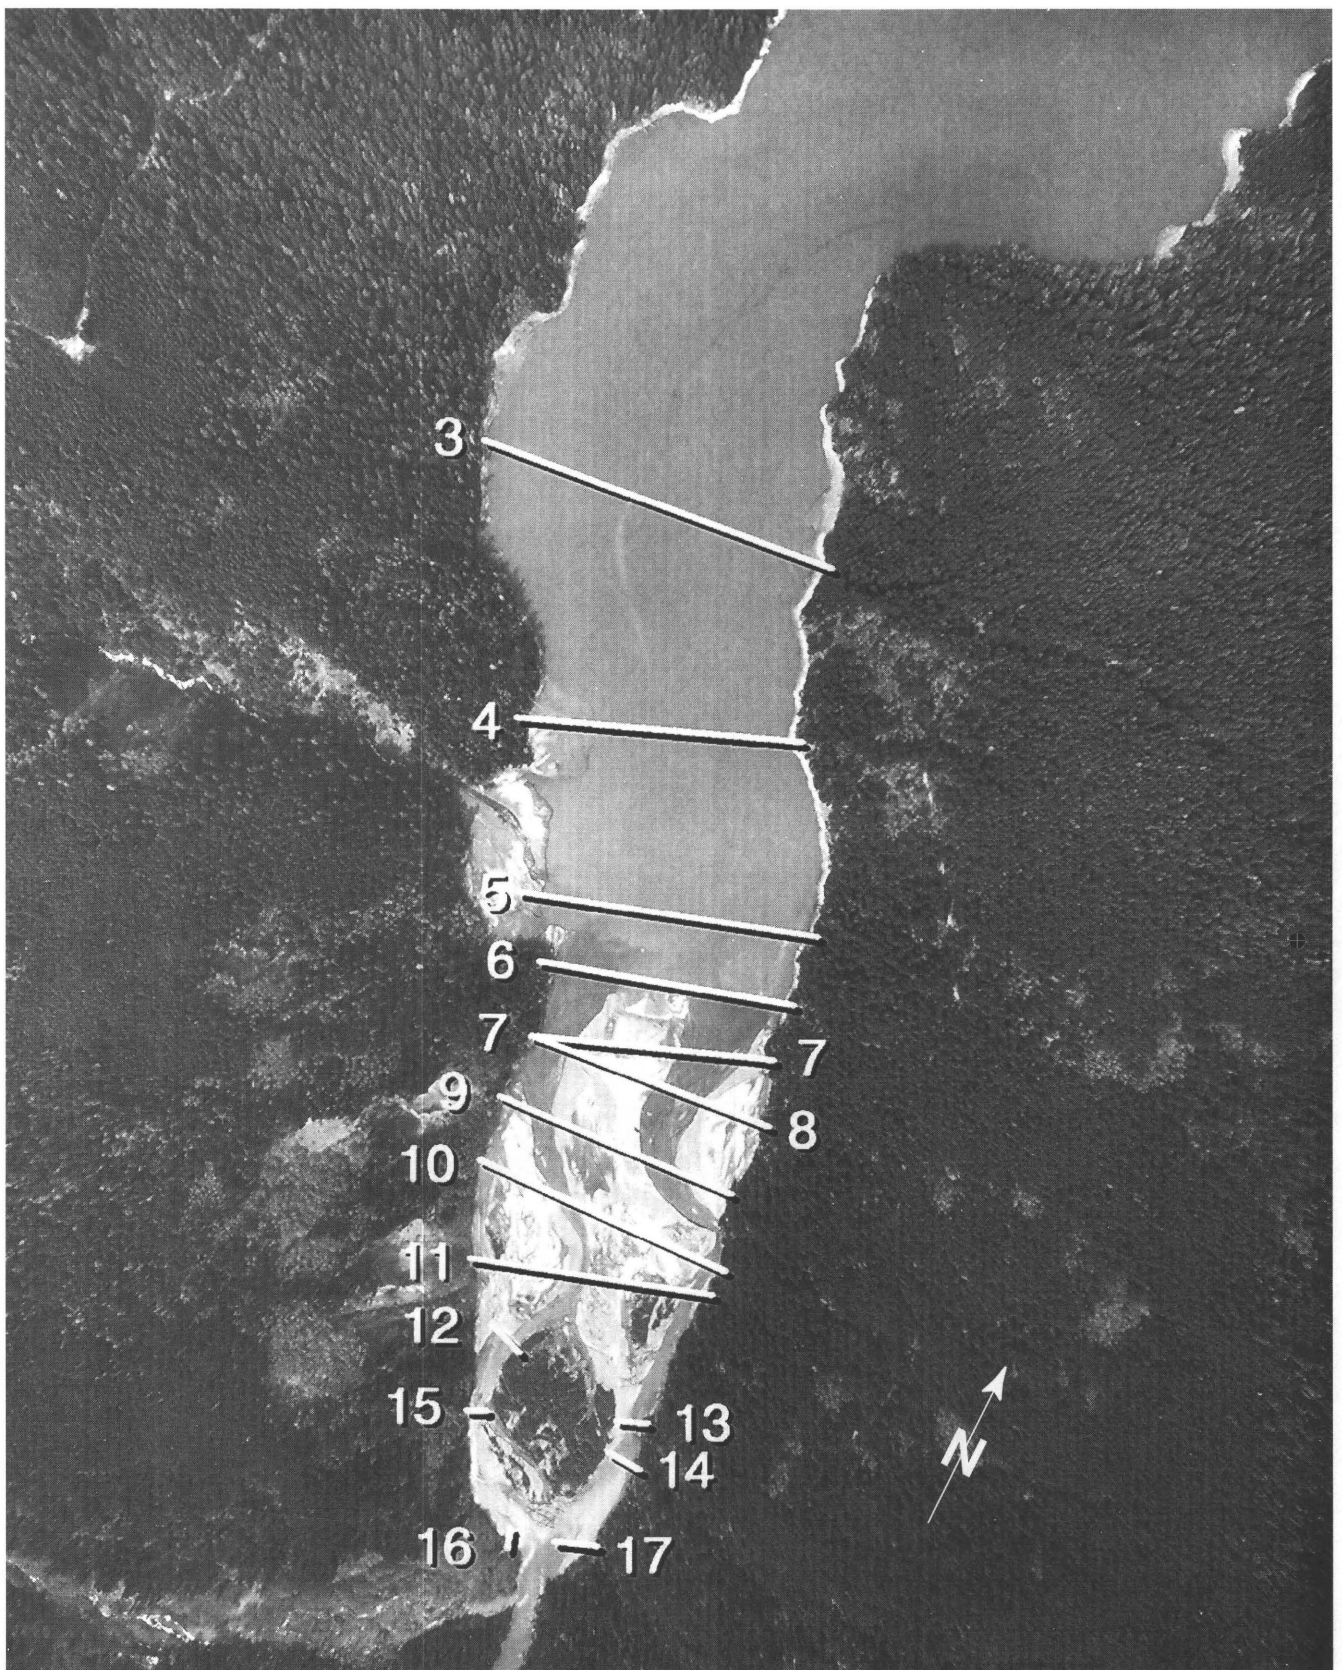
**Figure 17.** Locations of cross sections 3 through 17 surveyed on the Lake Mills Delta. Aerial photograph was taken at time of full reservoir drawdown on April 16, 1994. Photograph provided by the Bureau of Reclamation.

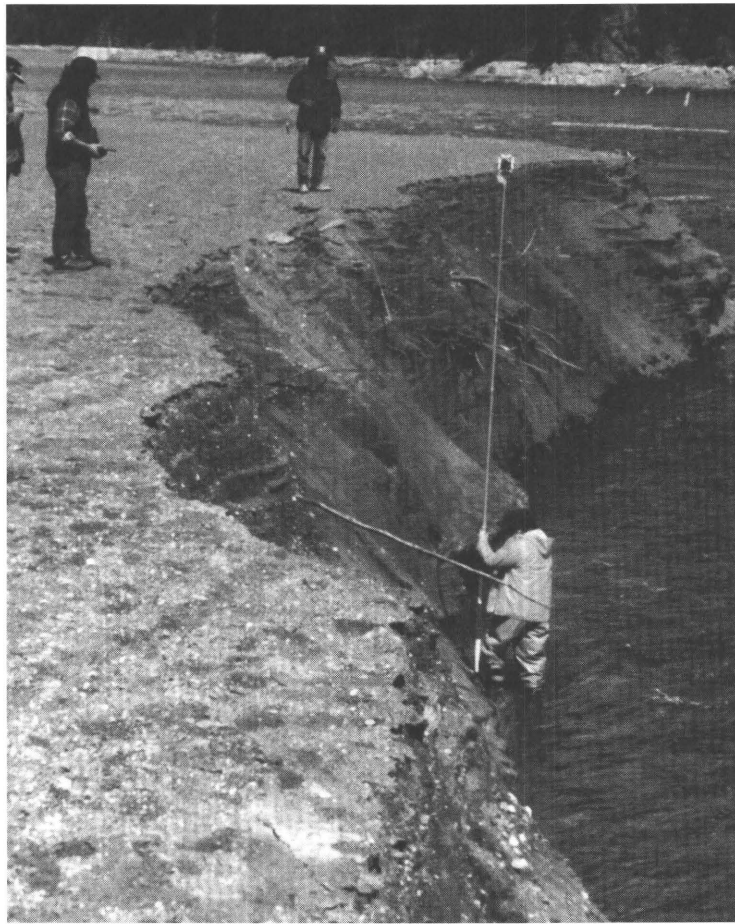
**Figure 18.** Land survey, with a total station and prism, of a Lake Mills Delta cross section.

An electronic total station referenced to three control points was used for the land surveys. One of the control points was used for the instrument setup location, from where the downstream two-thirds of the delta could be seen, and the other two were used as backsites. The position of the instrument was verified

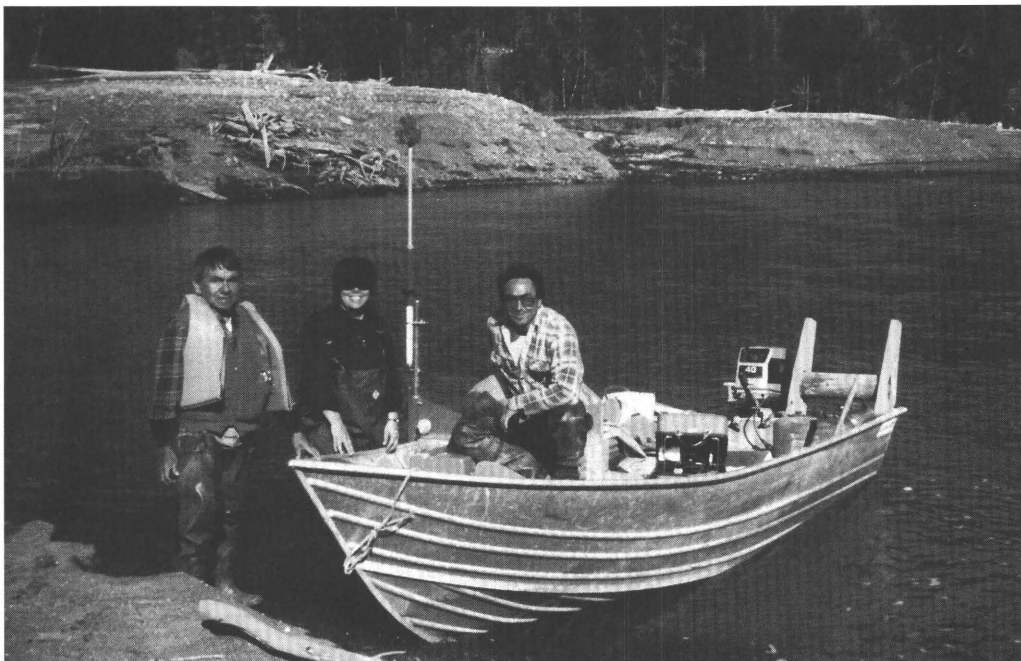
**Figure 19.** Bathymetric survey crew from the Lower Elwha Klallam Tribe and boat used to survey, with an electronic distance meter and fathometer, Lake Mills Delta cross sections that were too deep to wade.

The initial conditions of the eight most downstream cross sections were surveyed by boat on April 8, 1994. Depths were sounded and recorded with a fathometer, and horizontal distance was measured by an electronic distance meter (EDM) set up on shore over each cross section's west (left bank) monument. The EDM readings were relayed by radio to the boat and recorded on the fathometer chart. Bathymetric cross-section surveys were repeated daily from April 10 through April 26, 1994.

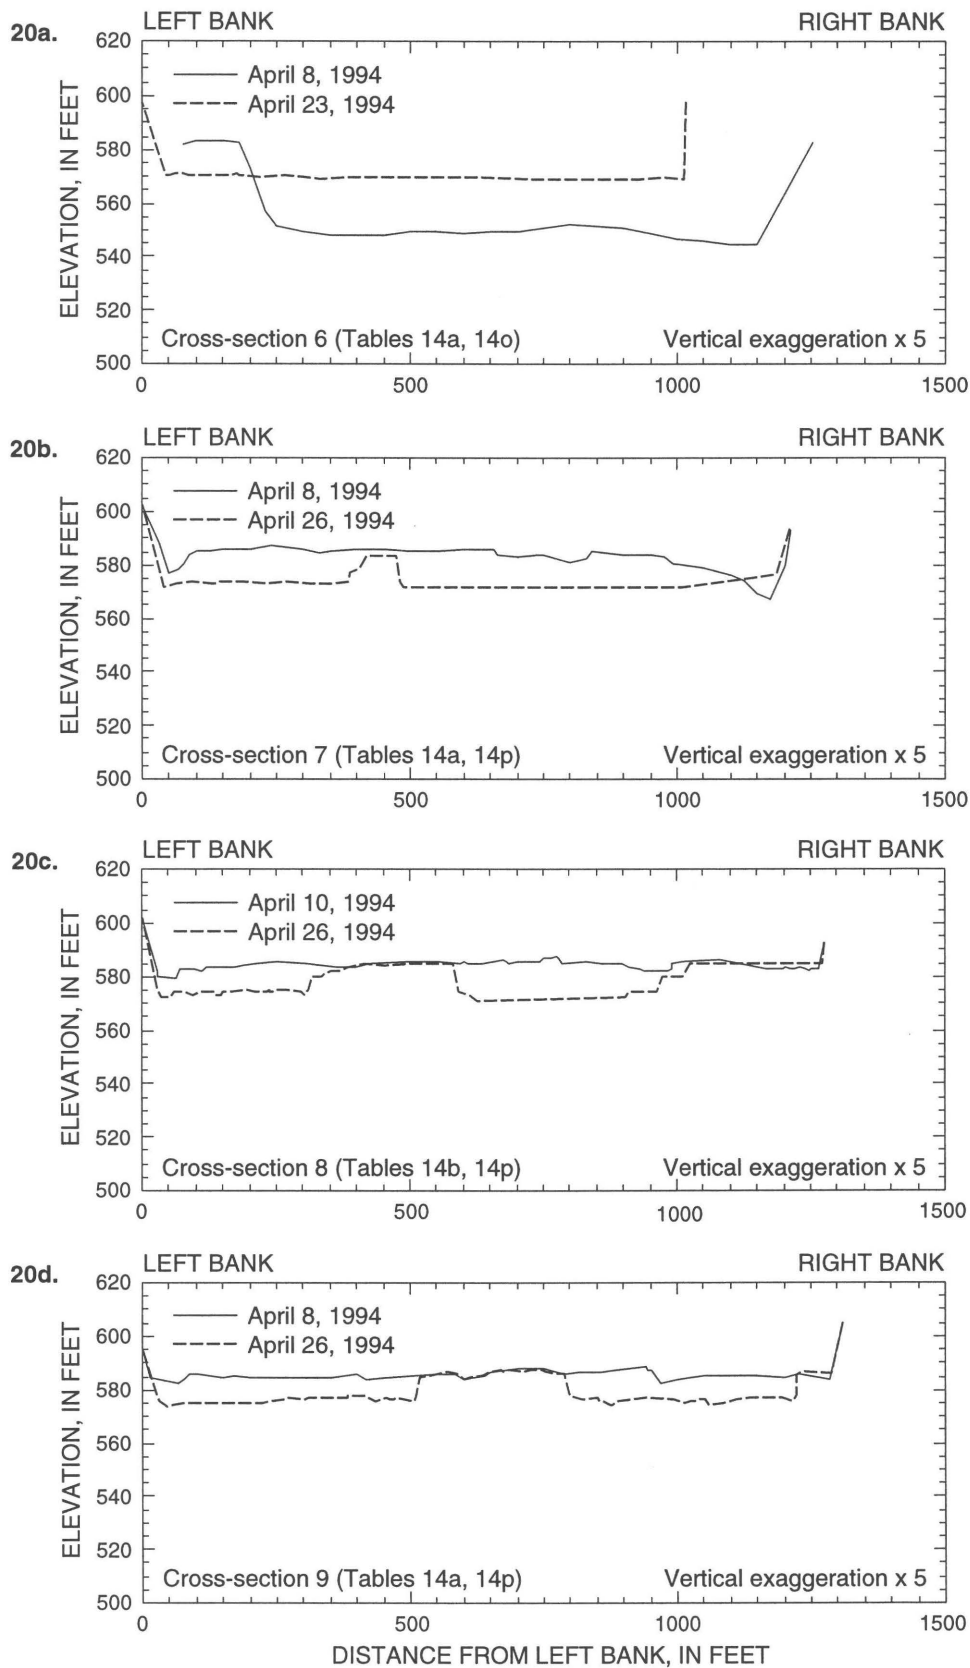
**Figure 20a-d.** Surface elevation of Lake Mills Delta, cross-sections 6-9.

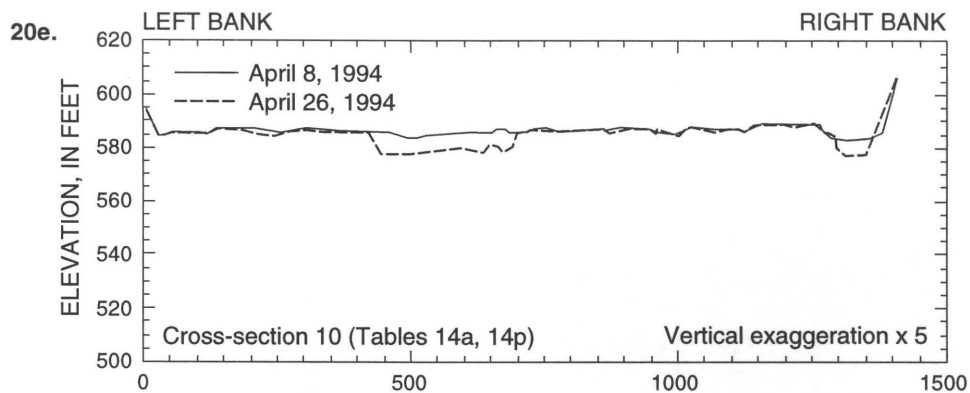
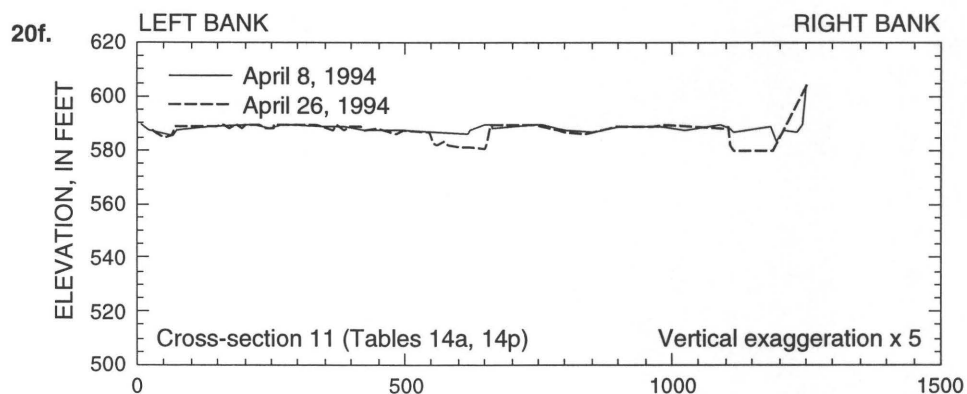
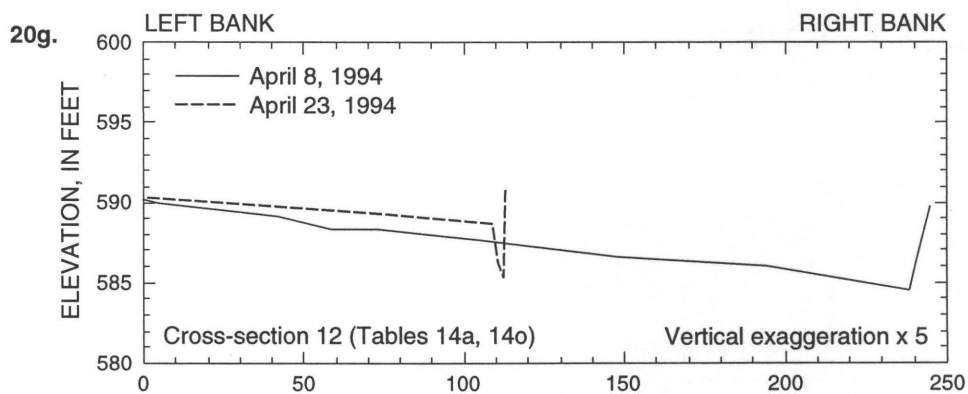
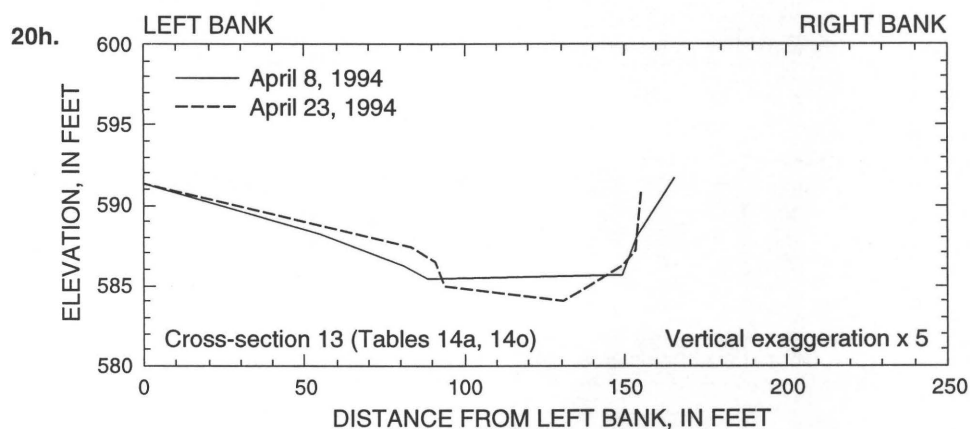
Figure 20e-h. Surface elevation of Lake Mills Delta, cross-sections 10-13.

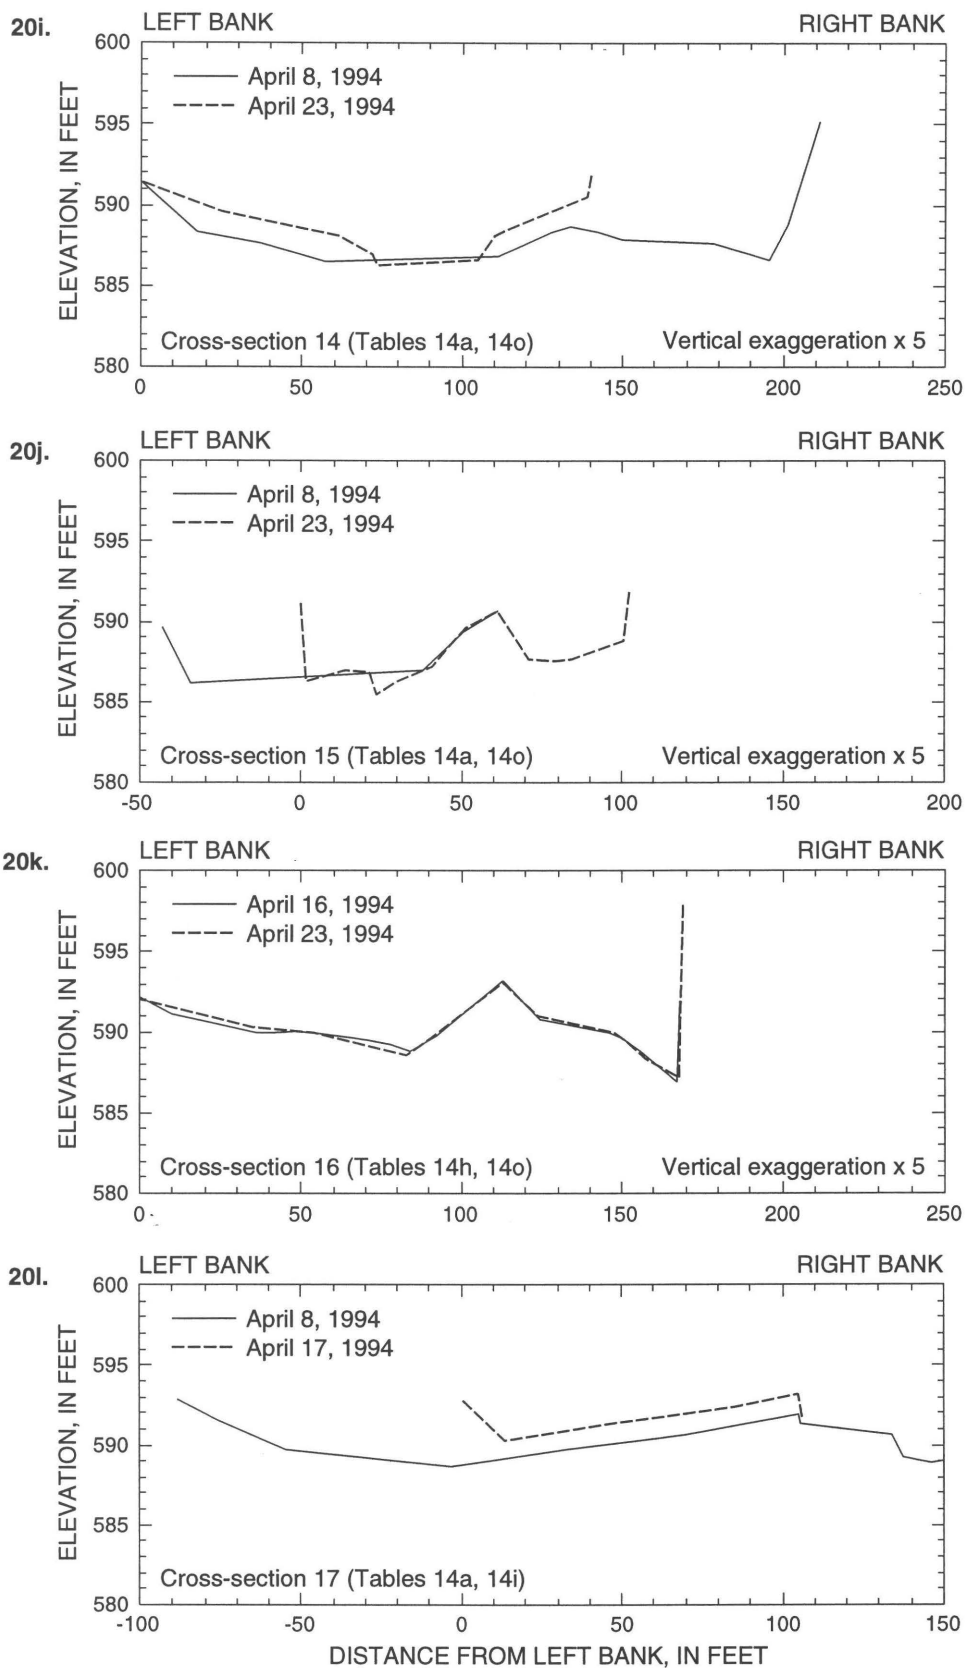
**Figure 20i-l.** Surface elevation of Lake Mills Delta, cross-sections 14-17.

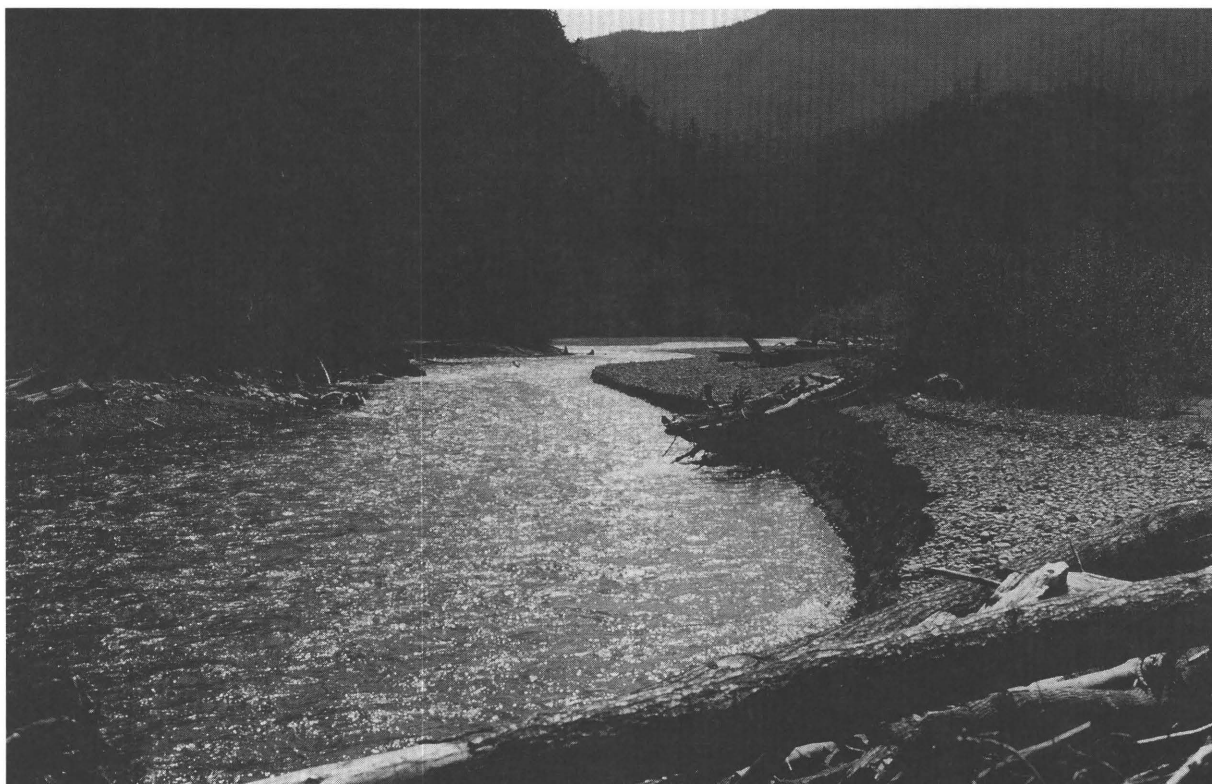
**Figure 21.** Upstream reach of the right channel near site 12044910, Elwha River Delta site 1 at Lake Mills (ELD1), looking upstream toward the head of the riffle.

During the course of the drawdown experiment, streambed erosion in the upper reaches of the left and right channels proceeded slowly and uniformly (photo, fig. 21). Nick points (points in the streambed where degradation begins) in both channels proceeded upstream but never reached the head of each riffle at the upstream end of the island separating the channels near the mouth of Rica Canyon. Bank erosion in the upper reaches of these two channels was limited to some degree by the abundance of logs and other woody debris from past floods deposited at the upstream end of the island and along the banks of the right channel. In the gravelly and cobbly upper part of the delta, erosion was primarily vertical during the entire experiment. As erosion continued, the bed became coarser, erosion slowed, and upstream progression of the nick points slowed.

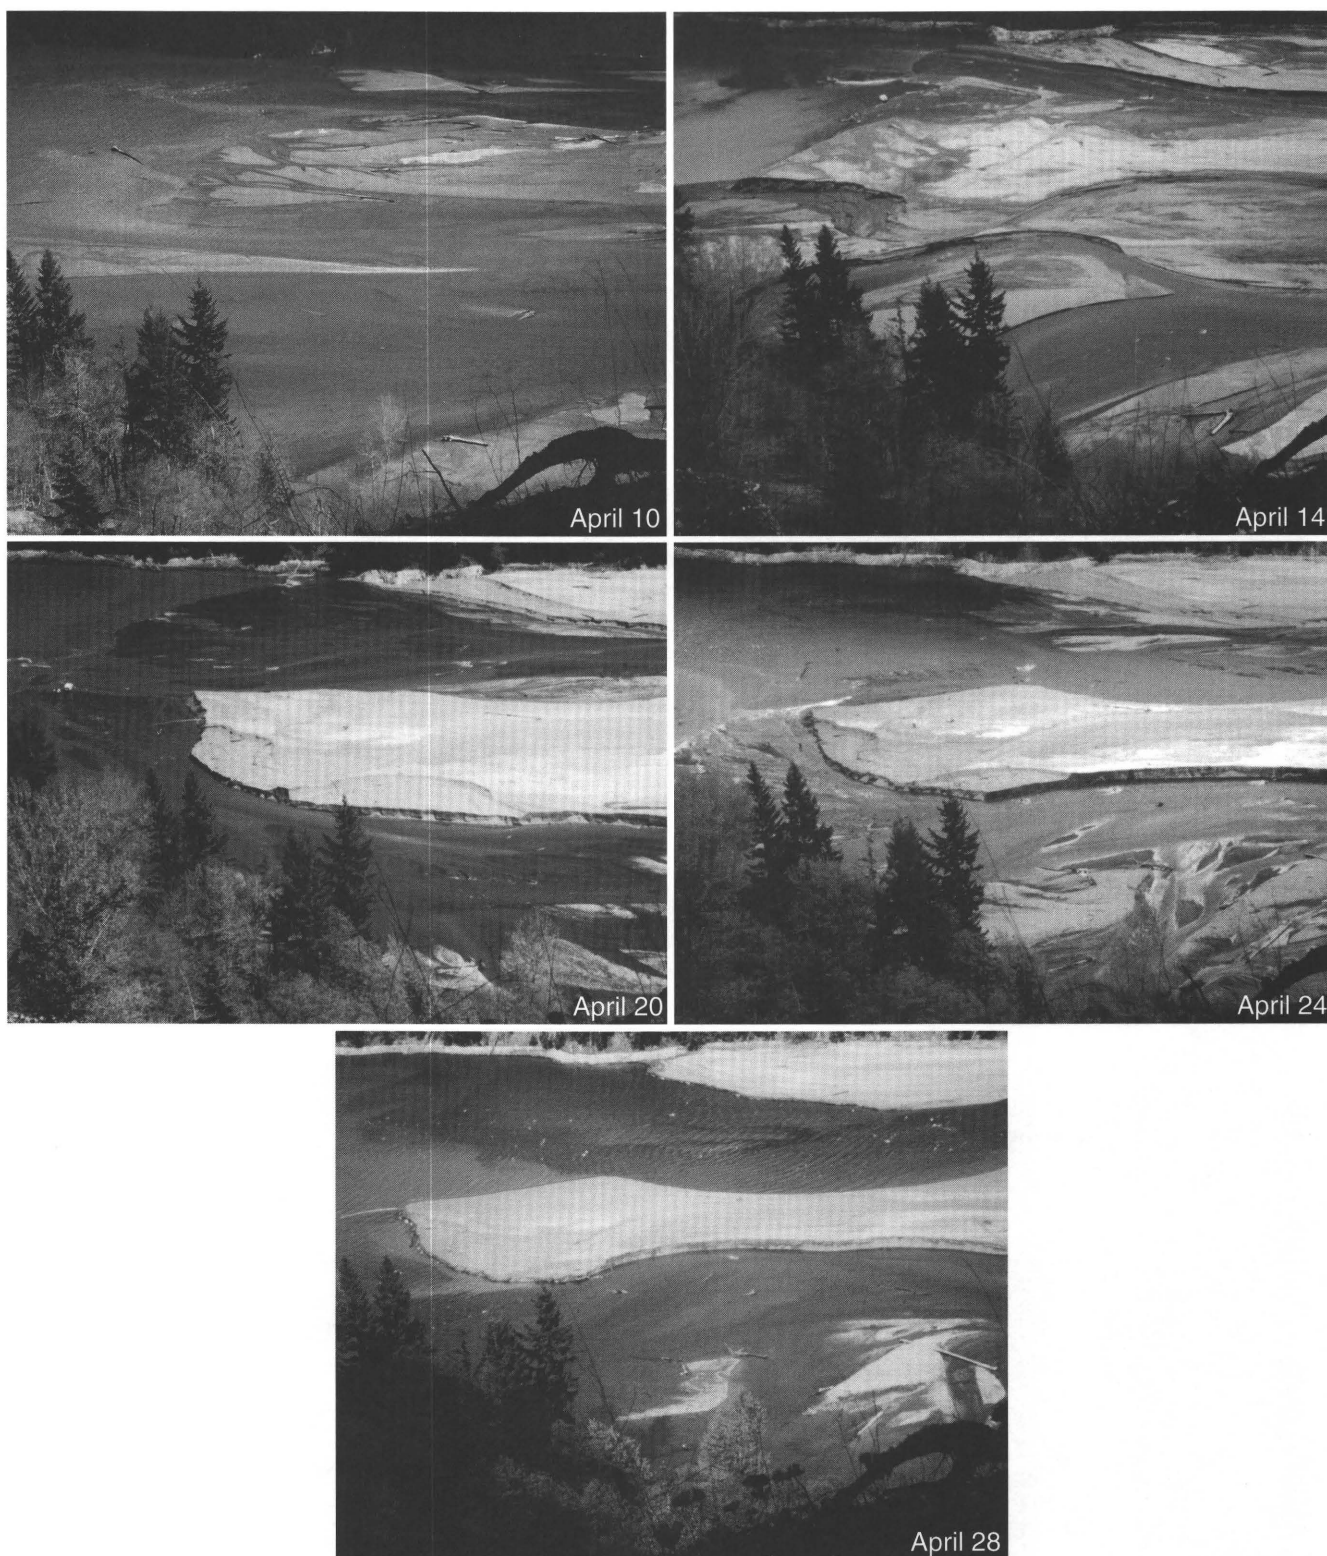
**Figure 22.** Time-lapse photographic sequence from camera looking at downstream reach of the delta on April 10, 14, 20, 24, and 28, 1994. Photographs provided by the National Park Service.

The repeat photography provided a visual record of delta erosion and redeposition during the drawdown and refilling of the lake. A few of these photographs are shown in figures 22, 23, and 24 to illustrate the channel development and movement during the drawdown experiment. Quantitative measurements can be made from the photographs because surveyed photo panels were placed in the image fields. The photographs were digitized and archived in photo-CD format from which a time-lapsed video was produced. The video is in three parts, one for each camera position. The video is on file at the Water Resources Division Office of the National Park Service in Fort Collins, Colorado.

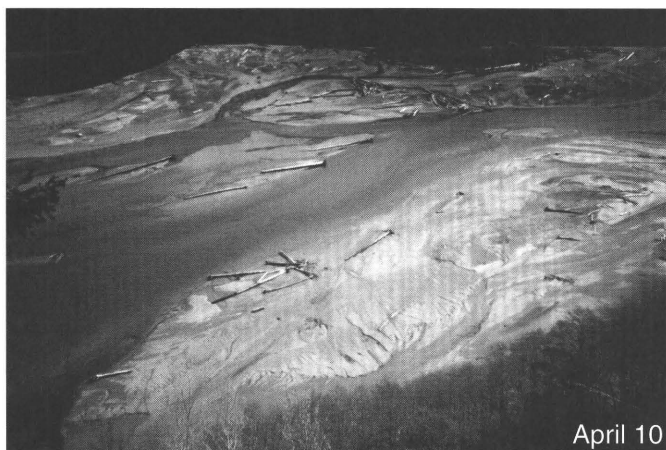
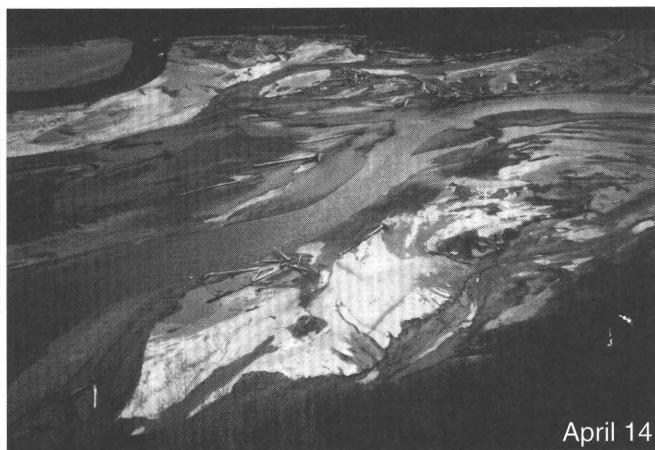
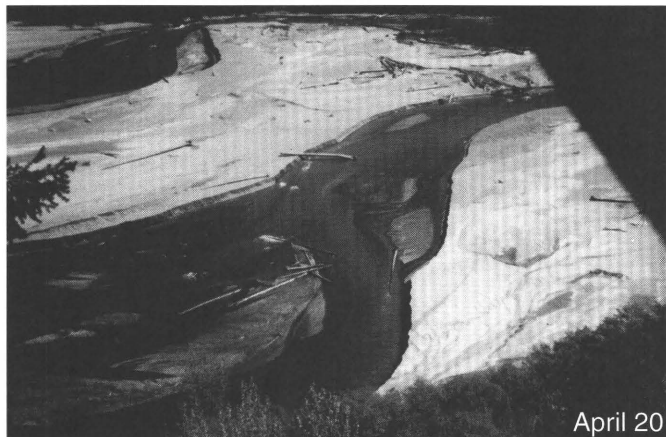
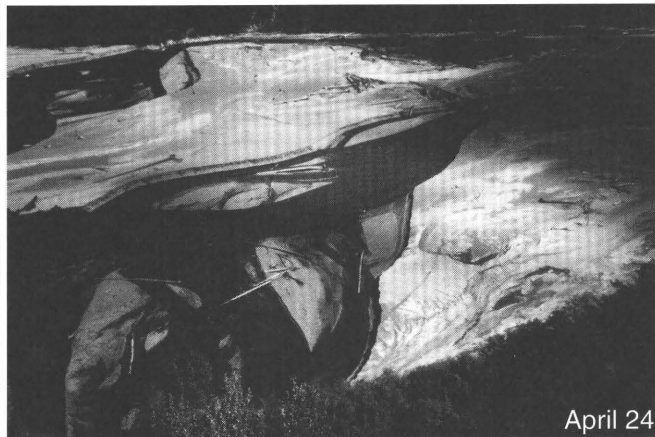
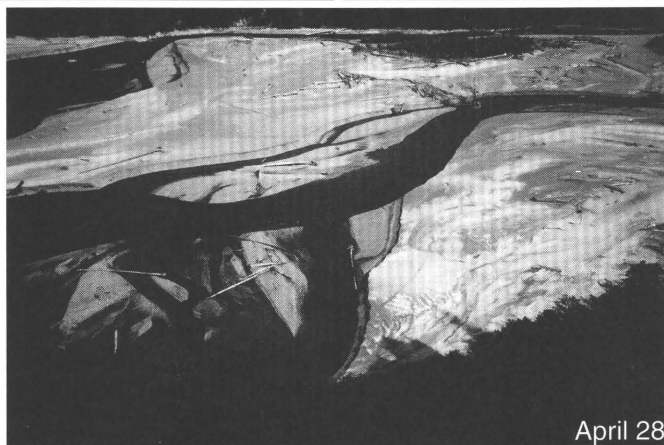
**Figure 23.** Time-lapse photographic sequence from camera looking at middle reach of the delta on April 10, 14, 20, 24, and 28, 1994. Photographs provided by the National Park Service.

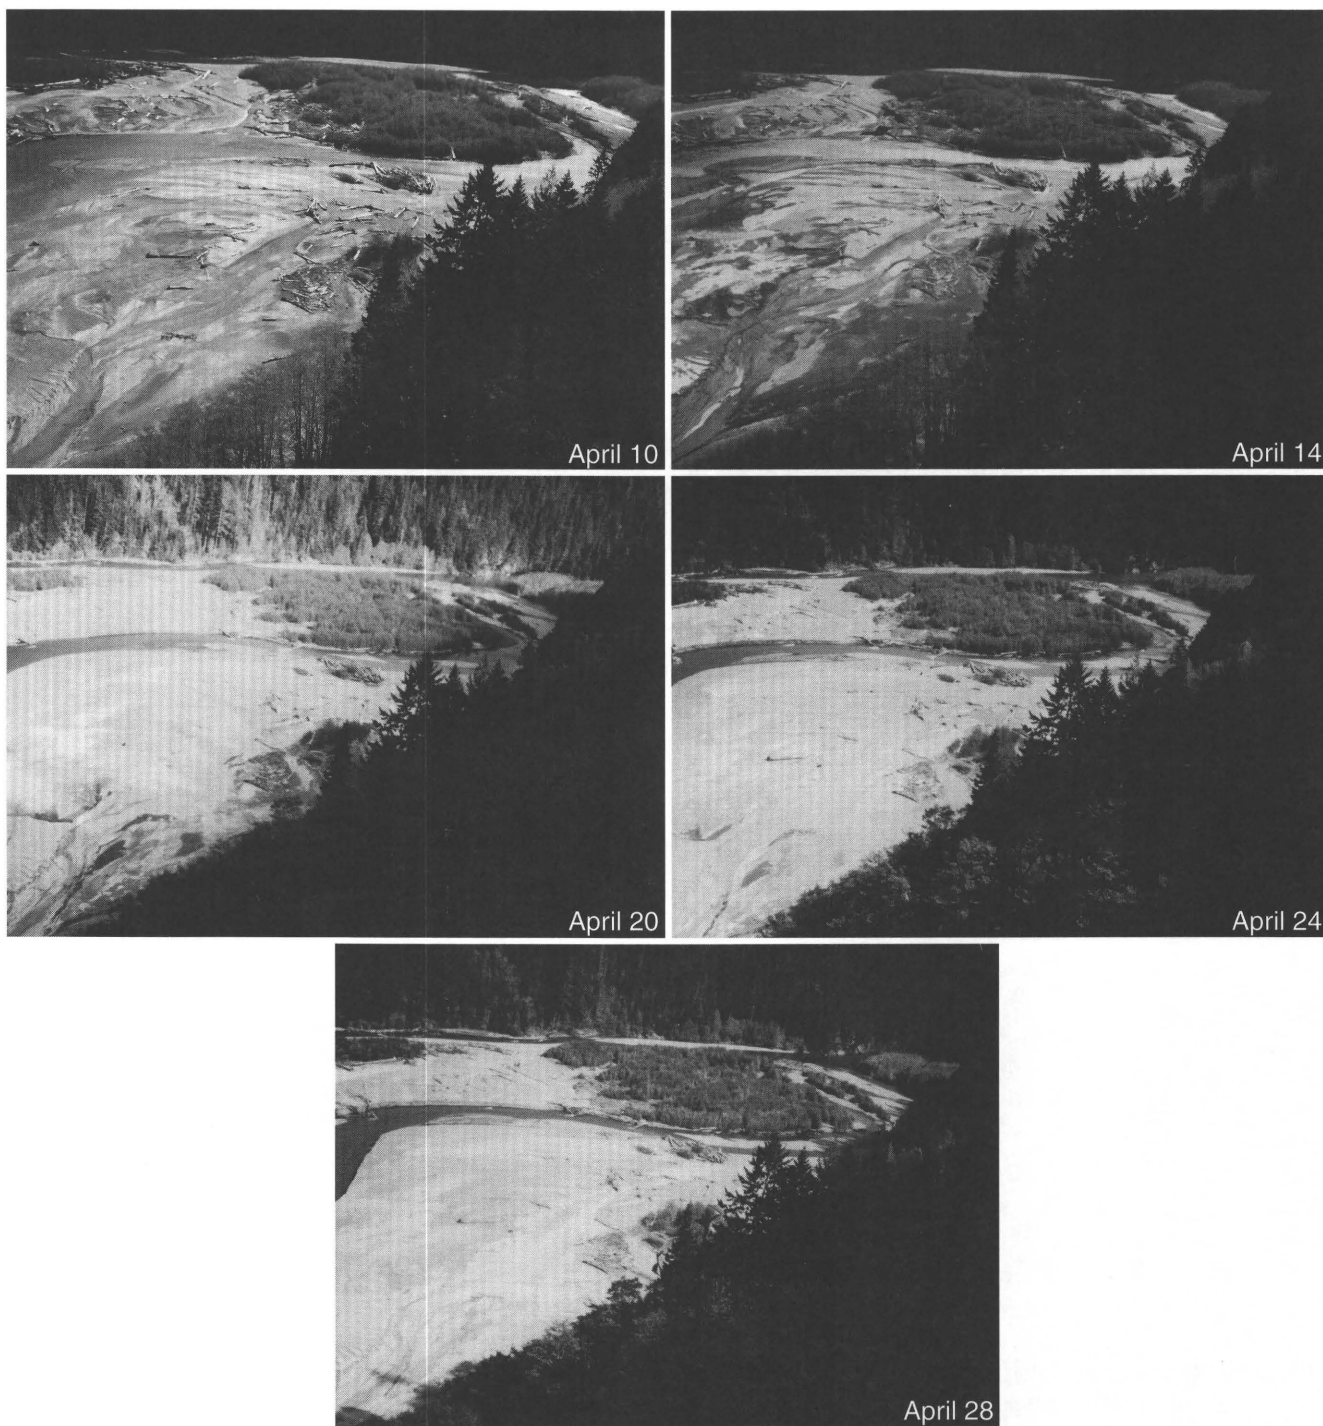
**Figure 24.** Time-lapse photographic sequence from camera looking at upstream reach of the delta on April 10, 14, 20, 24, and 28, 1994. Photographs provided by the National Park Service.
