INTRODUCTION

This report presents the morphometry, bathymetry, and sediment thickness of Grove and Plow Shop Ponds in map form. Orthophoto features in the area surrounding the ponds are included to facilitate field use of the map in future studies. Knowledge of the volume of water and of the soft sediments in the ponds, and of the topographic distribution of the pond sediments, will facilitate the evaluation of the trace-metal deposits.

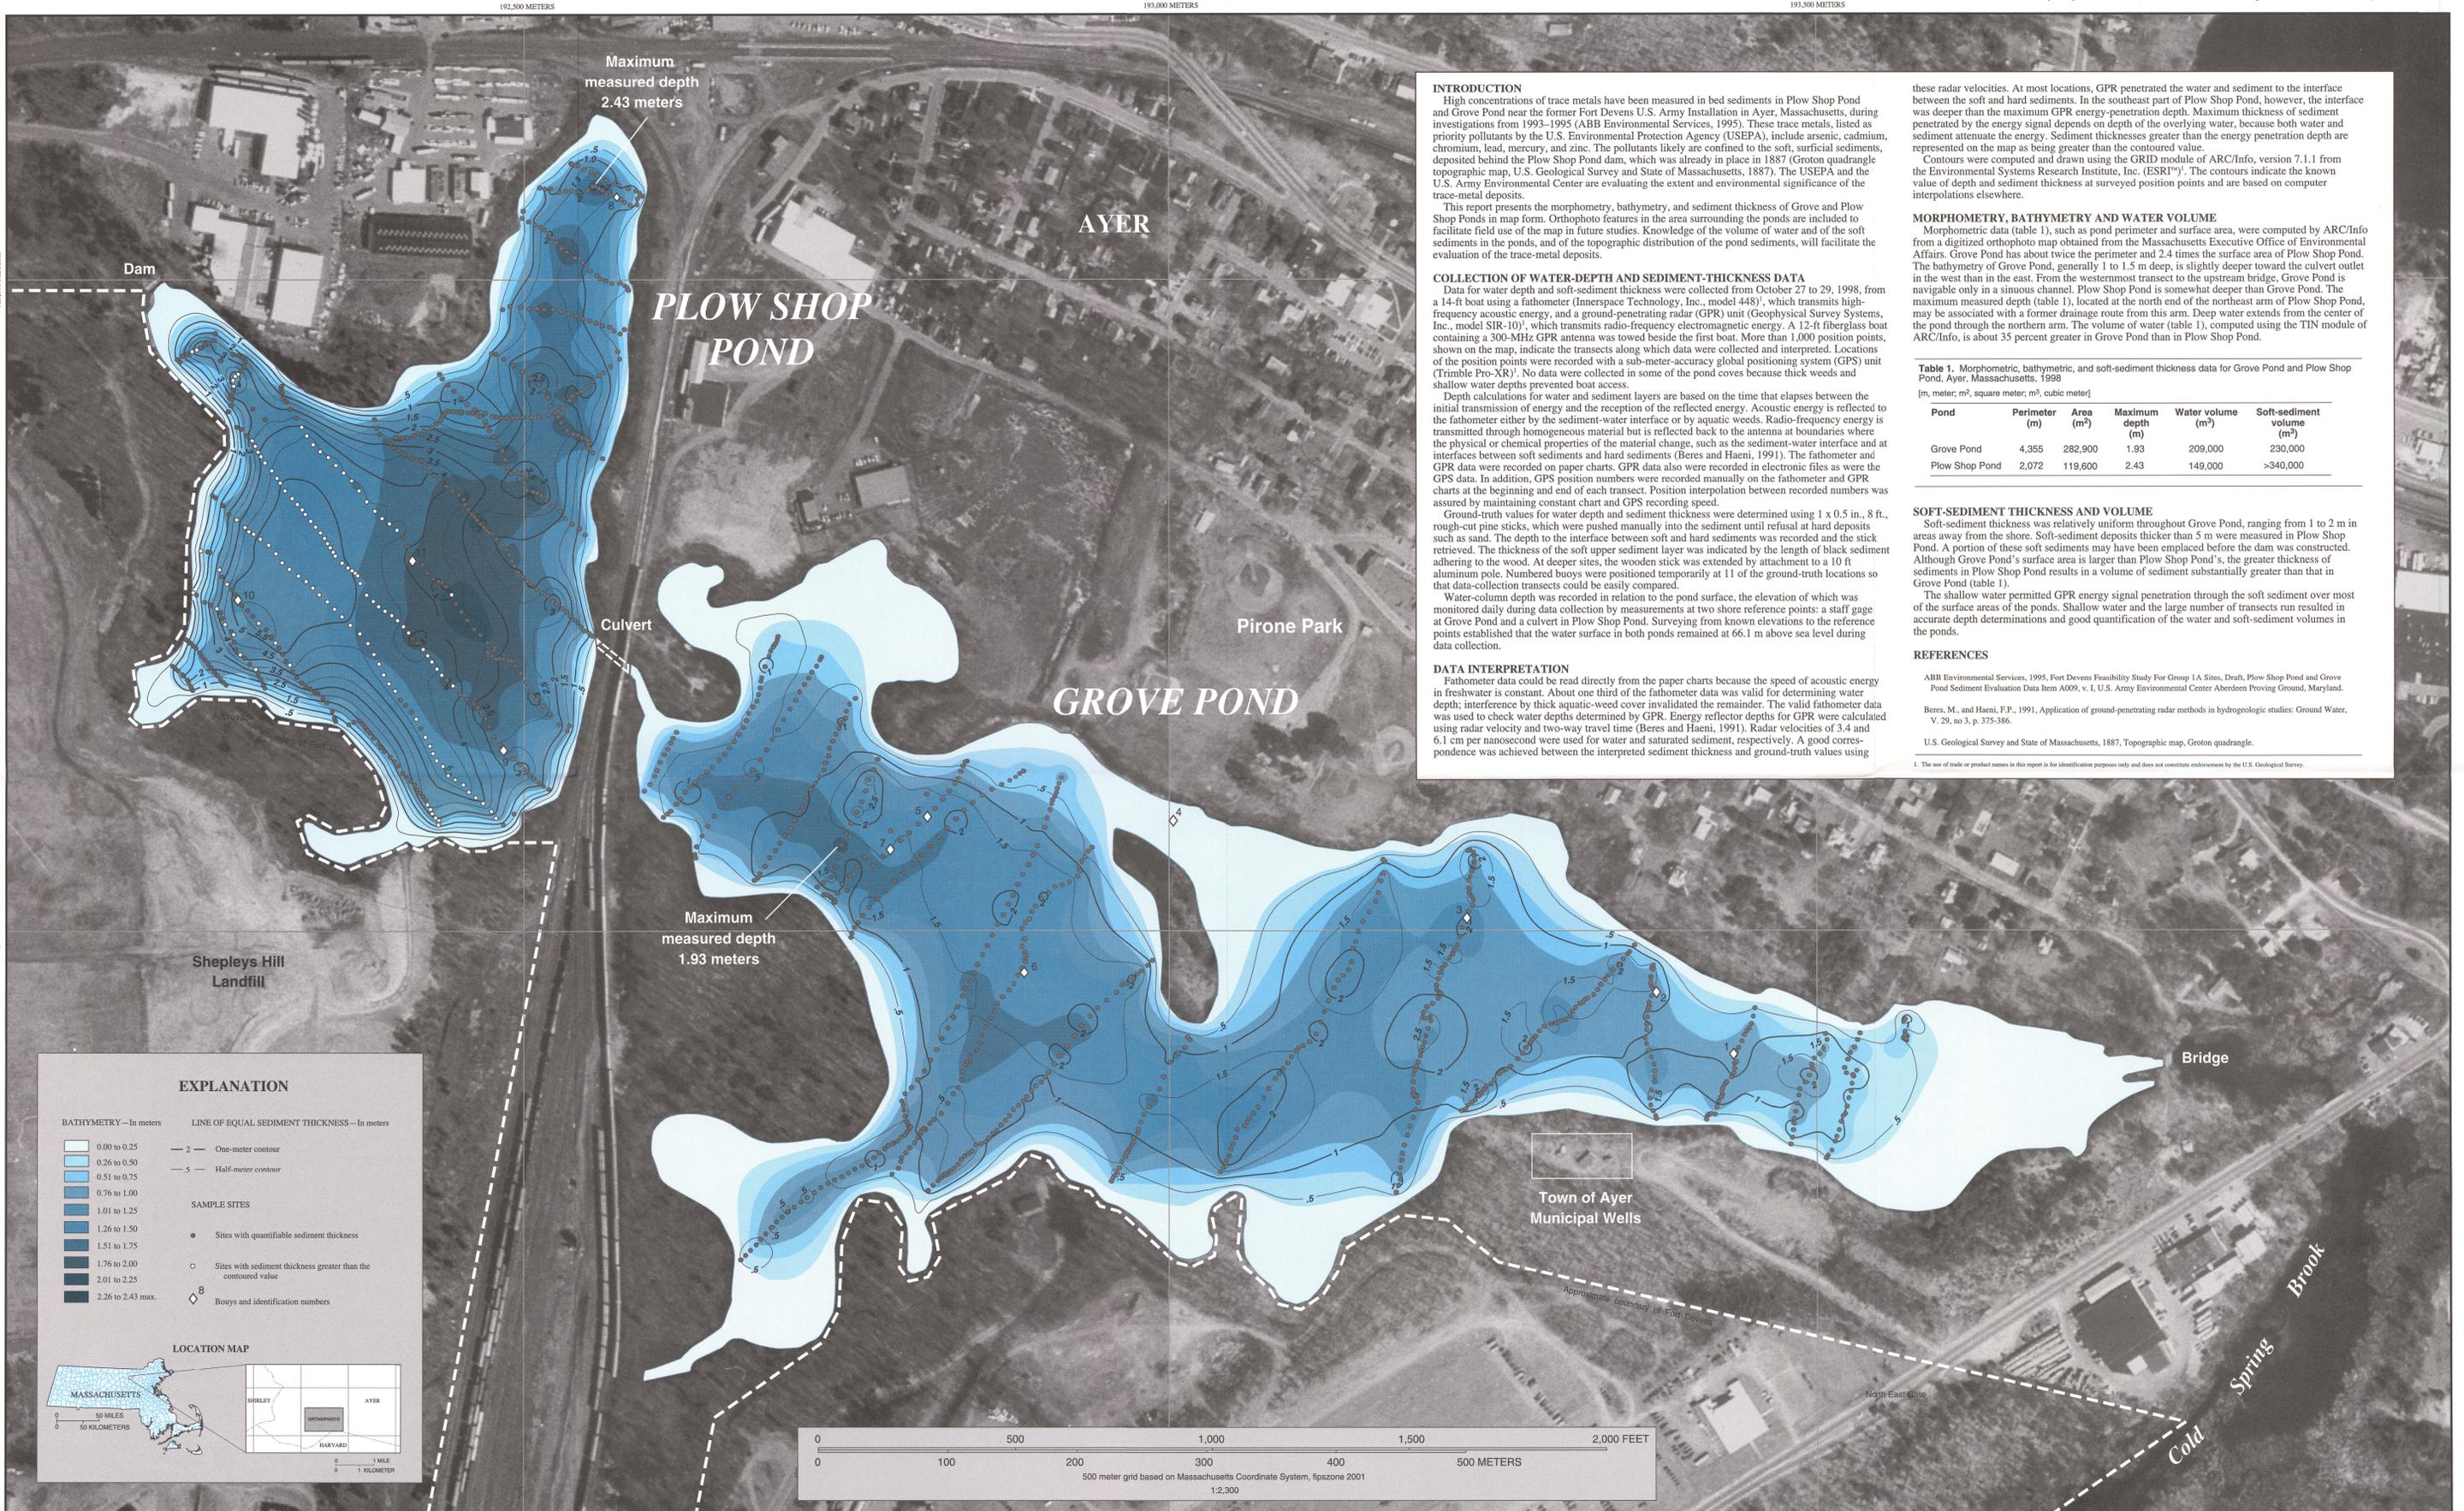
Orthophoto mosaic from Massachusetts Executive Office of Environmental Affairs, 1997, originally 1:5,000 rescaled to 1:2,300, Massachusetts Coordinate System 500 meter grid shown. Hydrogeology by Ariane M. Mercadante, John A. Colman, and Marc L. Buursink, 1999.

Contours were computed and drawn using the GRID module of ARC/INFO, version 7.1.1 from the Environmental Systems Research Institute, Inc. (ESRI)¹. The contours indicate the known value of depth and sediment thickness at surveyed position points and are based on computer interpolations elsewhere.

Morphometric data (table 1), such as pond perimeter and surface area, were computed by ARC/INFO from a digitized orthophoto map obtained from the Massachusetts Executive Office of Environmental Affairs. Grove Pond has about twice the perimeter and 2.4 times the surface area of Plow Shop Pond. The bathymetry of Grove Pond, generally 1 to 1.5 m deep, is slightly deeper toward the culvert outlet in the west than in the east. From the westernmost transect to the upstream bridge, Grove Pond is navigable only in a sinuous channel. Plow Shop Pond is somewhat deeper than Grove Pond. The maximum measured depth (table 1), located at the north end of the northeast arm of Plow Shop Pond, may be associated with a former drainage route from this arm. Deep water extends from the center of the pond through the northern arm. The volume of water (table 1), computed using the TIN module of ARC/INFO, is about 35 percent greater in Grove Pond than in Plow Shop Pond.

Soft-sediment thickness was relatively uniform throughout Grove Pond, ranging from 1 to 2 m in areas away from the shore. Soft-sediment deposits thicker than 5 m were measured in Plow Shop Pond. A portion of these soft sediments may have been replaced before the dam was constructed. Although Grove Pond's surface area is larger than Plow Shop Pond's, the greater thickness of sediments in Plow Shop Pond results in a volume of sediment substantially greater than that in Grove Pond (table 1).
