U.S. GEOLOGICAL SURVEY

Figure 2. Vertical profile representations along REACH 1 of the Tucson Aqueduct.

Figure 1. Study area showing location of reaches, test holes, and seismic-refraction profiles along the Tucson Aqueduct.

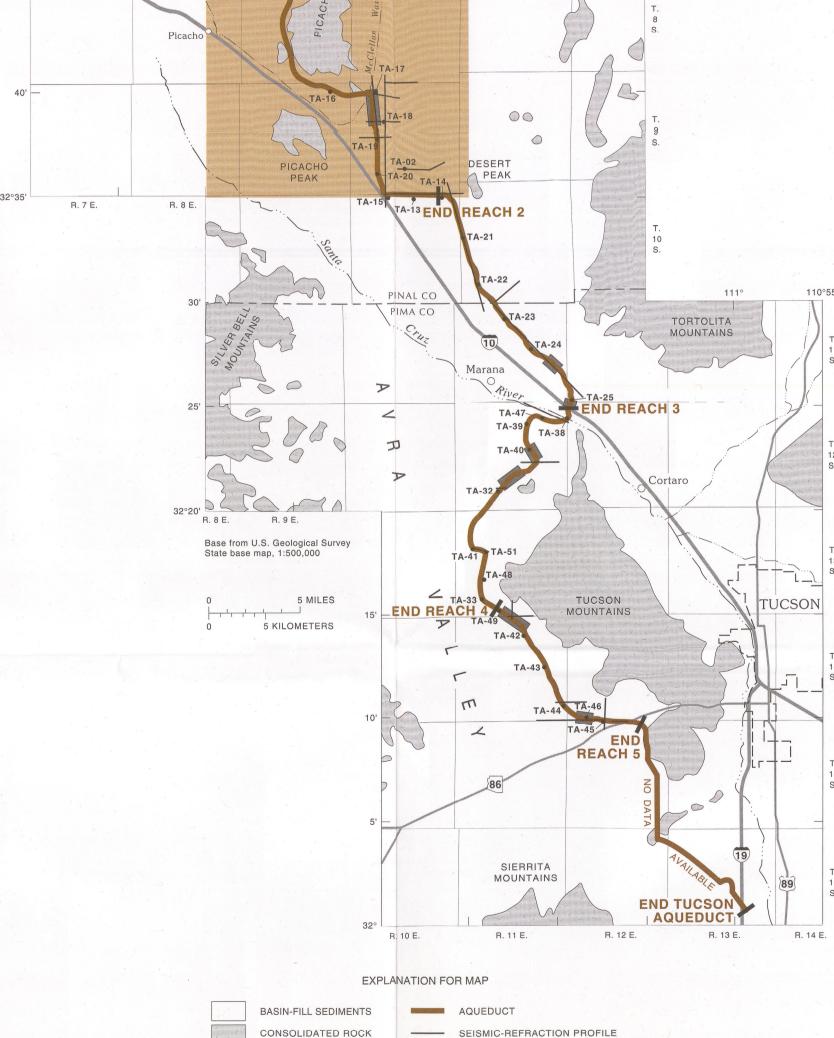
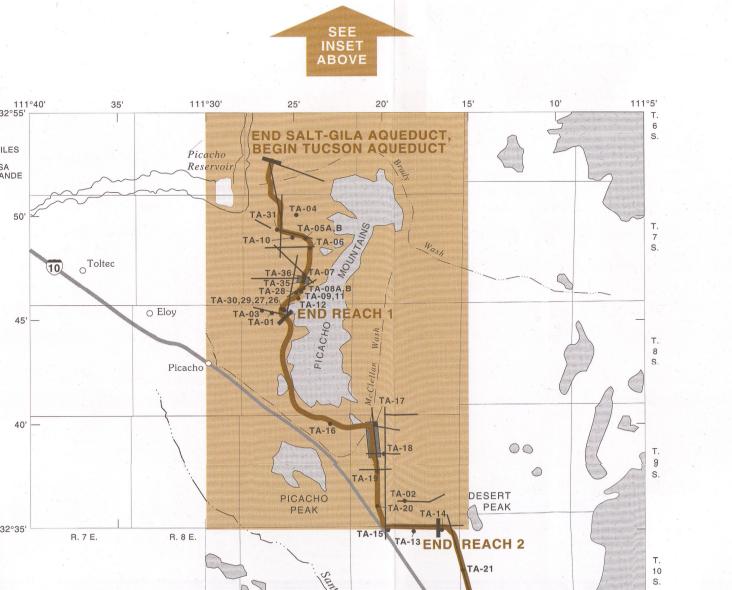
INSET SHOWING EARTH FISSURES ▼ BEGIN TUCSON AQUEDUC' **EXPLANATION FOR INSET** EARTH FISSURE DIRECTION OF FLOW

CONSOLIDATED ROCK SEISMIC-REFRACTION PROFILE number are identifier. See Wrege and others, 1985, for well information

A series of 50 deep test holes with an average spacing of about 1.5 mi were drilled along the Tucson Aqueduct route (fig. 1) to determine the thickness and physical characteristics of the alluvial aquifer materials and the lithology of the underlying consolidated rock units (Wrege and others, 1985). Locations for test holes were selected on the basis of available surface and subsurface geologic data and surfacegeophysical surveys. Air and mud-rotary drilling techniques were used to drill test holes that ranged from 135 to 1,970 ft deep along and near the Tucson Aqueduct route (Wrege and others, 1985). Twenty-nine of the test holes were equipped with one or more piezometers to allow water-level measurements at selected depths within the alluvial aguifer. Five test holes (TA-10, -13, -32, -33, and -44) were instrumented with vertical extensometers to monitor compaction of the water-bearing units. Water-level and compaction data are recorded continuously at these sites (Evans and Pool, 2000).

Seismic-refraction profiles were used to help define the configuration of subsurface geologic features such as scarps, benches, or peaks that may control the location of earth-fissure hazards along the Tucson Aqueduct route (fig. 1). The seismic lines were laid out to transect areas of suspected subsurface geologic faults and to help define the configuration of the buried consolidated rock surface beneath the route. Data from about 75 mi of seismic profiles were collected along 39 seismic lines oriented along and at approximately right angles to the alignment of the Tucson Aqueduct. Thicknesses of the seismic-velocity layers were derived from seismic-refraction profiles.

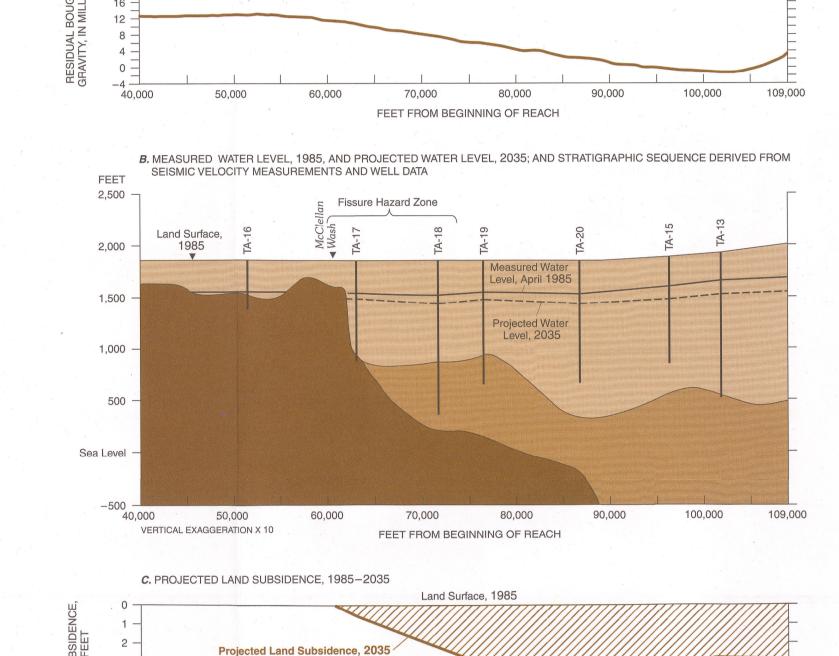
A. RESIDUAL BOUGUER GRAVITY PROFILE (Source of data: Lysonski and others, 1981)

Figure 3. Vertical profile representations along REACH 2 of the Tucson Aqueduct

Data from Bouguer gravity profiles, seismic-refraction profiles, well cuttings, and well logs were assembled into vertical profile plots for five reaches along the Tucson Agueduct route. The profile plots are shown together with the water levels for 1985 and the projected water levels for 2035 in figures 2–6. Historical water-level declines and subsidence at selected points within the study

Eight earth-fissure hazard zones were identified along the proposed route of the aqueduct. Water-level elevations and land subsidence amounts along each of the five reaches of the aqueduct were projected for 2035. The ranges of subsidence projections for the five reaches of the aqueduct generally are 0 to 4 ft for reaches 1 and 2, 1 to 3 ft for reach 3, 0 to more than 5 ft for reach 4, and 0 to 4 ft for reach 5 (figs. 2-6).

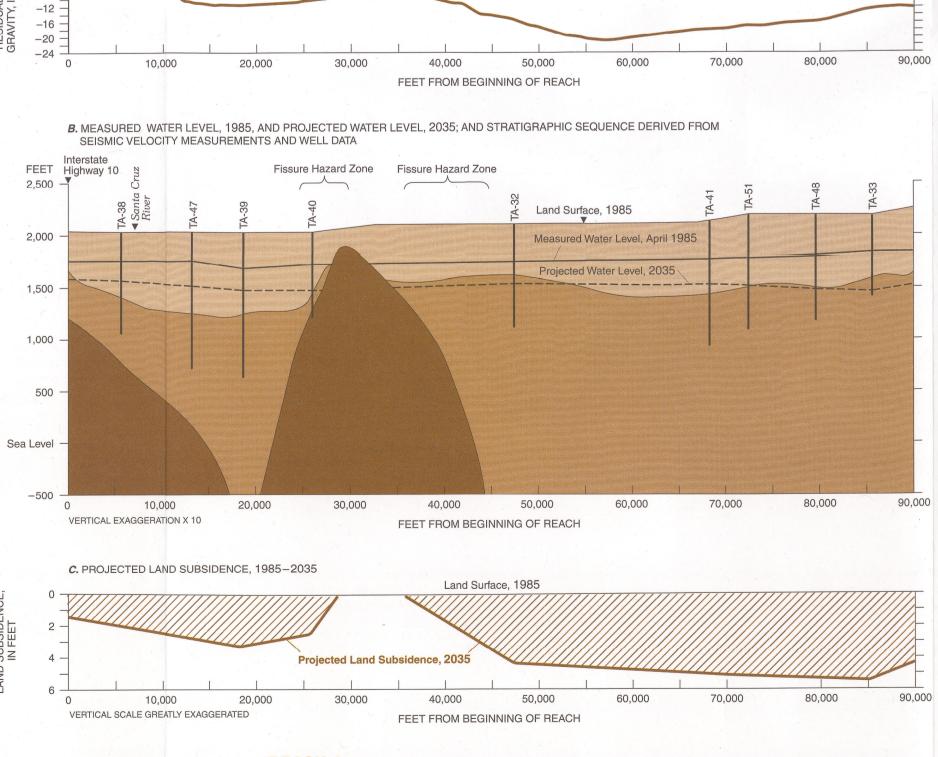
A. RESIDUAL BOUGUER GRAVITY PROFILE (Source of data: Lysonski and others, 1981)

Figure 5. Vertical profile representations along REACH 4 of the Tucson Aqueduct.
