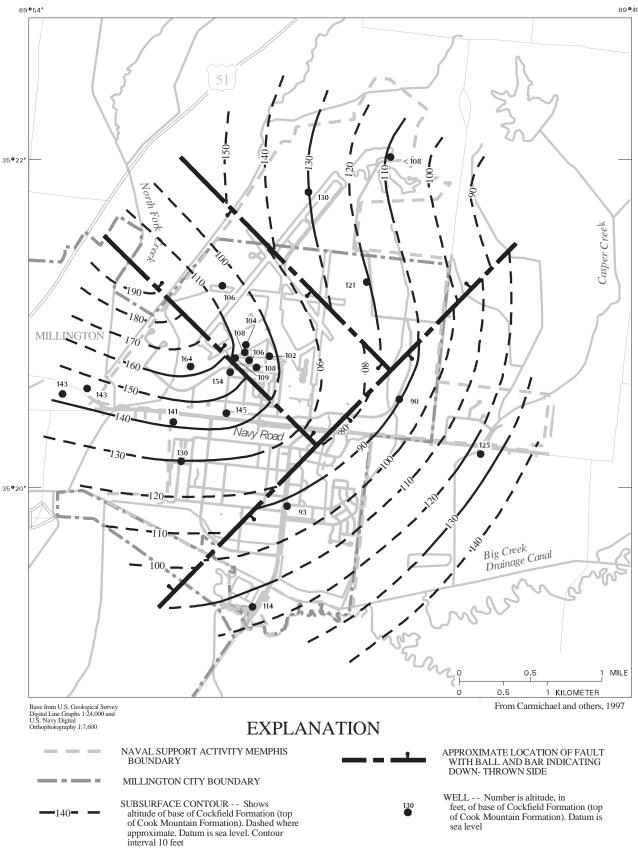
Figure 12. Altitude of base of Cockfield Formation (top of Cook Mountain Formation) and locations of faults that displace these formations at Naval Support Activity Memphis, Millington, Tennessee.
