Reconfigured-Channel Monitoring and Assessment Program

A U.S. Geological Survey program to monitor and assess channel reconfiguration activity is described. A data base available on the world wide web will enable land-management agencies and other interested parties to evaluate the long-term success of various channel reconfiguration projects. A demonstration project on the Lake Fork of the Gunnison River, Colorado, illustrates the program objectives and approach.

Lake Fork of the Gunnison River: A Demonstration Site

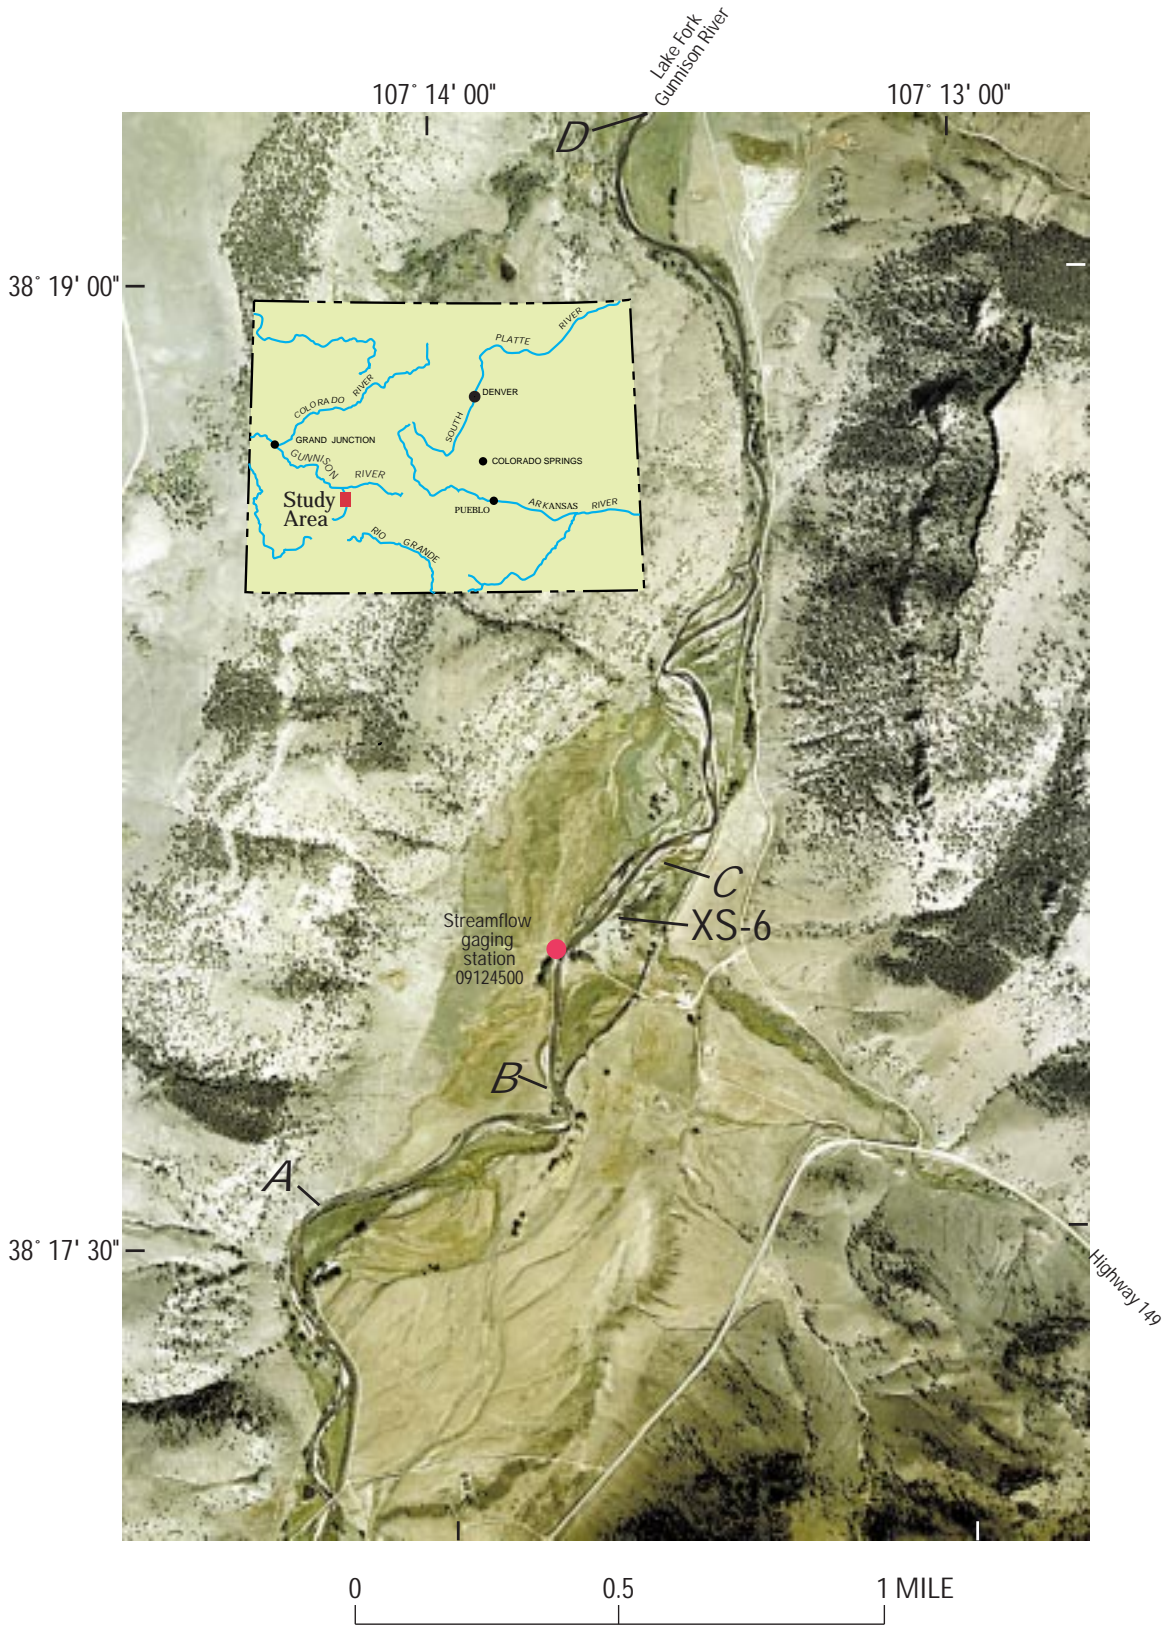
Figure 1. Aerial photograph of the Lake Fork of the Gunnison River at Gateview, Colorado, reach taken in 1977 before channel reconfiguration activities showing location of streamflow-gaging station 09124500, reach reconstructed in 1997 (A–D), and reach monitored by U.S Geological Survey in 1998 (B–C).

The Lake Fork of the Gunnison River at Gateview, Colorado, was selected as a demonstration site for the RCMAP (fig. 1). Prior to reconfiguration, this reach was characterized by a wide, shallow channel with a streambed composed of gravel, cobbles, and boulders (fig. 2A). Aerial photography from 1977 and onsite reconnaissance in 1992 indicate that segments of the river channel had been artificially straightened. Other segments were braided and prone to bank erosion and lateral shifting. Onsite reconnaissance and landowner interviews in 1998 indicated that some segments of the channel were laterally restricted by an engineered levee (figs. 3 and 4), and possibly dredged over a period of years.

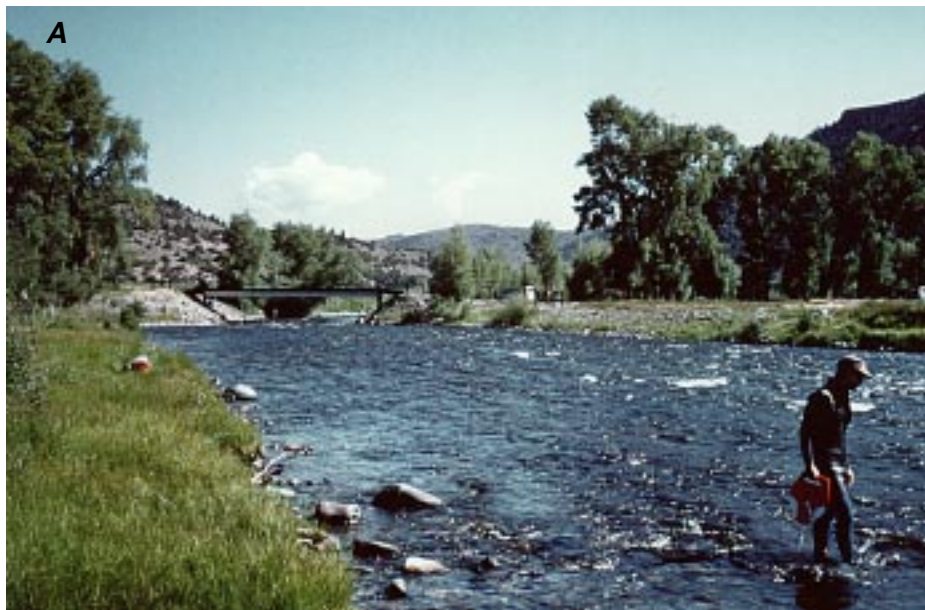
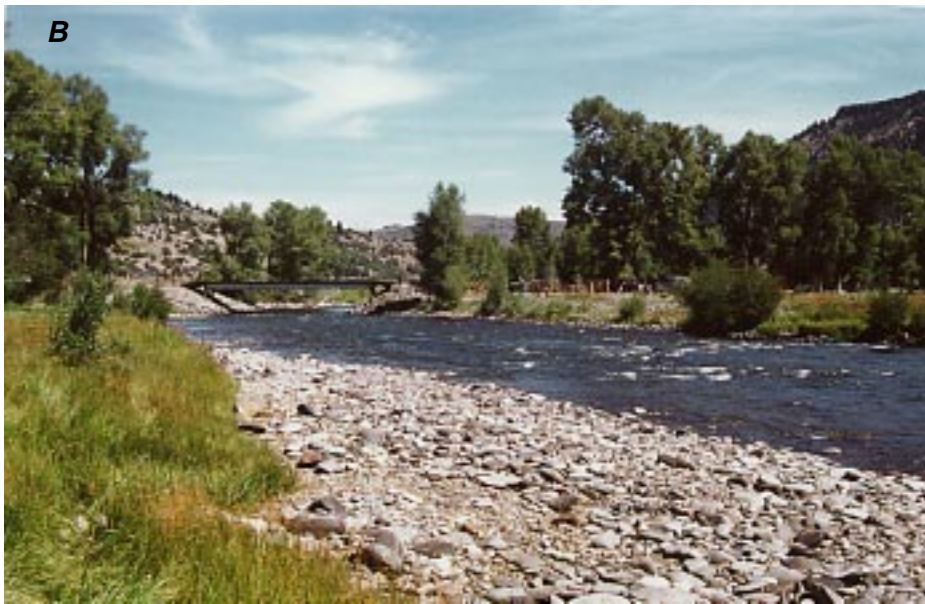
Figure 2. Lake Fork of the Gunnison River at Gateview, Colorado. Views looking downstream to the bridge near gaging station 09124500, (A) in 1992 prior to reconfiguration at a discharge of 270 cubic feet per second, and (B) in 1998 following reconfiguration at a discharge of 230 cubic feet per second. The cobble bar forming the left bank in (B) was constructed of material dredged from the streambed to the right. The large, partly submerged boulders in the right side of the channel in (B) were quarried offsite and added to the streambed during reconfiguration.

A 2-mile-long segment of the Lake Fork was reconfigured in late 1997 to mitigate past problems associated with flooding and gravel deposition on the flood plain and to improve the trout fishery. The channel modifications included (a) deepening of the channel by streambed excavation, (b) slight increases in sinuosity by constructing cobble alternate bars, (c) reduction of flow width and creation of streambank protection through addition of large cobbles and boulders to the former banks, (d) addition of streambed roughness elements and construction of grade-control and drop structures with large boulders (fig. 2), and (e) addition of vegetation root wads to riparian areas.
