Water-Supply and Irrigation Paper No. 192

DEPARTMENT OF THE INTERIOR  
UNITED STATES GEOLOGICAL SURVEY

# THE POTOMAC RIVER BASIN

GEOGRAPHIC HISTORY—RAINFALL AND STREAM FLOW—POLLUTION, TYPHOID  
FEVER, AND CHARACTER OF WATER—RELATION OF SOILS AND FOREST  
COVER TO QUALITY AND QUANTITY OF SURFACE WATER—  
EFFECT OF INDUSTRIAL WASTES ON FISHES

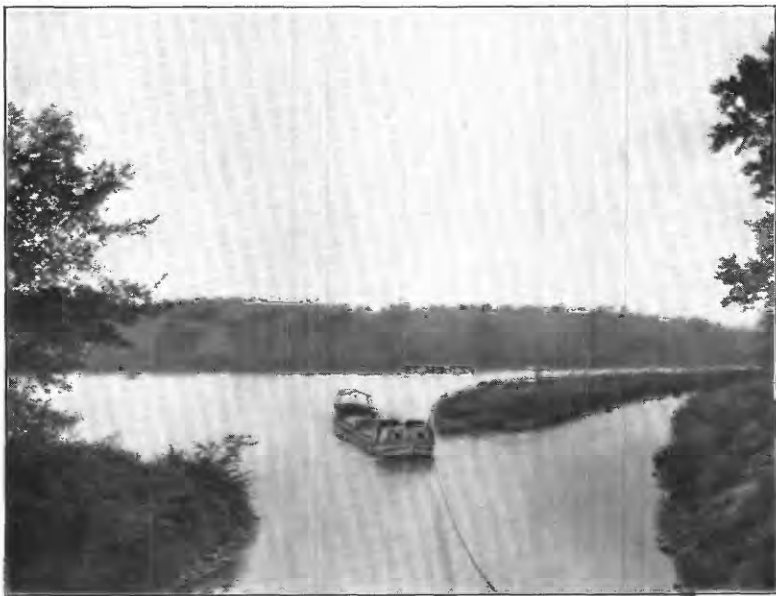
B. POTOMAC RIVER AND CHESAPEAKE AND OHIO CANAL AT DAM NO. 5.

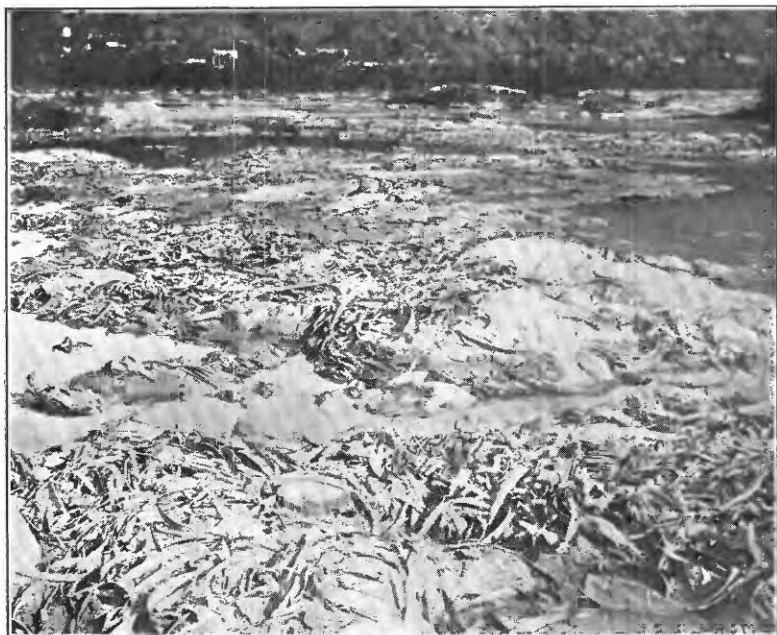
B. POLLUTION OF POTOMAC RIVER BY WASTES FROM THE MECHANICAL WOOD-PULP MILL AT HARPERS FERRY.

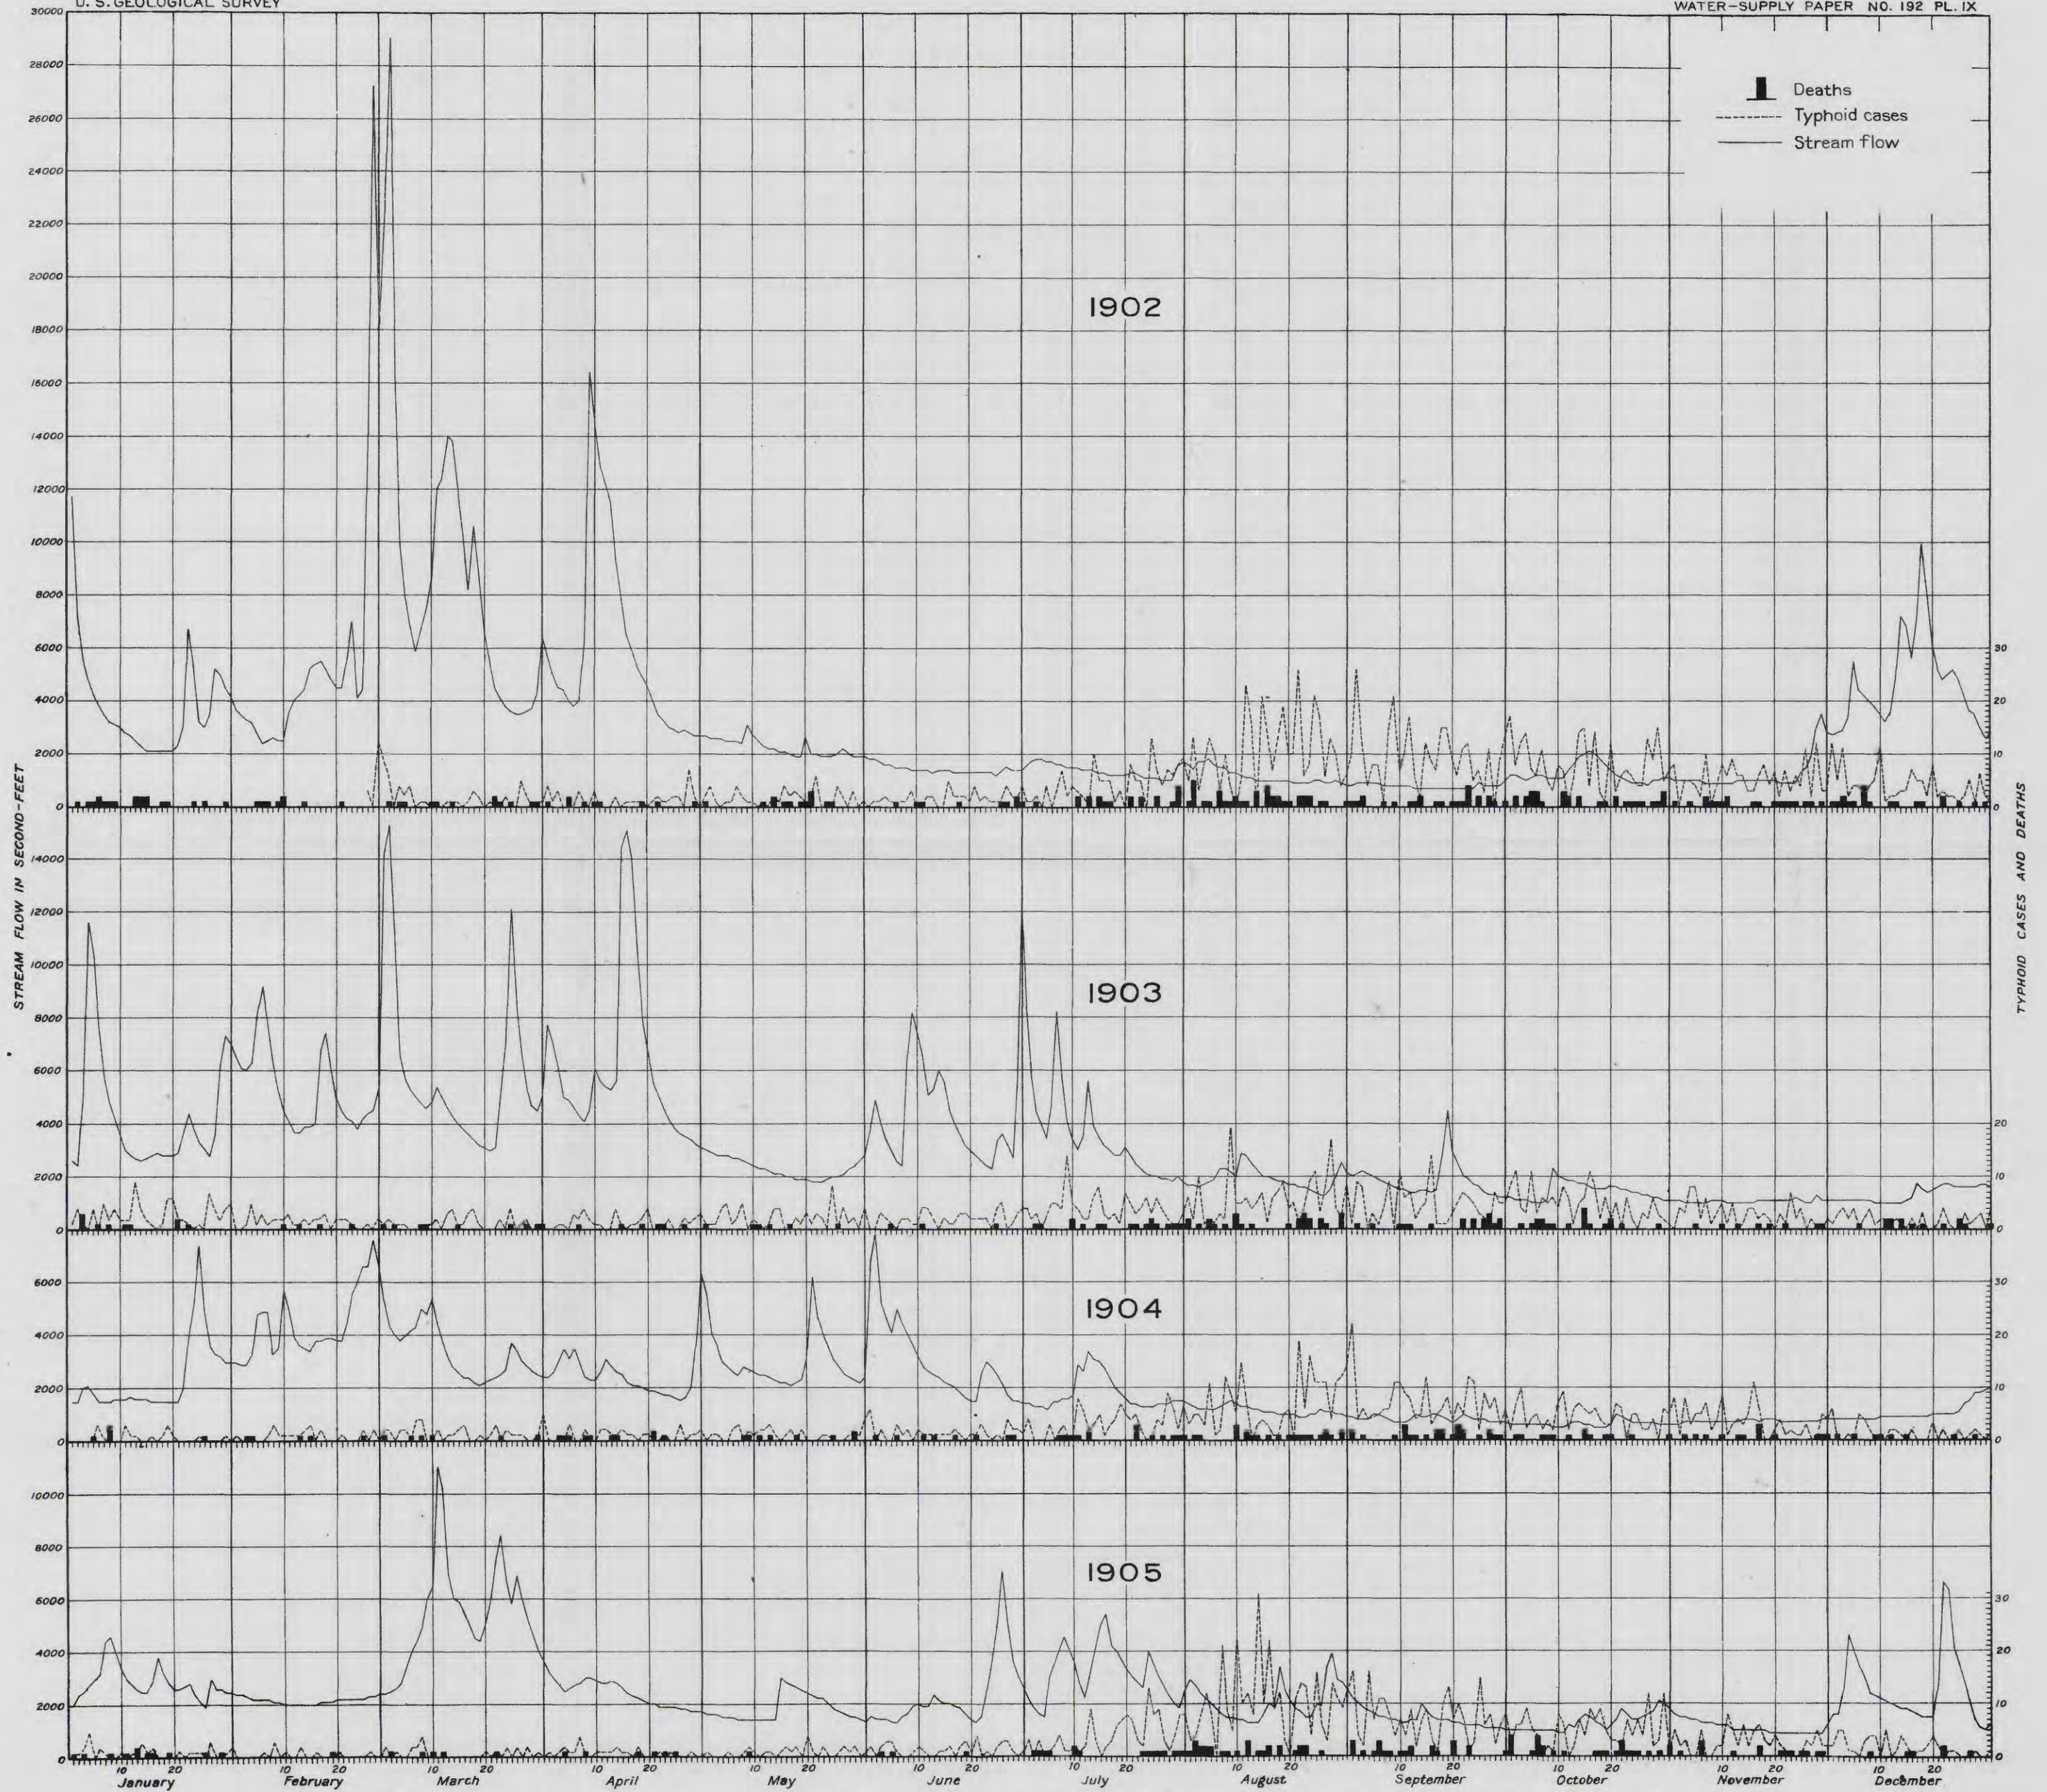
DIAGRAM SHOWING RELATION OF STREAM FLOW TO CASES OF TYPHOID FEVER IN THE DISTRICT OF COLUMBIA

Pl. IX shows for the years 1902, 1903, 1904, and 1905 the daily flow of Potomac River at Point of Rocks, the daily deaths from typhoid fever in the District of Columbia, and the number of cases of typhoid fever reported daily at the health office of the District. The total deaths and the deaths from typhoid fever in the District from August, 1874, to December, 1905, inclusive, are shown in the table on pages 281-282.

Pl. IX shows that typhoid fever is prevalent during periods of low water, while there are comparatively few cases in the portions of the year when the water is high. At first thought these results seem surprising, for it would perhaps be natural to expect that the periods of excessive typhoid would occur in flood seasons, when a great deal of filth and excrement are washed into the river. But one who is thoroughly familiar with the river realizes that it is the constant recipient of large amounts of fecal matter from the many sewers and multitude of privies that line its banks and that the scourings intermittently washed into the stream are small, indeed, compared to the excrement that is every day dropped into it. Therefore it is perfectly natural that when this everyday defilement is concentrated in a small stream flow the results should be disastrous, for at such times, when typhoid germs are present, the chances of one's drinking a considerable dose of them are many times multiplied. Typhoid fever is known to be a disease of summer and autumn, and therefore the bacilli are most likely to be in the stools at the very time the river is low. If the germs are not present, there will not be typhoid in times of low water. It can be seen from an inspection of the diagram (Pl. IX) that low water has occurred in winter, but that there has not been a large increase of typhoid following. It would be foolish to maintain that a rain never brings about an increase of typhoid among the users of Potomac water. It may do so, provided it washes in a large quantity of bacilli and does not at the same time bring about such a dilution of the water containing them that the possibility of drinking them is no greater than it was before. There is an ever-

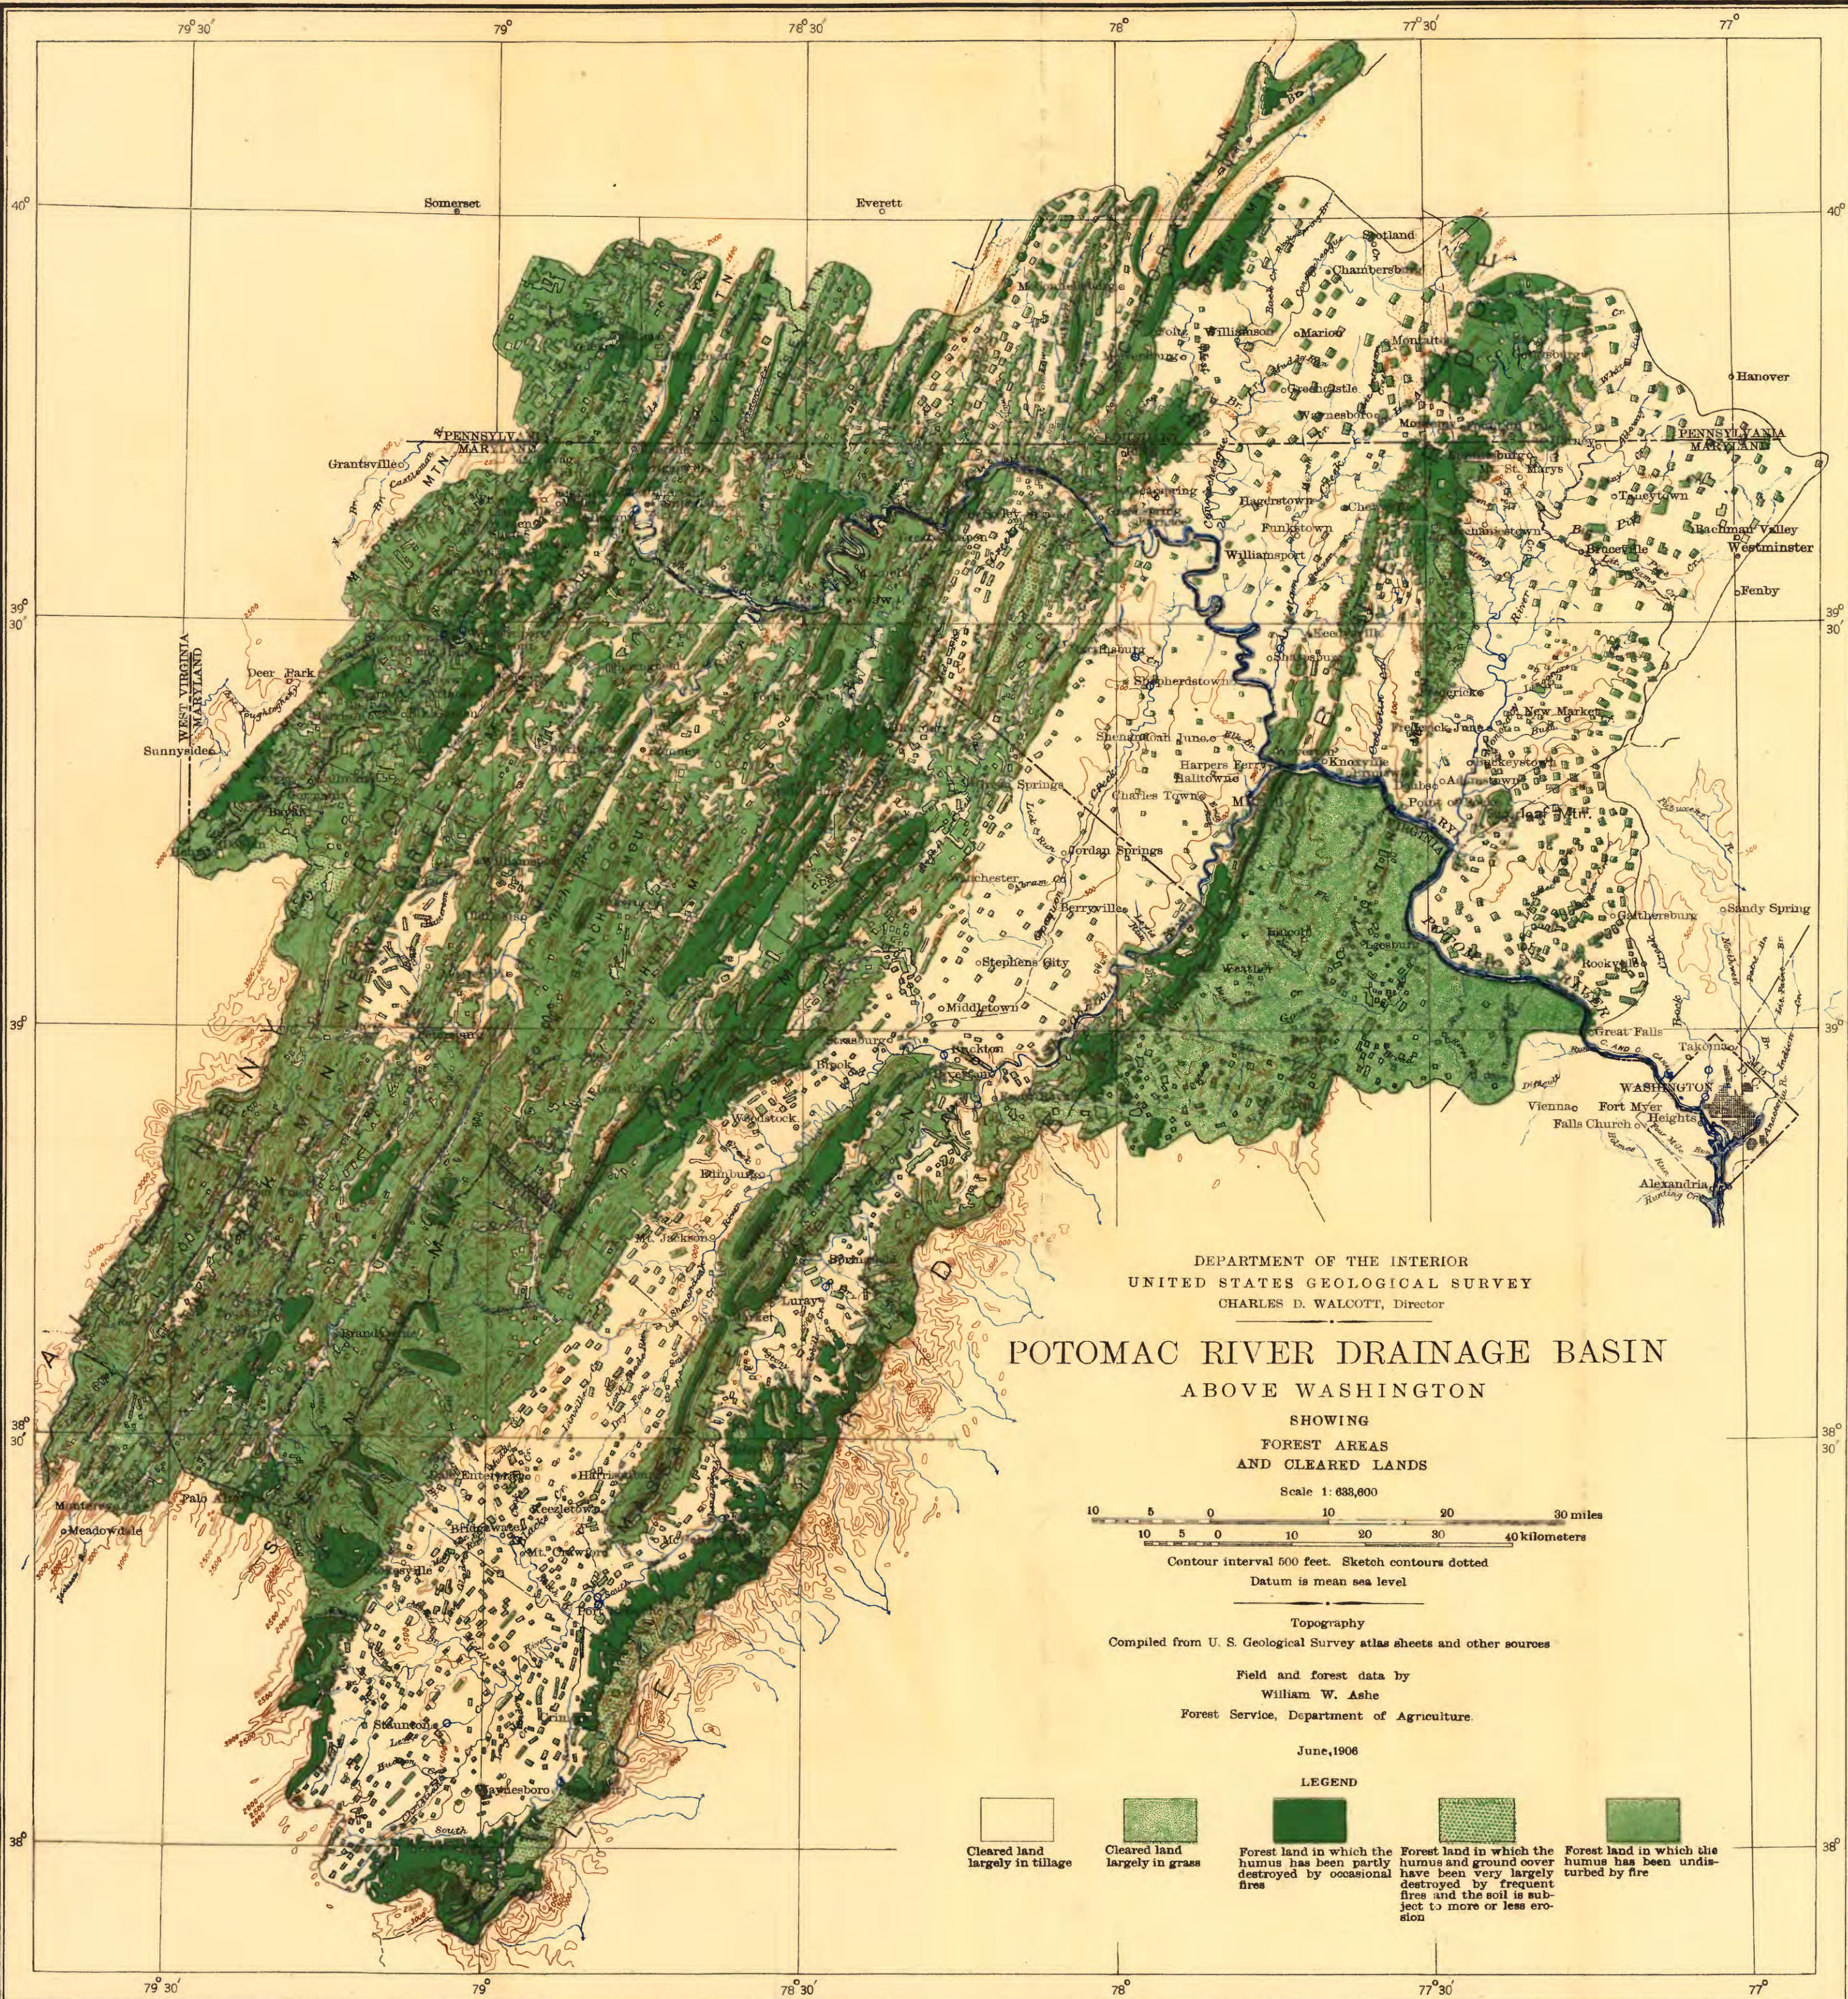
**POTOMAC RIVER DRAINAGE BASIN**  
 ABOVE WASHINGTON
