A. COLORADO RIVER AT LEES FERRY WITHOUT CORRECTION FOR DEPLETION

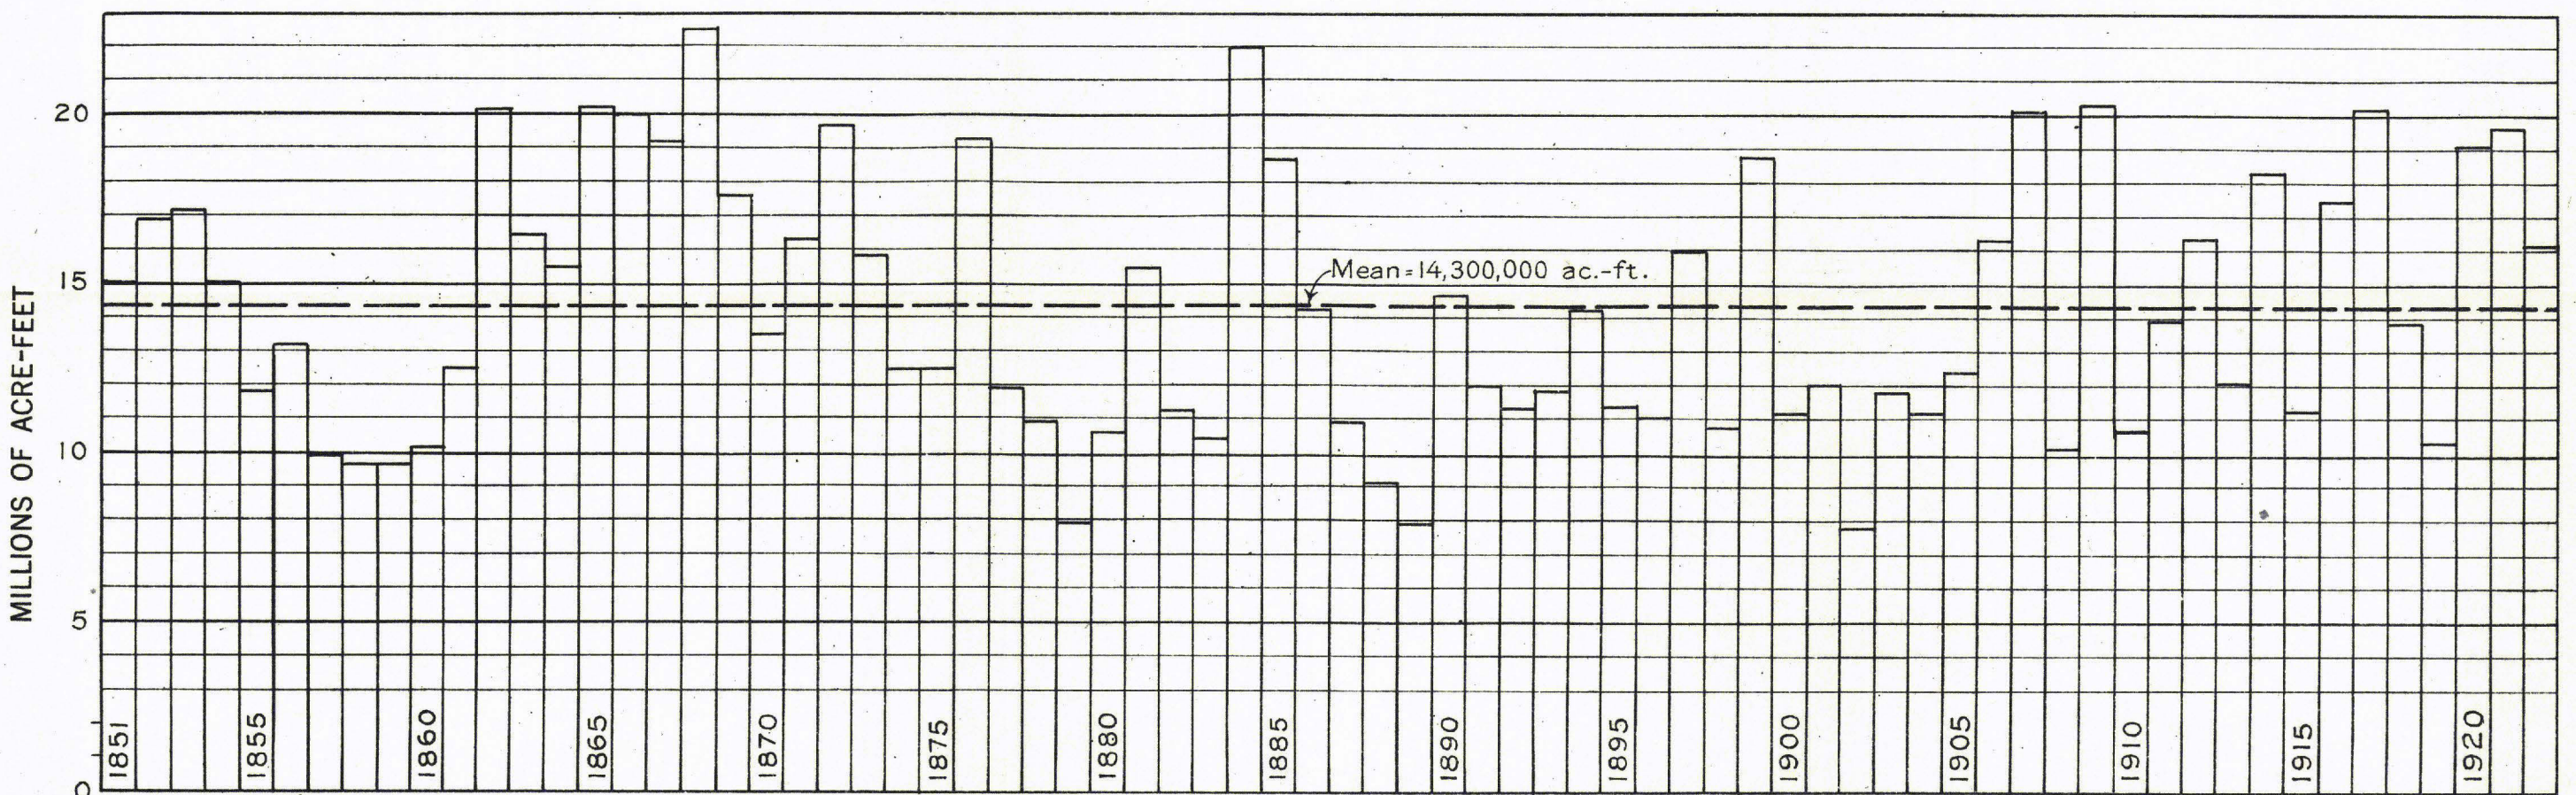
B. COLORADO RIVER AT LEES FERRY CORRECTED FOR PAST IRRIGATION DEPLETION

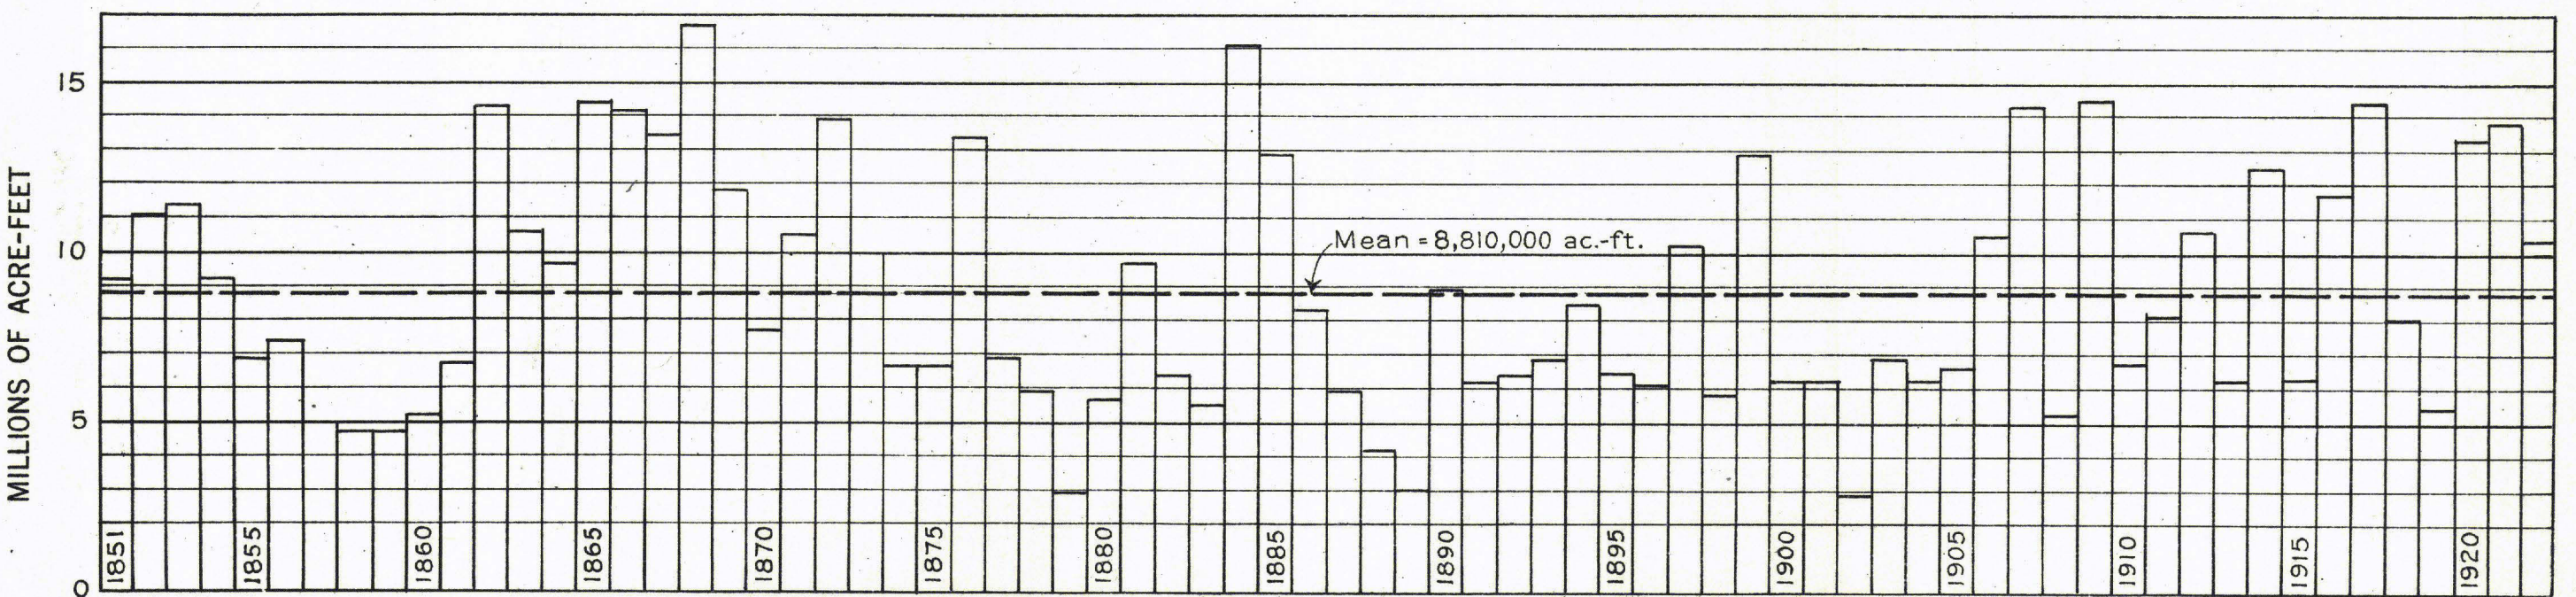
C. COLORADO RIVER AT LEES FERRY WITH COMPLETE IRRIGATION DEVELOPMENT IN THE UPPER BASIN

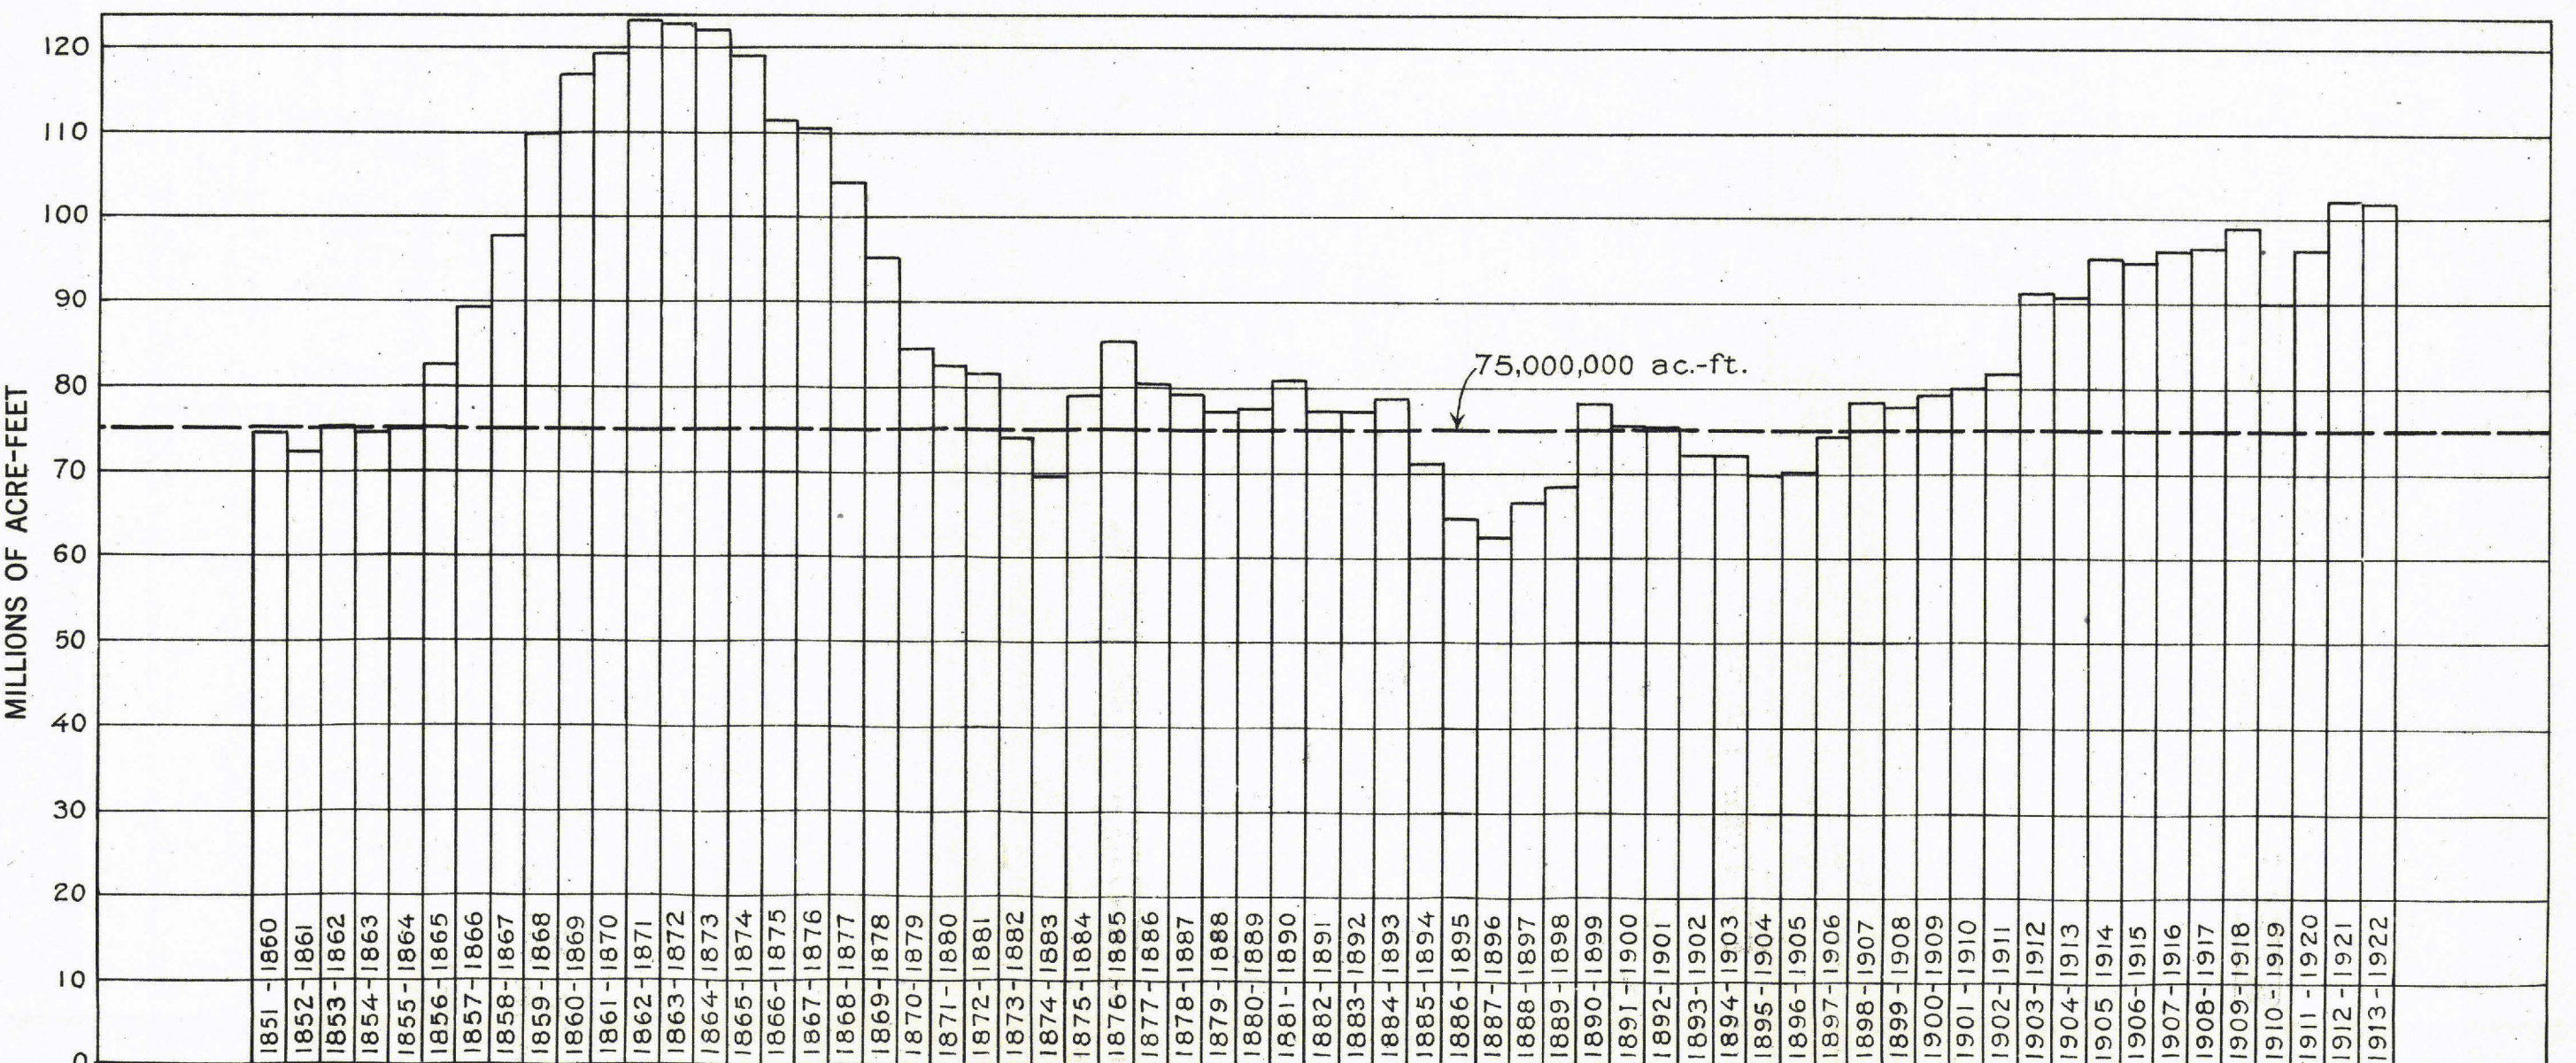
D. COLORADO RIVER AT LEES FERRY WITH COMPLETE IRRIGATION IN THE UPPER BASIN. 10-YEAR PERIODS
