GENERAL CHARACTERISTICS OF CERTAIN PRE-1936 DEPOSITS IN THE CONNECTICUT VALLEY.

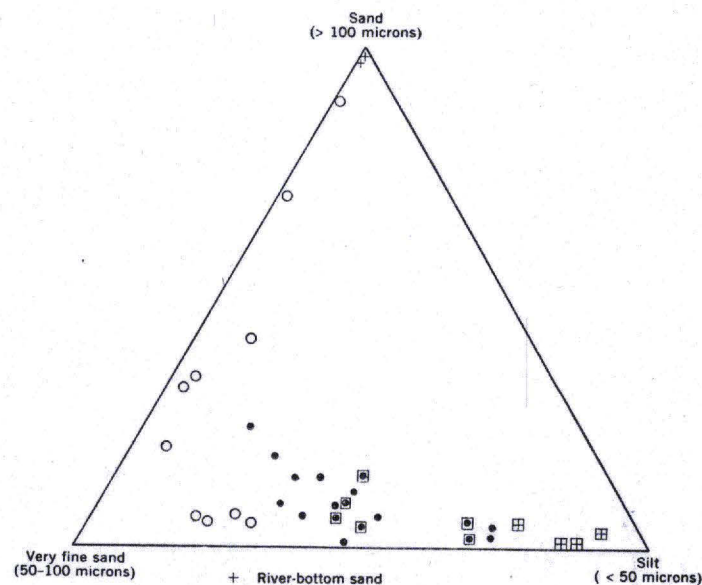
A. Flood-plain materials

- + River-bottom sand
- Sample from lower flood-plain or "banded" sequence
- Sample from upper flood-plain sequence
- ▣ Loessial material from upper flood-plain sequence
- ▤ Loess sample from Ohio Valley area (Water-Supply Paper 838, pl. 25, fig. 13)
