MAP OF THE EDISON-MARICOPA AREA, CALIFORNIA, SHOWING THE DEPTH TO THE MAIN WATER BODY IN DECEMBER, 1958

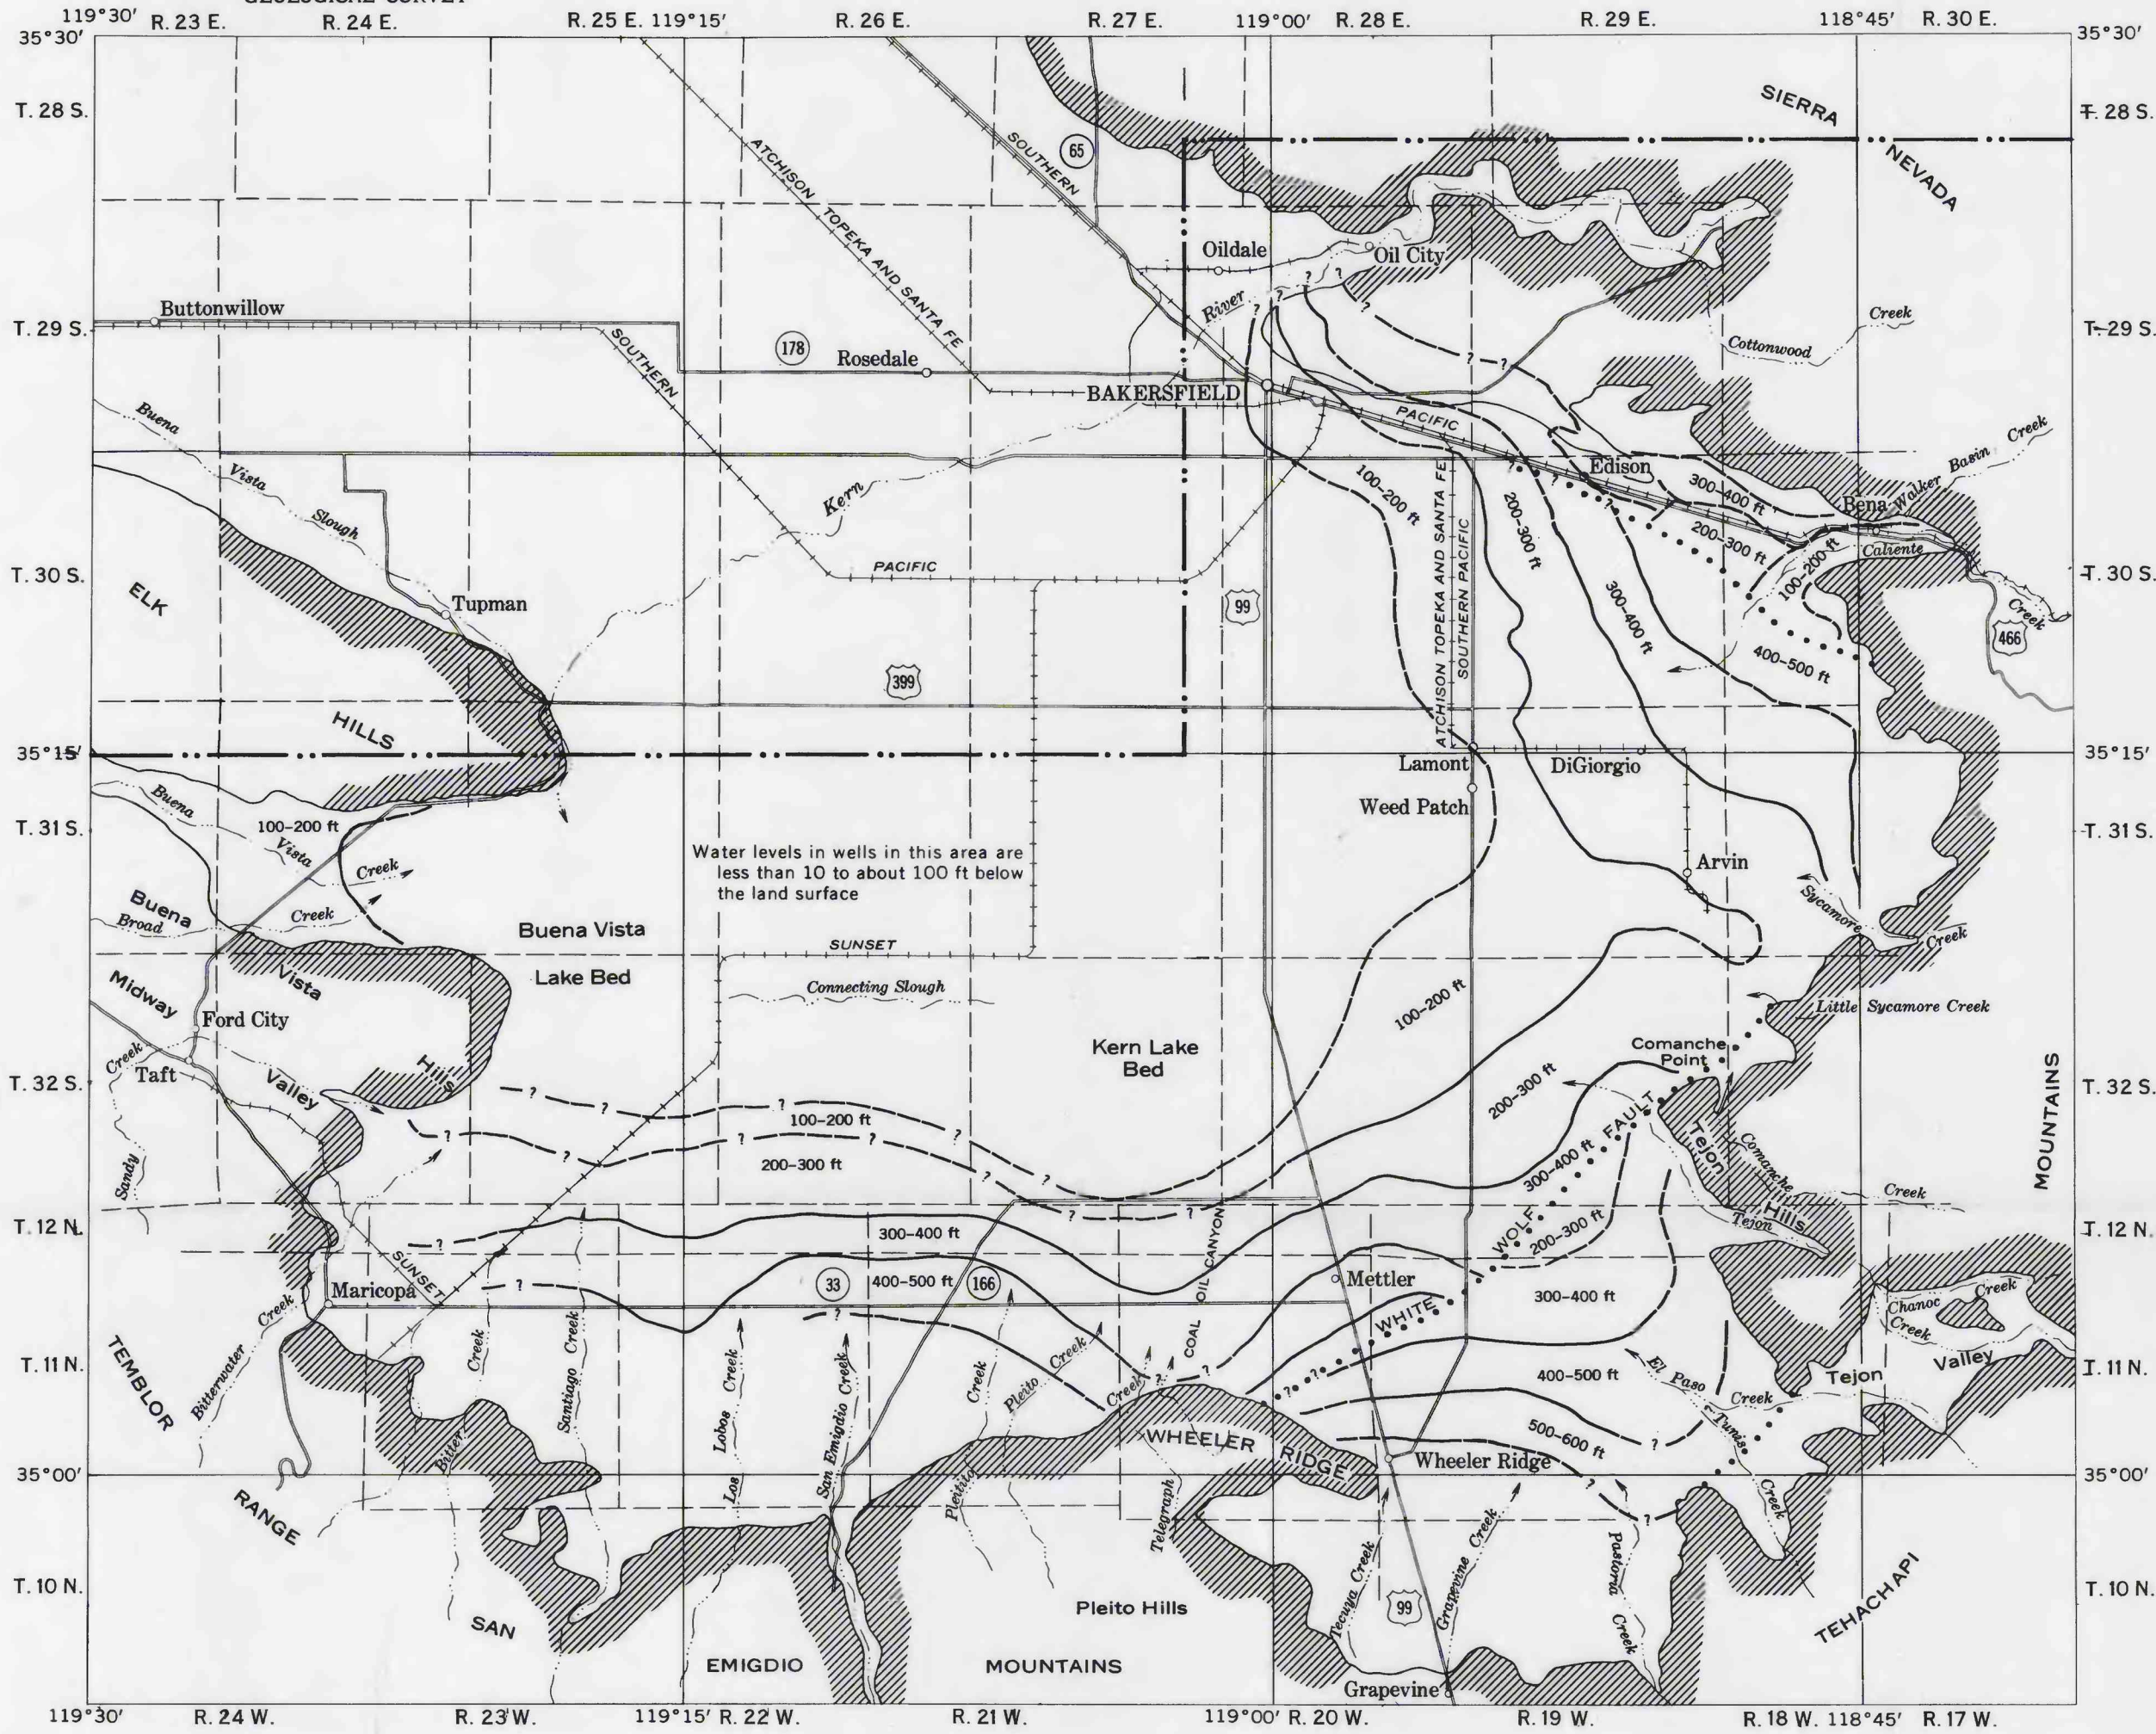
—?—
Line of equal depth to water
Dashed where approximate; queried where uncertain

Ground-water barrier
Queried where uncertain
