**U.S. DEPARTMENT OF THE INTERIOR  
U.S. GEOLOGICAL SURVEY**

**RECONNAISSANCE REPORT ON THE 12 OCTOBER 1992  
DAHSHUR, EGYPT, EARTHQUAKE**

Open-File Report 93-181

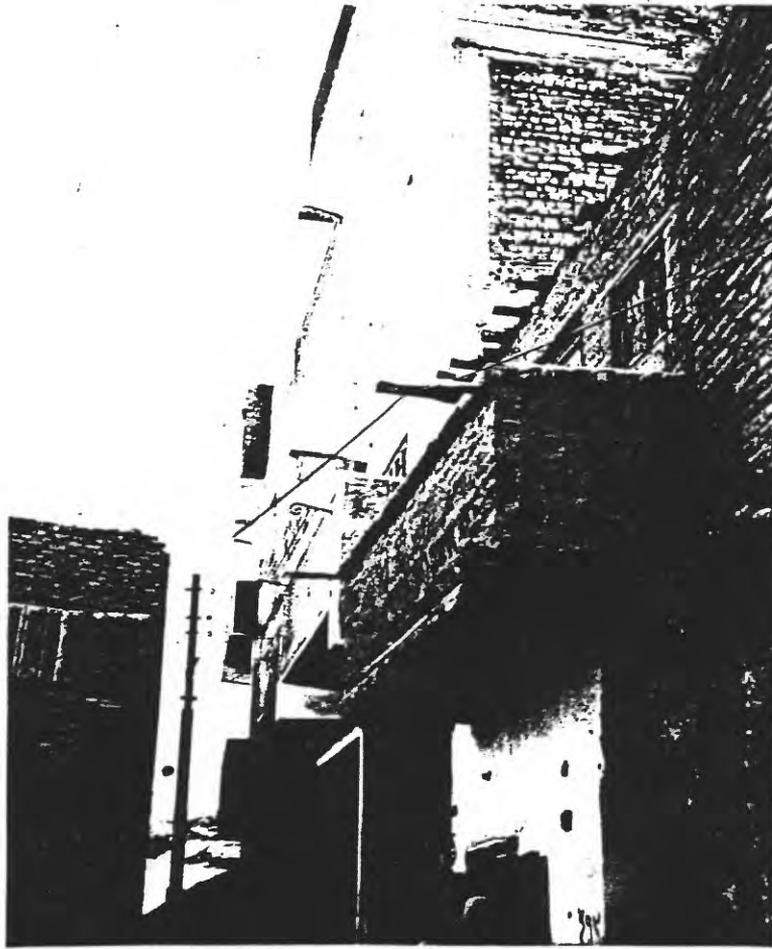
Figure 5. Better built brick masonry and reinforced concrete framed building with infill walls.

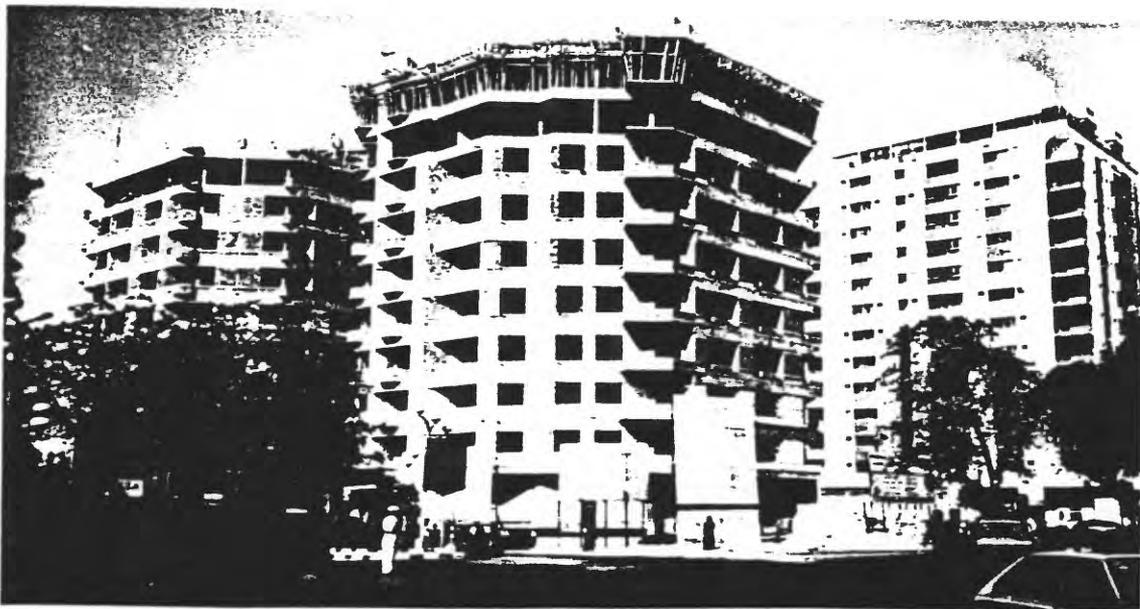
In general, most mid-rise and tall buildings are reinforced concrete framed with brick infill walls. Two such buildings under construction are shown in Figure 10. An older building of this type is shown in Figure 11. These buildings appeared to be well constructed and did not suffer any damage. Another building shown in Figure 12 appeared to be slightly out of plumb. The corner column (Figure 13) and some of the internal infill walls of the building were damaged. Similarly, the building in Figure 14 experienced damage to some of its columns and beams (Figure 15). These appeared to be local. The foundations of both of the buildings (Figure 12 and 14) possibly were not deeply embedded. The basement of the building in Figure 14 was only half embedded and one of the foundation footings (dug out) was not deeper than one-half meter and was moist because of high water table. To further illustrate possible foundation and foundation-embedment problems that may affect the performance of many such buildings in Cairo, in Figure 16, the foundation of a 14-story reinforced concrete building originally designed as 8 stories) is shown. The foundation footing to column reinforcement, sticking out after the rubble had been cleared, appeared to be insufficient. Clearly, such a foundation system is inadequate for an 8- or 14-story building. The collapse of this building resulted in the loss of 69 lives. There is a large inventory of such buildings in Cairo. It is possible that, in many cases, there may have been significant rocking of such 5-15 story rather stiff buildings that have shallow-embedded or non-embedded foundations.

Figure 10. Two reinforced concrete framed buildings with infill walls (under construction).

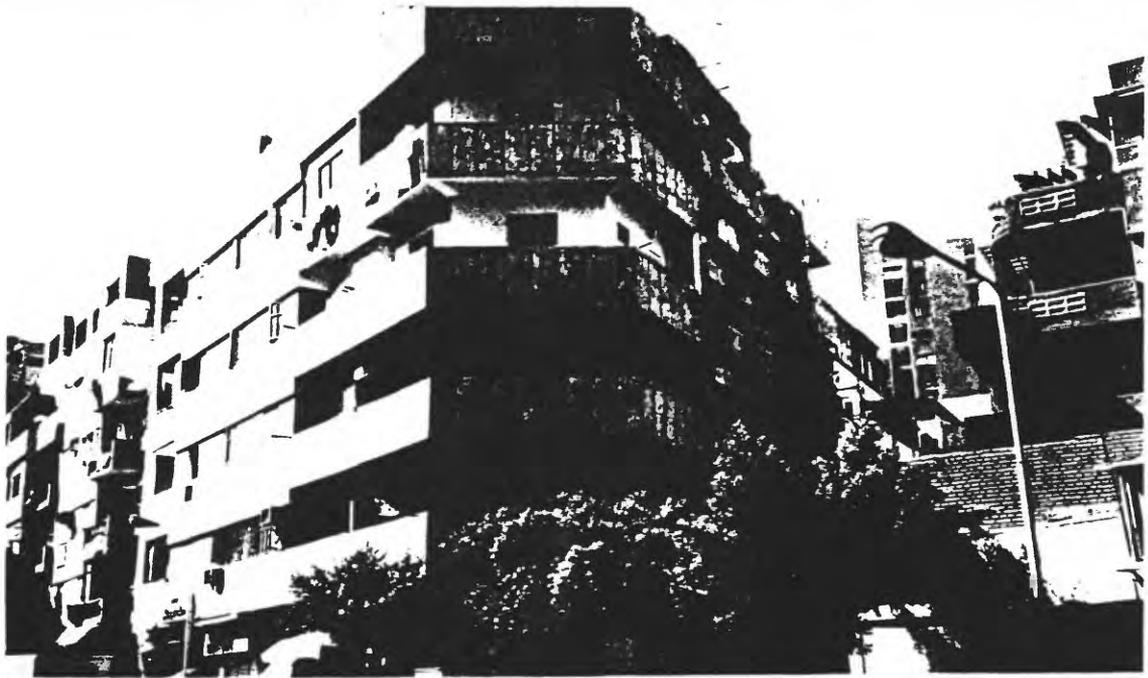
Figure 11. An older reinforced concrete framed building with infill walls.

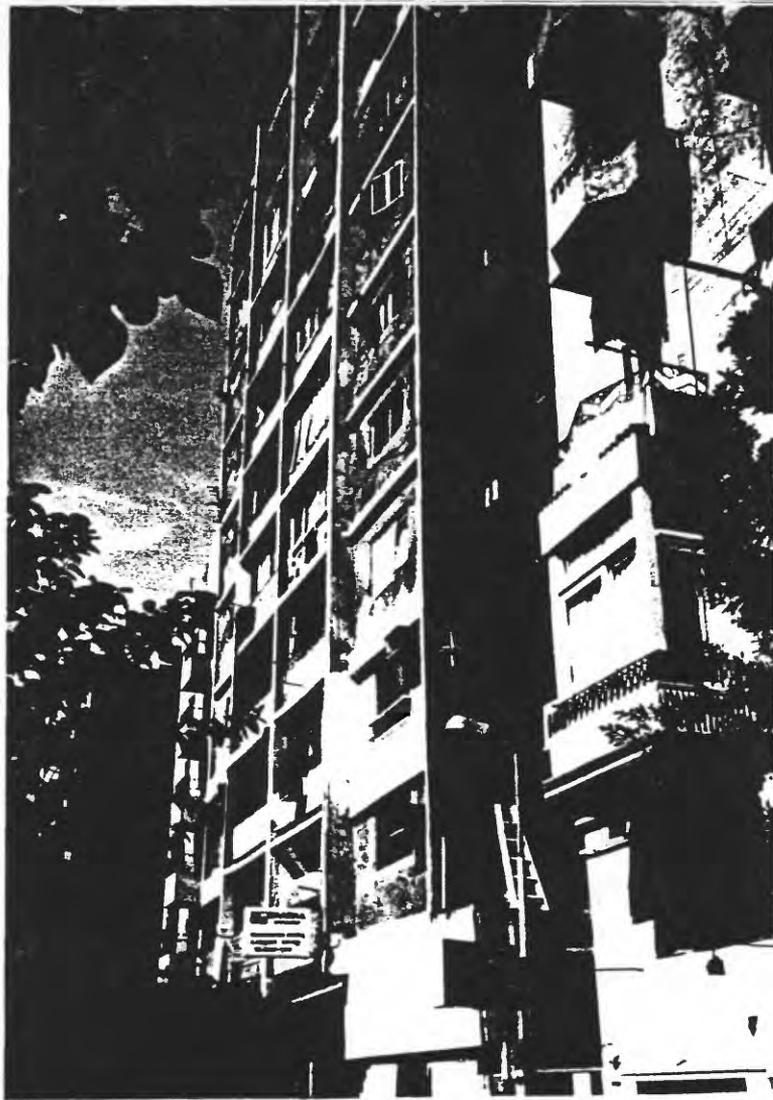
Figure 14. An eleven-story reinforced concrete building with infill walls.

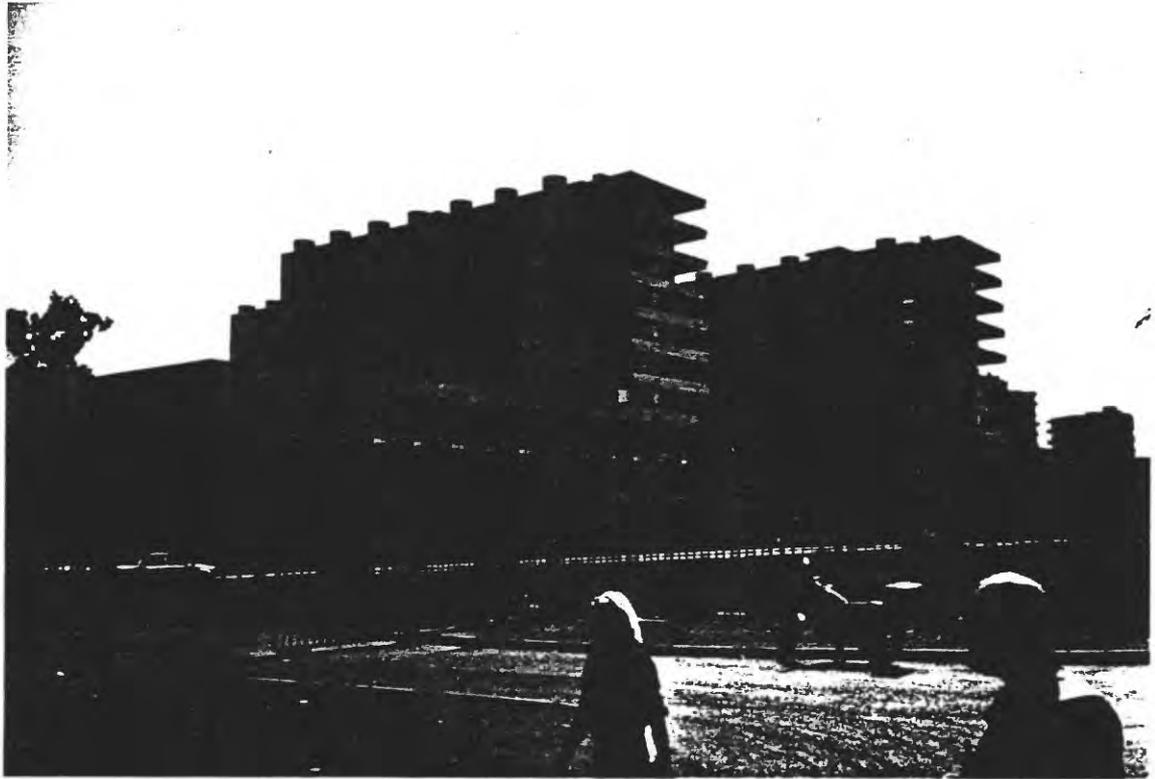
A modern hospital building in Cairo is seen in Figure 22. This building was reported not to have suffered any damage. An older hospital (Figure 23) suffered minor structural and non-structural damage. One person was reported to have been killed and 400 persons injured in this hospital

Figure 22. Nasser Institute Hospital in Cairo.

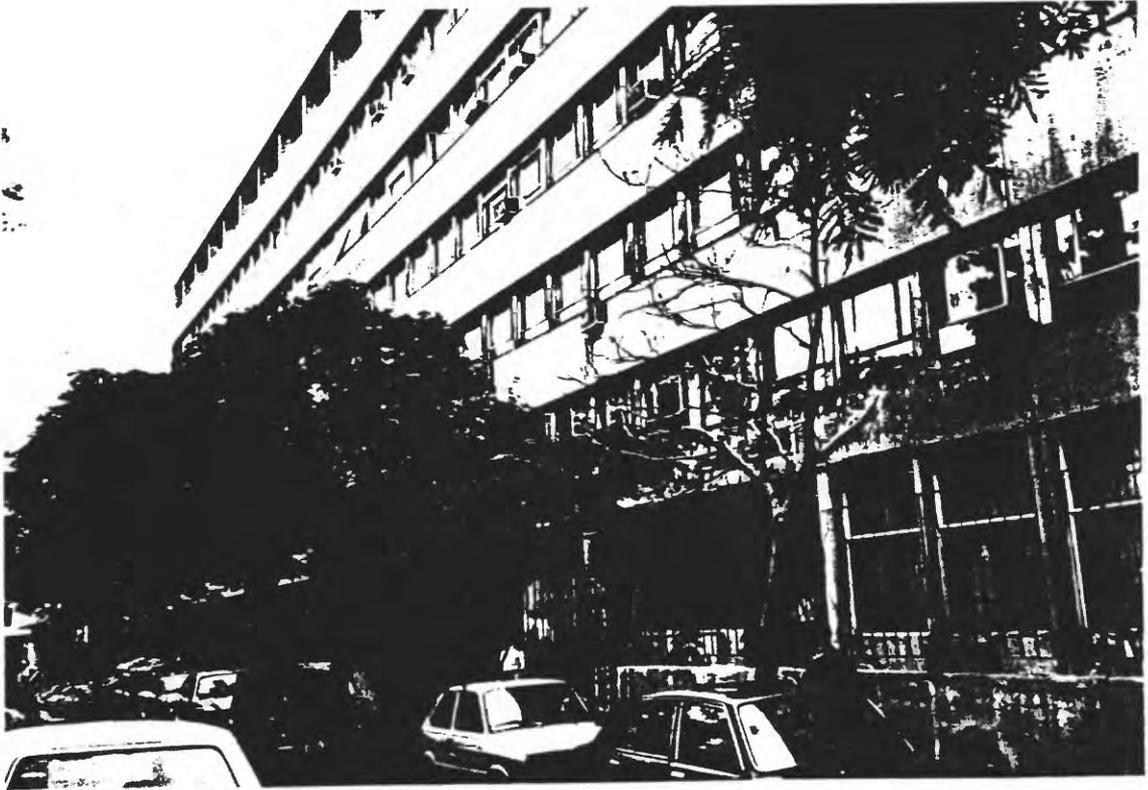
Figure 23. Shobra Hospital in Cairo.

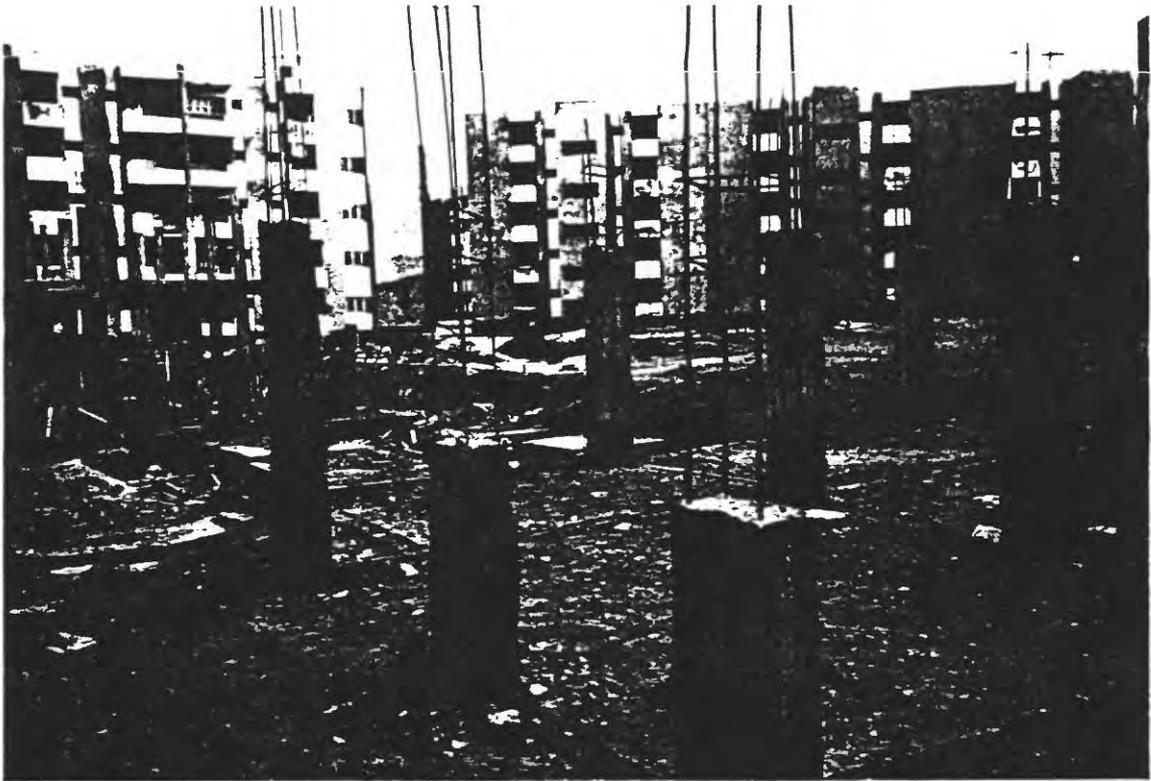
Figure 24. "10 Ramadan City" -- Reinforced concrete framed buildings with infill walls (complete and under construction).
